EVALUATION OF RUNOFF LOADINGS AND IMPACTS FROM UNTREATED LAKE HOLDEN DRAINAGE SUB-BASINS

**Draft Final Report
October 2016**

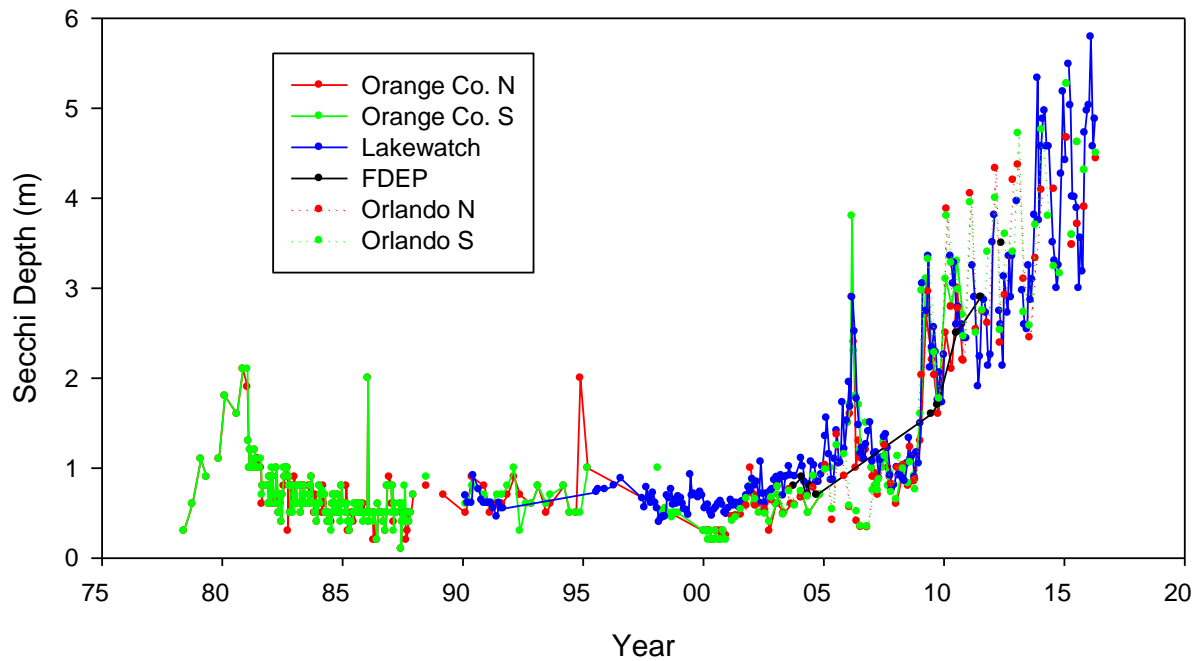
A graphical summary of historical Secchi disk depth measurements in Lake Holden from 1978-2015 is given in Figure 2-4. Similar to the trends previously observed for total nitrogen, total phosphorus, and chlorophyll-a, Secchi disk depth has been highly variable in Lake Holden over the past 30-40 years. Secchi disk measurements substantially less than 1 m were common in Lake Holden during the period from approximately 1980-2000. However, beginning in 2000, Secchi disk depths within the lake began to increase gradually, with rapid improvements in Secchi depth beginning in 2005. The sudden increases in Secchi disk depth illustrated on Figure 3-4 from 2005 to the present are likely related to the combination of the ongoing stormwater enhancement projects and alum sediment inactivation treatments conducted to the lake during this time. In general, Secchi disk measurements appear to be relatively similar between the various sources, although slightly lower Secchi disk depths have been reported by Orlando during the many events. Measured Secchi depth measurements over the past five years have consistently exceeded 3 m, with many Secchi disk measurements in excess of 4 m. Current Secchi disk depth in Lake Holden is also similar to some of the more pristine lakes in the Butler Chain.

Figure 2-4. Summary of Historical Secchi Disk Depths in Lake Holden from 1978-2015.

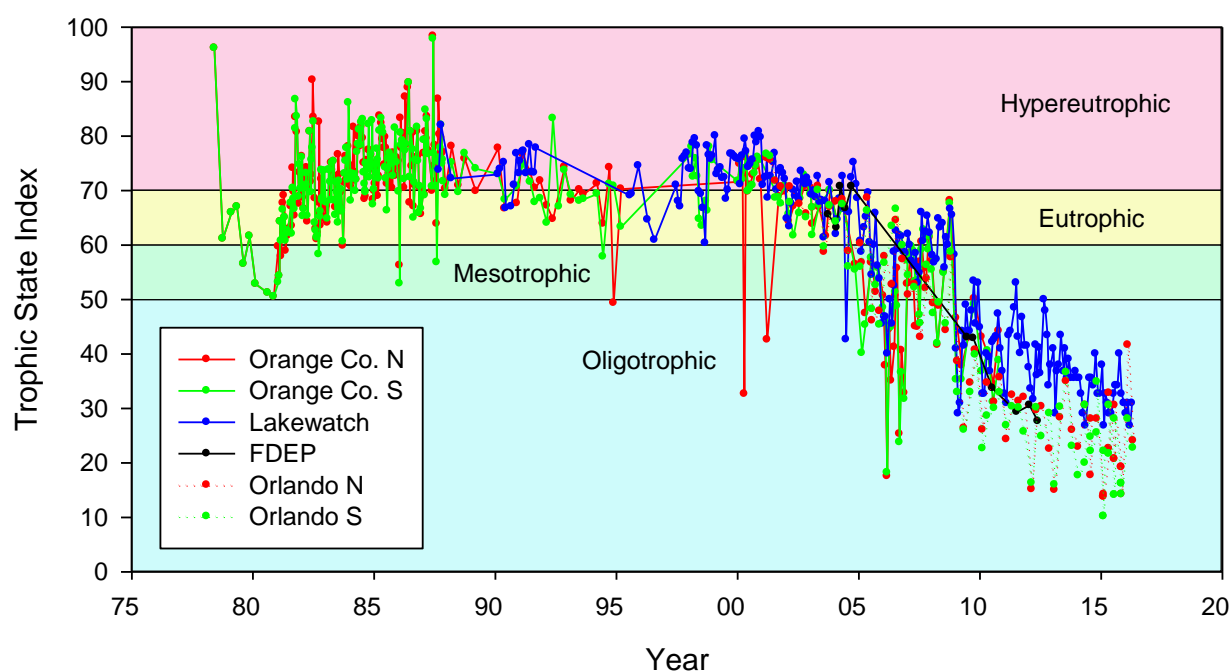
A graphical summary of calculated trophic state index (TSI) values in Lake Holden from 1978-2015 is given in Figure 2-5. Since TSI is a measure of primary productivity, TSI values are calculated using chlorophyll-a only when chlorophyll-a data are available. If chlorophyll-a data are not available, then the TSI is estimated as the average of the TSI values for total phosphorus and Secchi depth. During the period from 1980-1990, Lake Holden was classified as a eutrophic or hypereutrophic lake system, with many calculated TSI values in excess of 80. A significant decrease in TSI values began to occur within the lake during 2000, with the TSI value gradually decreasing from hypereutrophic to eutrophic to mesotrophic, and highly oligotrophic conditions observed beginning in 2007. Over the past 10 years, calculated TSI values in Lake Holden have indicated primarily oligotrophic conditions.

Figure 2-5. Summary of Historical Trophic State Indices (TSI) in Lake Holden from 1978-2015.

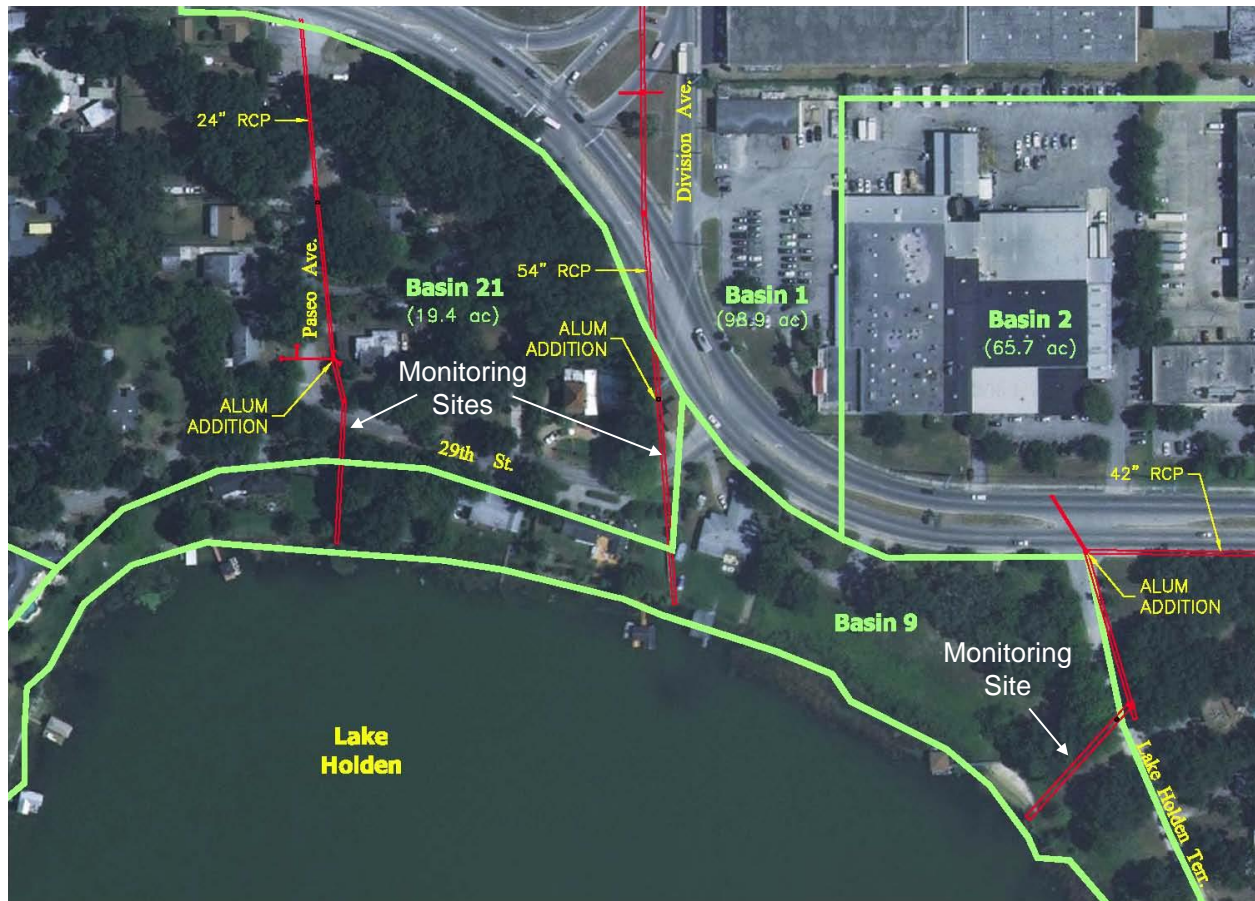
Figure 3-3. Overview of the Drainage System and Monitoring Sites for Alum Treated Sub-basins B-1, B-2, and B-21.

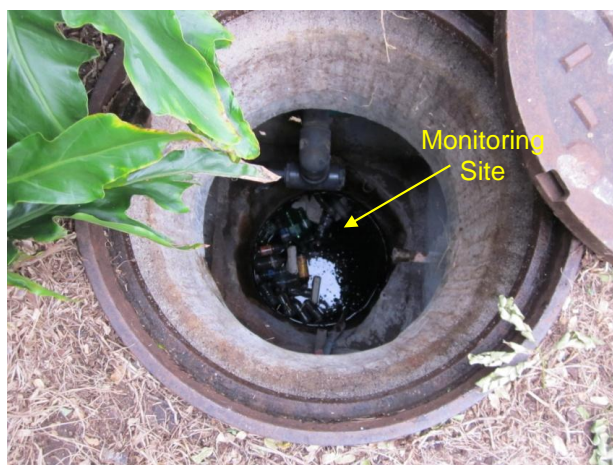
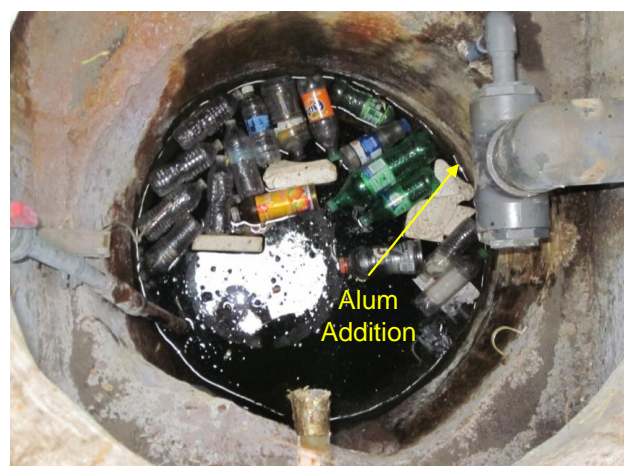
Manhole access location used for stormwater monitoring

Collected debris inside manhole

Figure 3-4. Runoff Monitoring Location for Sub-basin B-1 (Division Street).

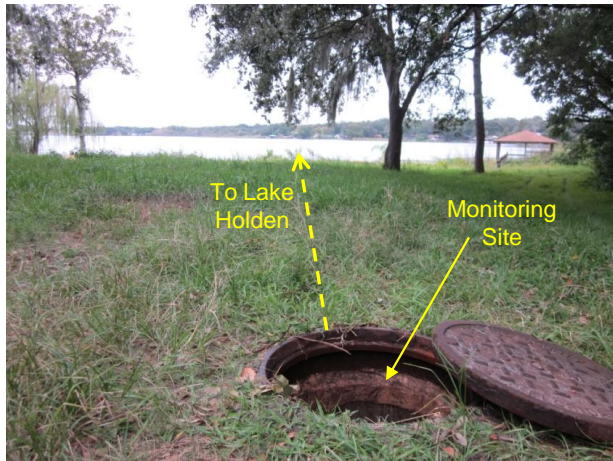
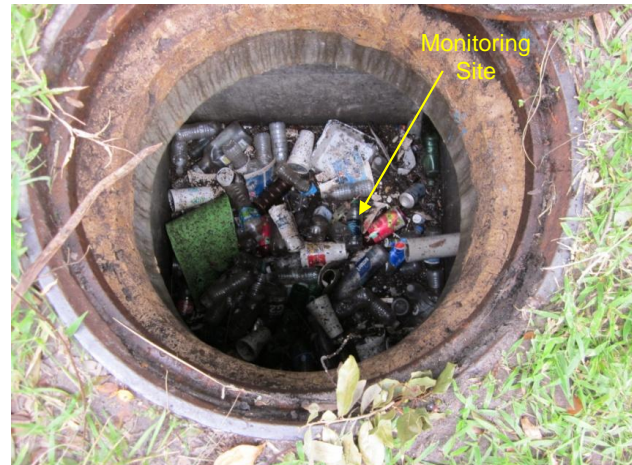
Photographs of the runoff monitoring location for Sub-basin B-2 are provided on Figure 3-5. This site is also located downstream from the point of alum addition, and the alum treated runoff samples were allowed to settle in the ERD Laboratory for approximately 24 hours to separate the treated runoff from the generated floc. The 48-inch x 76-inch ERCF at this location was also surcharged, allowing trash and debris to accumulate within the manhole riser.

Manhole access location used for stormwater monitoring

Collected debris inside manhole

Figure 3-5. Runoff Monitoring Location for Sub-basin B-2 (Michigan Street).

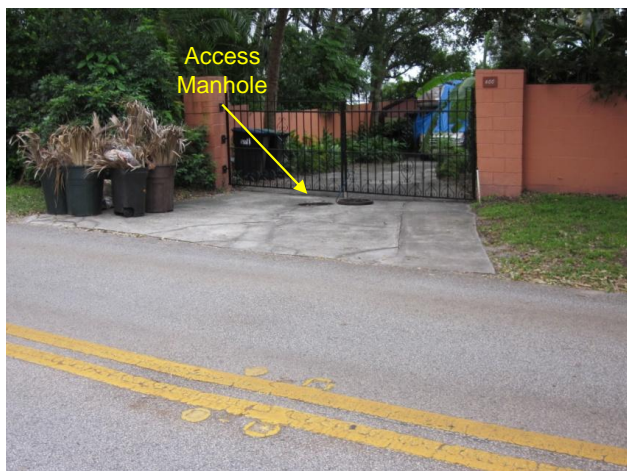
An overview of the runoff monitoring location for Sub-basin B-21 is given on Figure 3-6. The monitoring site was located inside a manhole located in a private driveway which is the final point of access into the stormsewer system prior to discharging into Lake Holden. The autosampler at this location was installed inside the manhole structure and suspended using a stainless steel harness. The runoff samples collected at this site were also allowed to settle for approximately 24 hours in the ERD Laboratory to separate the treated runoff from the generated floc.

Manhole access location used for stormwater monitoring

Monitoring location inside manhole

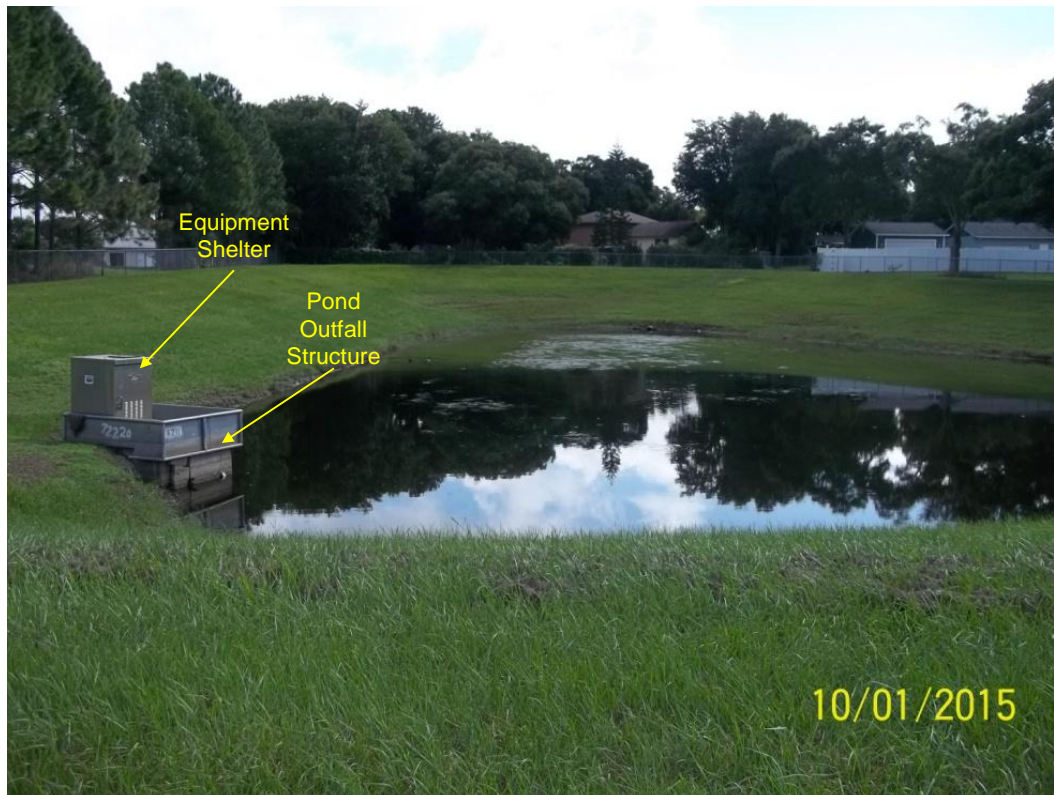
An overview of the runoff monitoring location and equipment for Sub-basin B-4B is given on Figure 3-8. Monitoring was conducted on the downstream side of the pond outfall structure to reflect the characteristics of water discharging from the pond to Lake Holden. An ISCO Model 3712 composite autosampler was installed inside an insulated aluminum equipment shelter and programmed to collect composite outflow samples in a flow weighted mode. Discharge measurements were conducted using the depth of water above the circular outfall orifice.

Figure 3-8. Runoff Monitoring Location and Equipment for Sub-basin B-4B (MacArthur Drive).

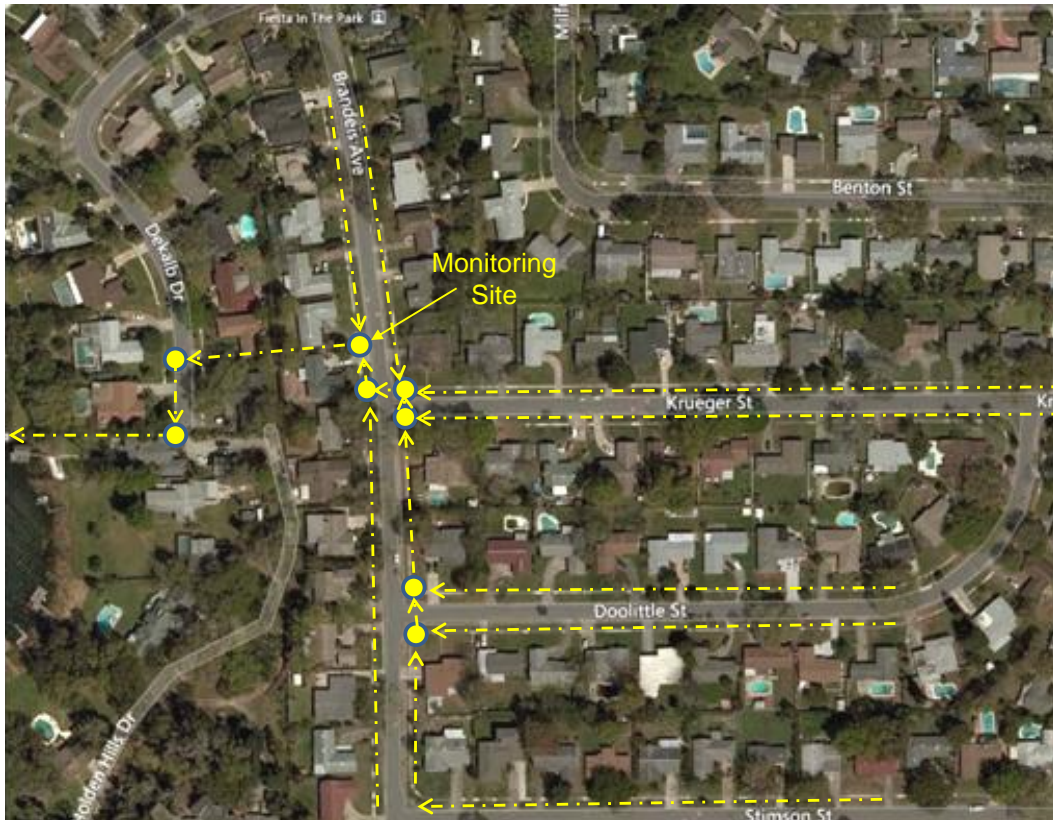
Figure 3-9. Overview of Runoff Drainage Patterns for Sub-basin B-7 (Krueger Street).

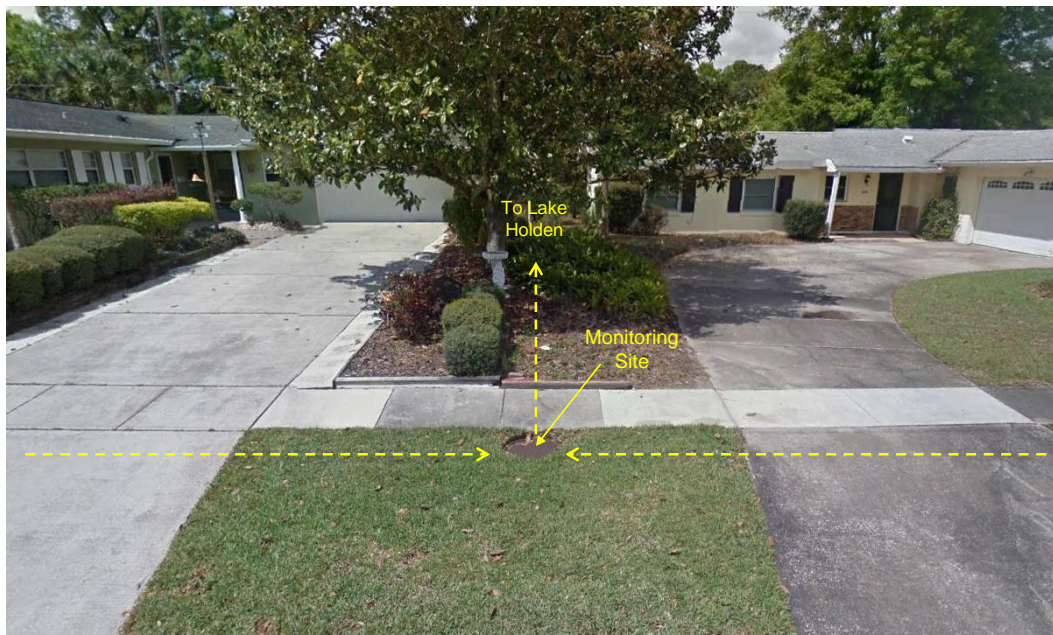
An overview of the monitoring location for Sub-basin B-7 is given on Figure 3-10. The location selected for the monitoring site consists of a manhole structure where flows generated along Krueger Street, Doolittle Street, and Brandeis Avenue combine together prior to discharge to Lake Holden. Runoff monitoring was conducted at this site using an ISCO Model 3712 composite autosampler with an integral area velocity flow probe to provide measurements of discharge rates through the stormsewer system and allow collection of runoff samples on a composite flow-weighted mode. Photographs of the manhole monitoring site for Sub-basin B-7 are given on Figure 3-11. The manhole consists of a deep structure with the stormsewer pipe located approximately 10 ft below the ground surface. This site maintained a constant baseflow throughout the field monitoring program.

Figure 3-10. Overview of the Monitoring Location for Sub-basin B-7 (Krueger Street).

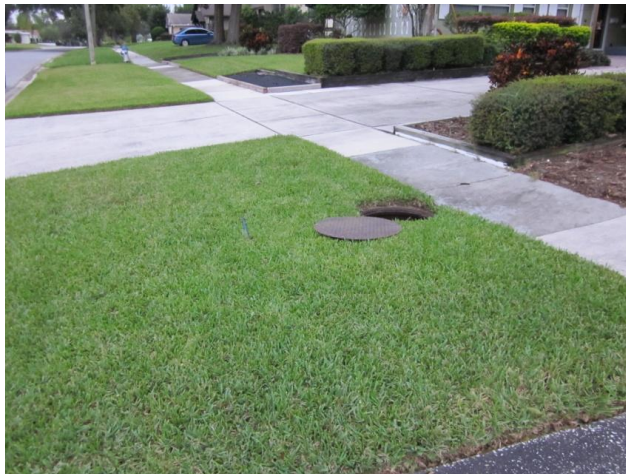
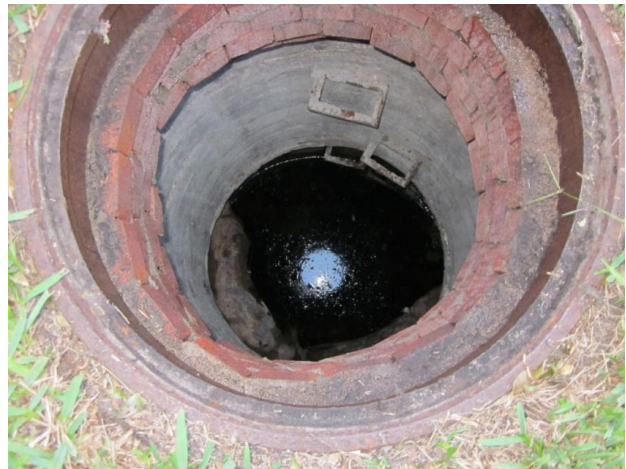
Krueger Street site with manhole cover removed

Photo inside manhole

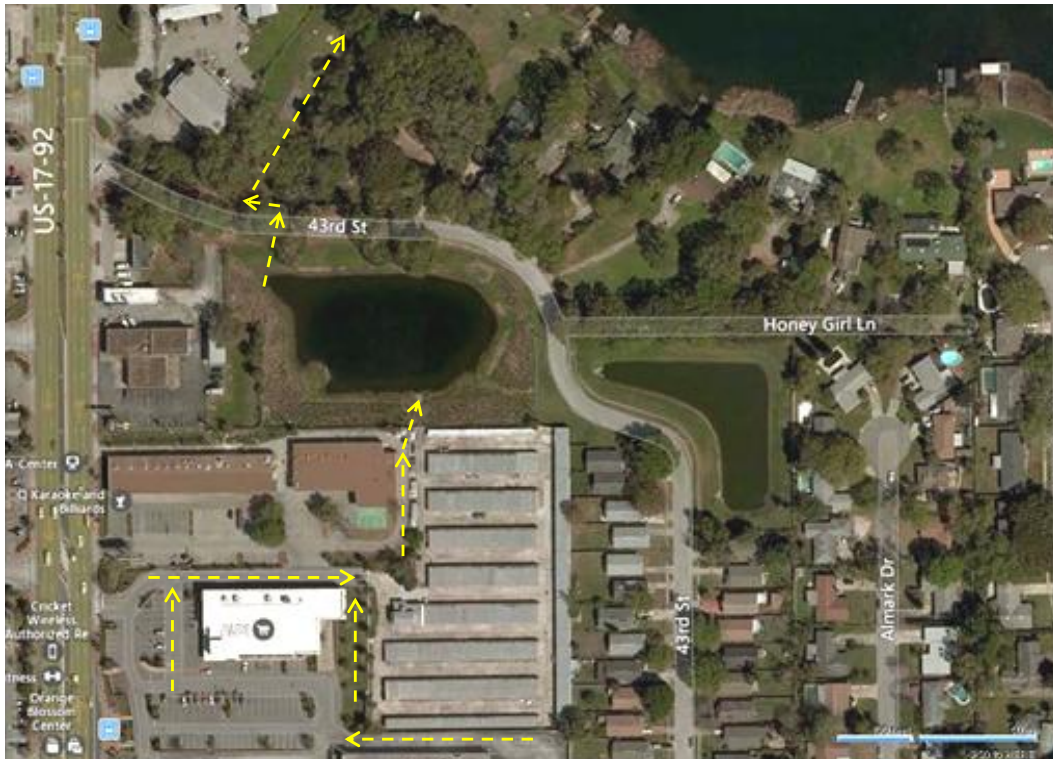
Figure 3-12. Drainage Patterns in the Vicinity of Sub-basin B-12 (43rd Street).

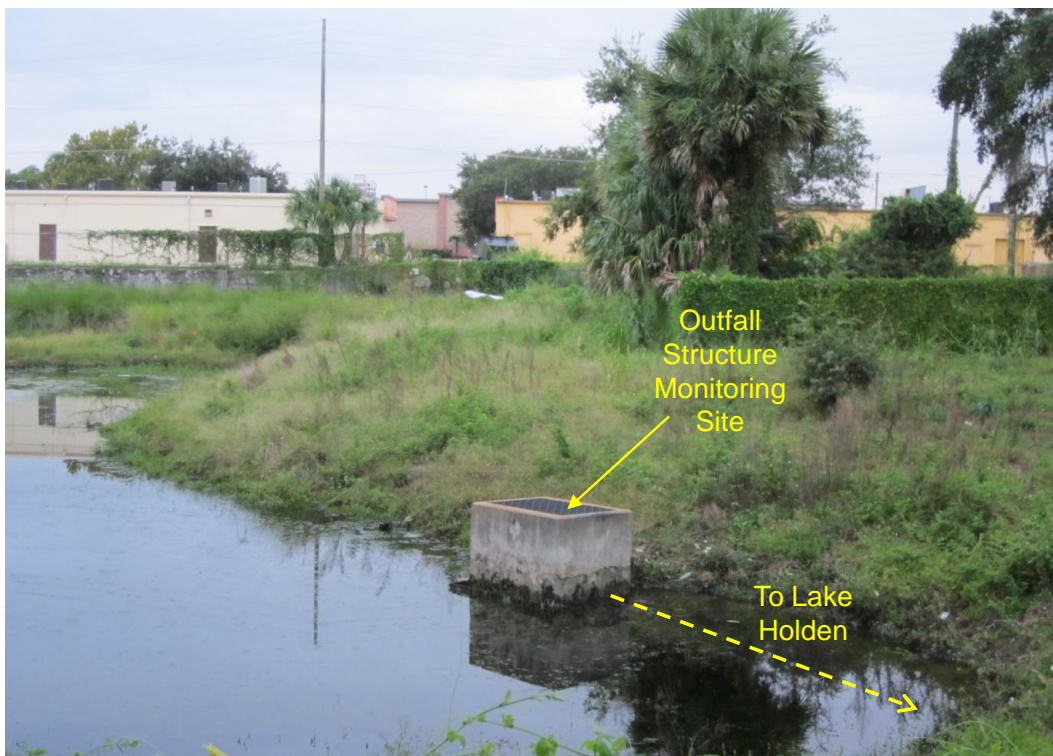
An overview of the runoff monitoring site for Sub-basin B-12 is given on Figure 3-13. Due to security concerns, runoff monitoring was conducted at this site using manual collection methods following significant storm events. Multiple samples of discharges from the pond were collected over a 2- to 3-hour period following rain events to form a composite discharge sample for laboratory analyses.

Figure 3-13. Overview of Runoff Monitoring Site for Sub-basin B-12 (43rd Street).

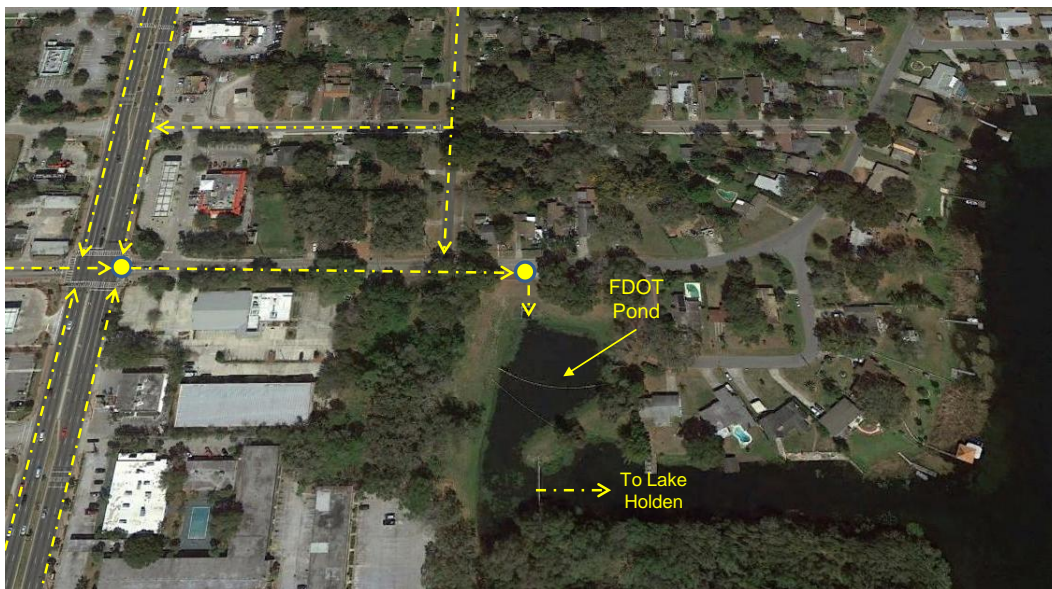
An overview of drainage patterns in the vicinity of Sub-basin B-13, commonly referred to as the FDOT Pond Basin, is given on Figure 3-14. With an area of 81.5 acres, this sub-basin is one of the larger individual basins discharging to Lake Holden. Runoff is generated in this area from portions of US 441 along with residential areas both west and east of the FDOT roadway. The combined runoff inflows discharge into a small wet detention pond which is substantially undersized for the area of runoff which it receives. After a relatively short residence time within the pond, the runoff discharges through an outfall structure and into a canal on the west side of Lake Holden.

Figure 3-14. Drainage Patterns in the Vicinity of Sub-basin B-13 (FDOT Pond).

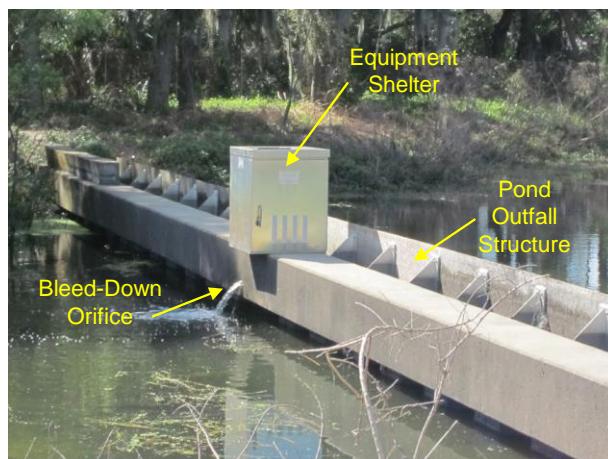
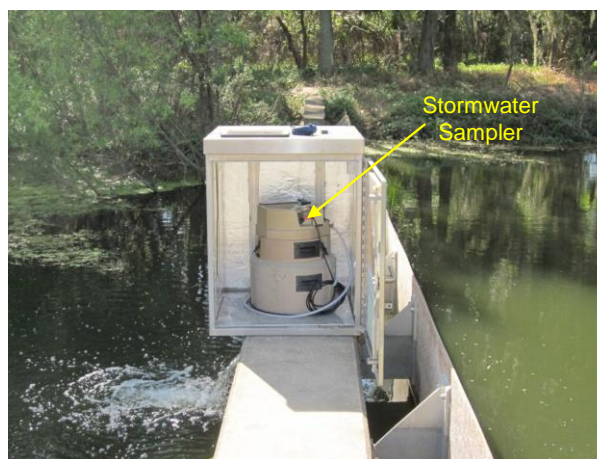
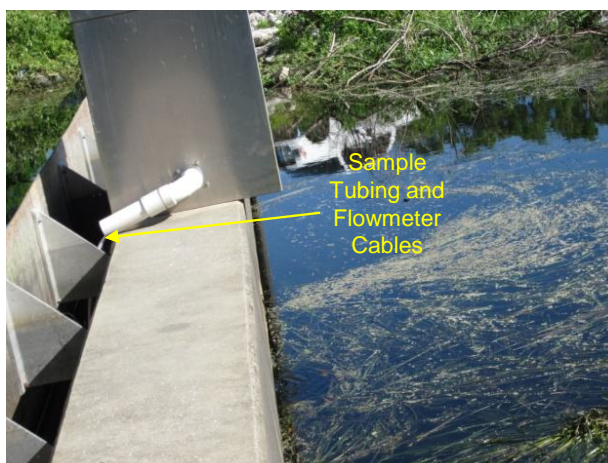
Photographs of monitoring equipment used at the Sub-basin B-13 site are provided on Figure 3-15. Sample collection at this site was conducted using a Sigma Model 850 composite autosampler with an integral pressure transducer flow probe which provides measurements of discharge based upon height above the circular bleed-down orifice. The autosampler was programmed to collect discharges from the pond in a flow-weighted composite mode.

Pond outfall structure with equipment shelter

Autosampler used to collect outflow samples

Sample tubing and flow meter cables

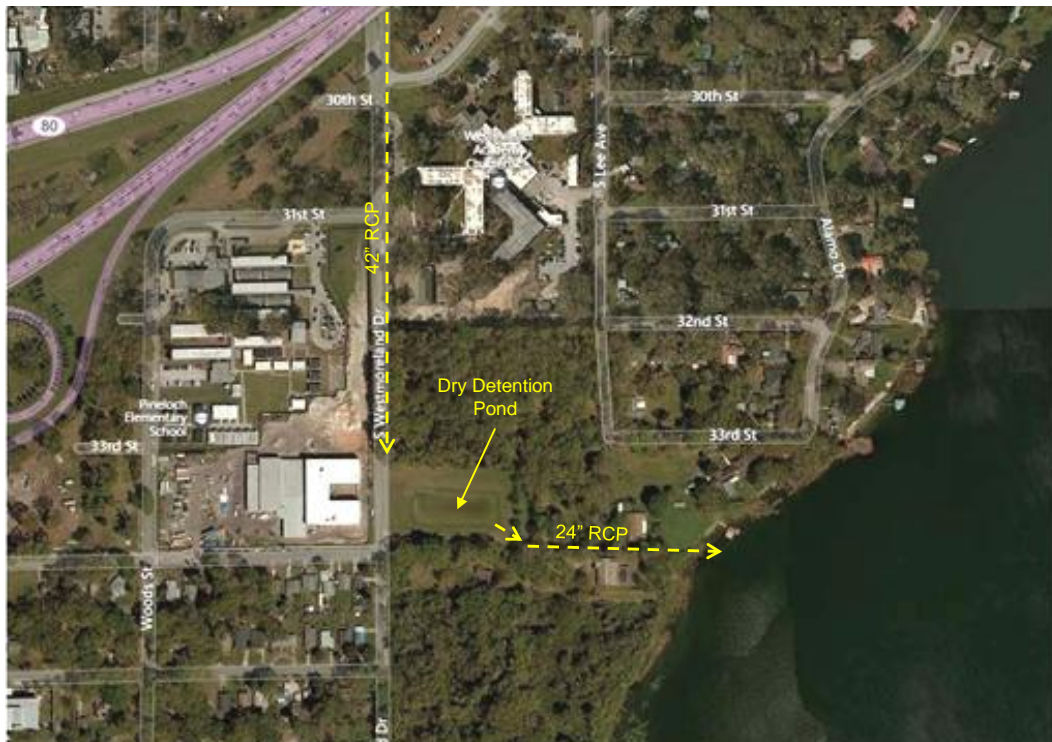
An overview of drainage patterns in the vicinity of Sub-basin B-19, commonly referred to as the Westmoreland Drive sub-basin, is given on Figure 3-16. Most of the actual sub-basin area for Sub-basin B-19 is located north of the photograph and includes portions of Michigan Street and Westmoreland Drive to the intersection with I-4. Runoff generated in this area is piped through an underground 24-inch RCP stormsewer into a dry detention pond at the location indicated on Figure 3-16. The dry detention pond is equipped with a perimeter underdrain system which provides filtration for the runoff inflows prior to reaching the outfall structure and discharge into Lake Holden.

Figure 3-16. Overview of Drainage Patterns in the Vicinity of Sub-basin B-19 (Westmoreland Drive).

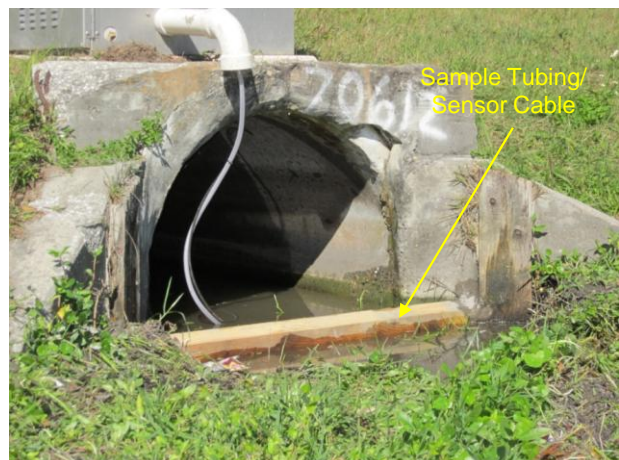
Photographs of the inflow and outflow structures for the Sub-basin B-19 pond are given on Figure 3-18. Monitoring of inflows at this site were conducted using an ISCO Model 3712 autosampler equipped with a pressure transducer probe which converted measurements of water level above an installed rectangular horizontal weir into runoff discharge rates. The autosampler at this site was programmed to collect composite inflow samples on a flow-weighted basis. A similar equipment shelter was also installed on top of the pond outfall structure, with sample tubing and flow probe extended into downstream portions of the discharge pipe. The flow monitor provided a continuous record of discharge from the pond through both the underdrain and stormsewer system, with composite samples collected in a flow-proportioned mode.

24-inch RCP Pond inflow with monitoring equipment

Horizontal weir used for inflow measurement

Pond outflow structure

Underdrain discharge entering outflow structure

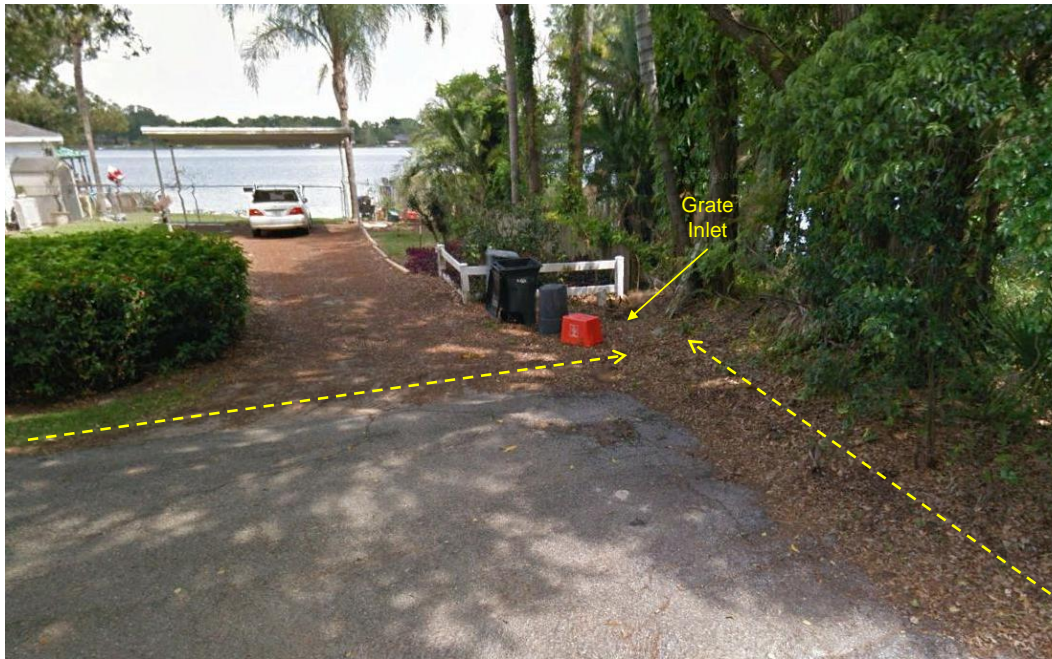
An overview of the monitoring location for Sub-basin B-20 is given on Figure 3-20. Runoff generated along Alamo Drive and 33rd Street travels primarily by overland flow and enters a cast iron grate inlet at the location indicated on Figure 3-20. An insulated aluminum equipment shelter was installed on top of the grate inlet, and an ISCO Model 3712 autosampler with integral area-velocity flow probe was used to measured runoff discharges into the inlet structure and collect composite runoff samples in a flow-proportioned mode. This inlet frequently became clogged with vegetation which required removal on a routine basis during the field monitoring program.

Figure 3-20. Overview of the Monitoring Location for Sub-basin B-20.

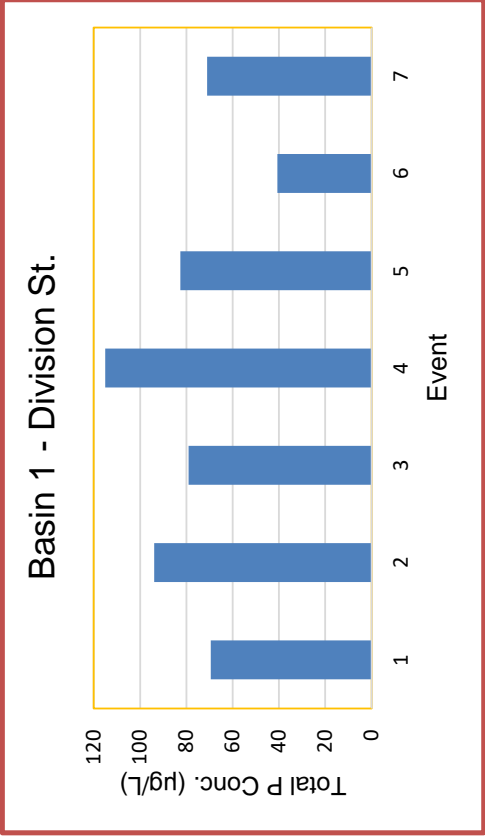
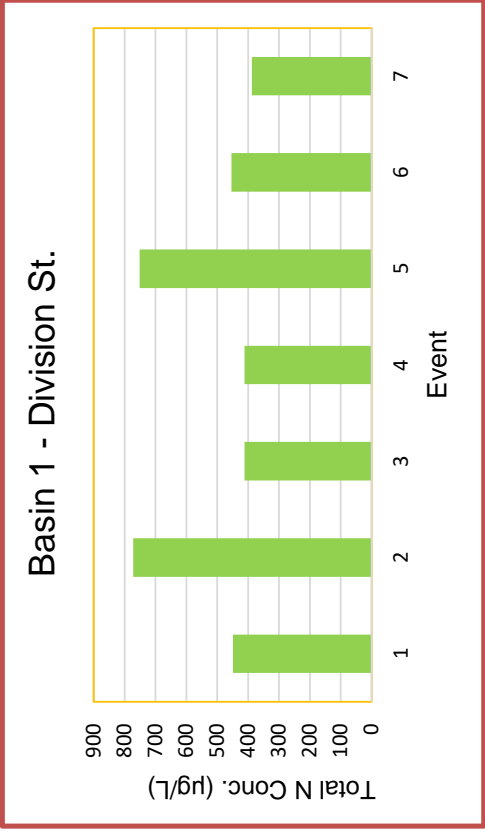
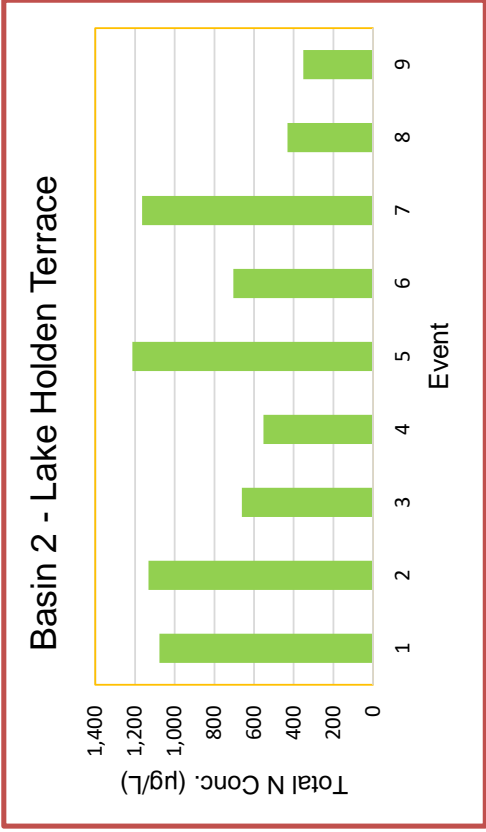
In general, a relatively high degree of variability was observed in measured concentrations of both total phosphorus and total nitrogen between individual events at each of the two monitoring sites. Each of the two sub-basins provides treatment of stormwater using alum injection. Alum treatment of stormwater runoff at the recommended coagulant dose should reduce concentrations of total phosphorus to approximately 50 µg/l (ppb) or less. One of the monitored events at Sub-basin B-1 and two of the monitored events at Sub-basin B-2 exhibited treated runoff characteristics in the range of 50 µg/l. Each of the remaining samples collected at Sub-basin B-1 (Division Street) appear to have been impacted by the alum treatment process since the observed concentrations were substantially less than typical phosphorus concentrations in raw runoff measured at this site, but the alum system appears to have been operating at less than optimum conditions during many of the Sub-basin 1 events.

A similar pattern is also exhibited at Sub-basin B-2 where two of the nine monitored events exhibited phosphorus concentrations near the target treatment goal of 50 µg/l. Five of the remaining monitored events exhibited clear signs of significant alum treatment, although at less than optimum levels. The initial monitoring event (which exhibited a total phosphorus concentration of 260 µg/l) appears to have received little or no alum addition, with Event 2 exhibiting only a partial treatment level.

Figure 3-24. Comparison of Event Mean Concentrations (emc) of Total Phosphorus and Total Nitrogen in Individual Runoff Samples Collected from Sub-basins B-1 and B-2.

A high degree of variability was also observed in measured nitrogen concentrations during each of the monitoring events conducted at Sub-basins B-1 and B-2. Since alum only provides significant removal for organic and particulate nitrogen forms, treatment levels are highly impacted by the nitrogen species present in the runoff inflows.

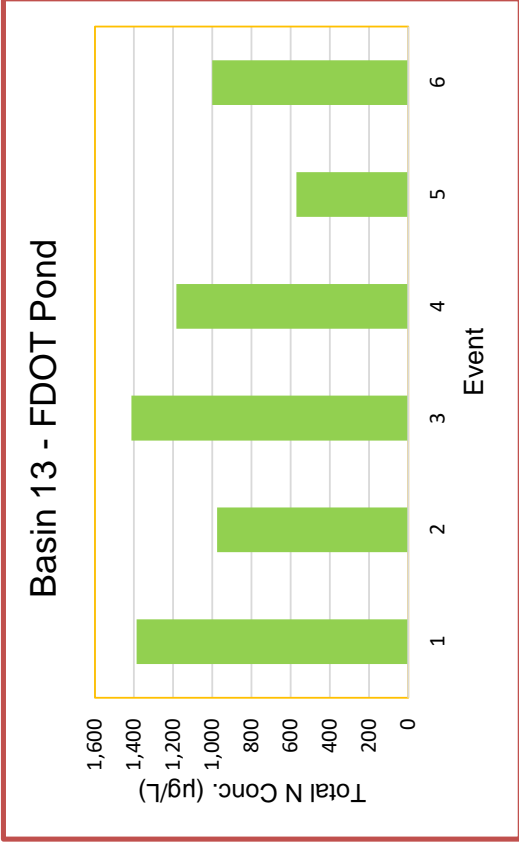
A comparison of event mean concentrations (emc) of total phosphorus and total nitrogen in runoff samples collected from Sub-basins B-12 and B-13 is given on Figure 3-26. Samples collected at each of these sites reflect discharges from wet detention systems which provide treatment for runoff generated along US 441 and adjacent commercial areas and residential roadways. Total phosphorus concentrations measured in Sub-basin B-12 were moderate in value and typical of phosphorus concentrations commonly observed in discharges from wet detention ponds with a relatively short detention time. The lower observed total phosphorus concentrations likely reflect discharges of water which have been within the pond for an extended period, while the more elevated concentrations likely reflect samples collected following large individual storm events or multiple events over a period of days. Total phosphorus concentrations exceeded 100 µg/l during 3 of the 8 monitoring events at this site.

Figure 3-26. Comparison of Event Mean Concentrations (emc) of Total Phosphorus and Total Nitrogen in Individual Runoff Samples Collected from Sub-basins B-12 and B-13.

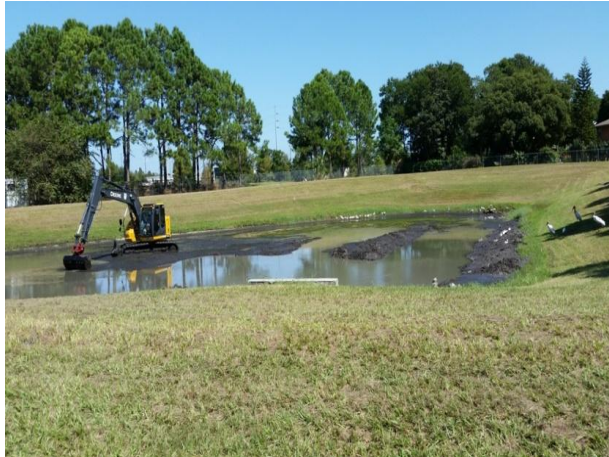
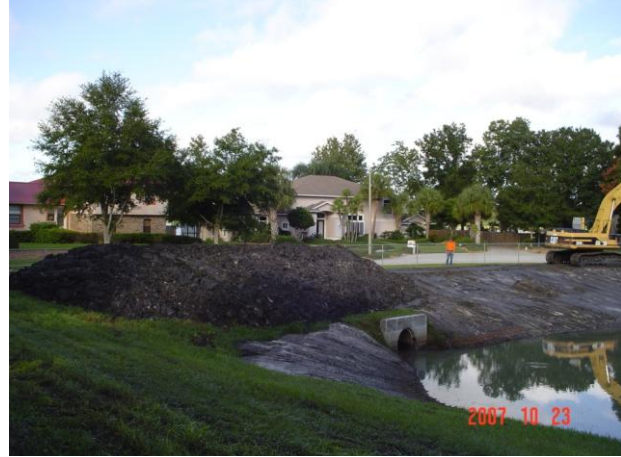
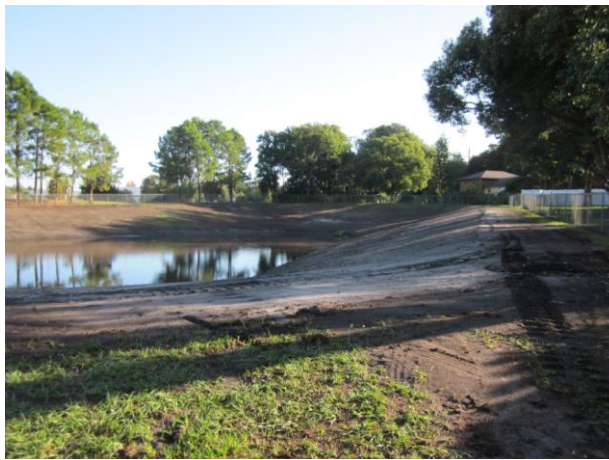
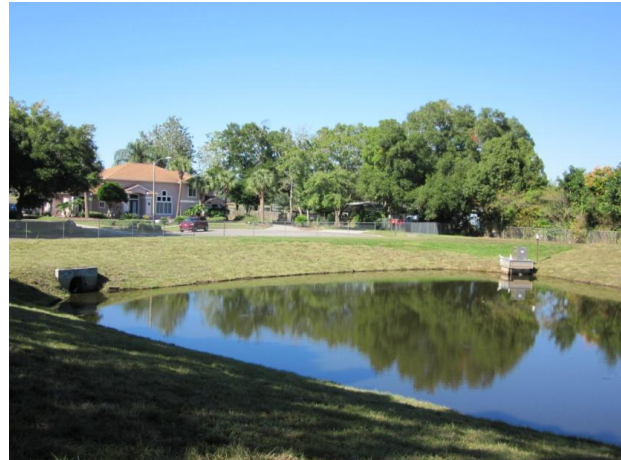
Excavation of pond

Stockpile of dredged material

Re-contouring pond slopes

Completed project

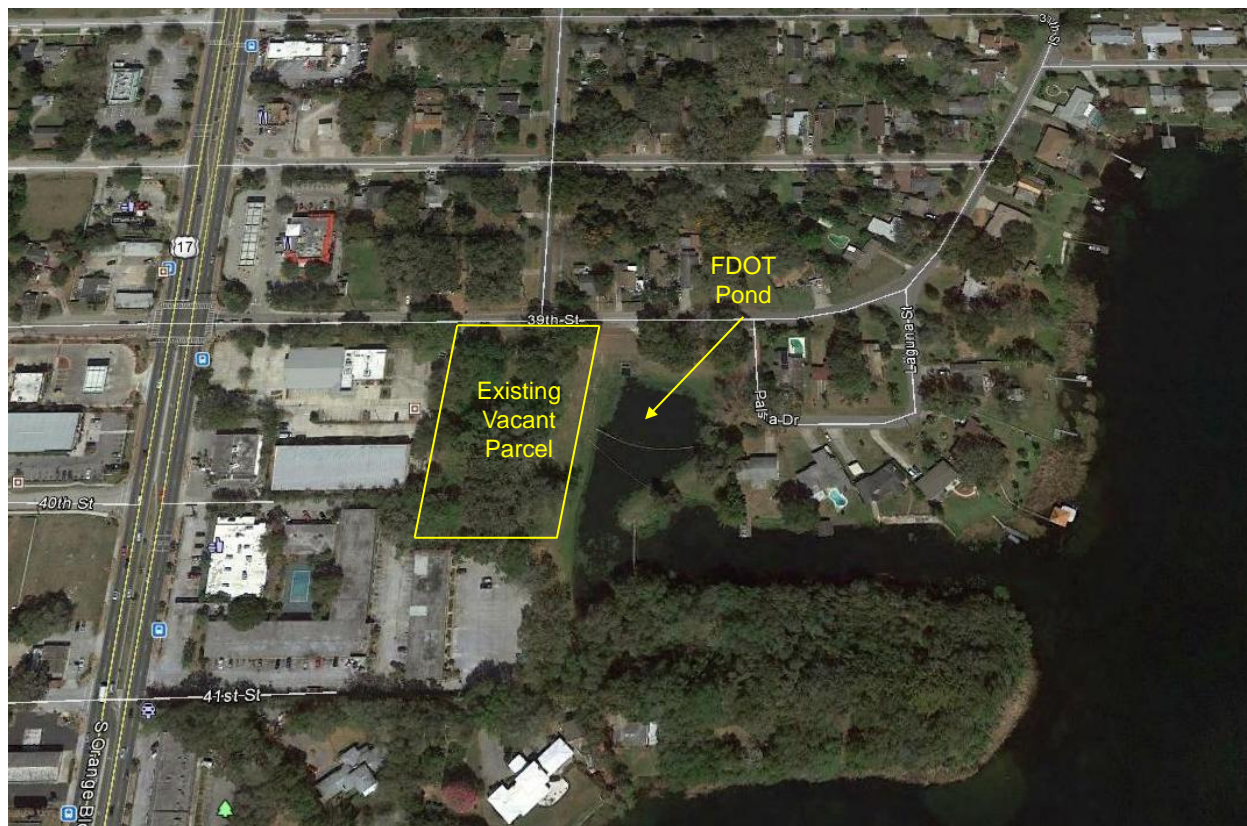
Figure 4-3. Proposed Area for Pond Expansion for Sub-basin B-13.

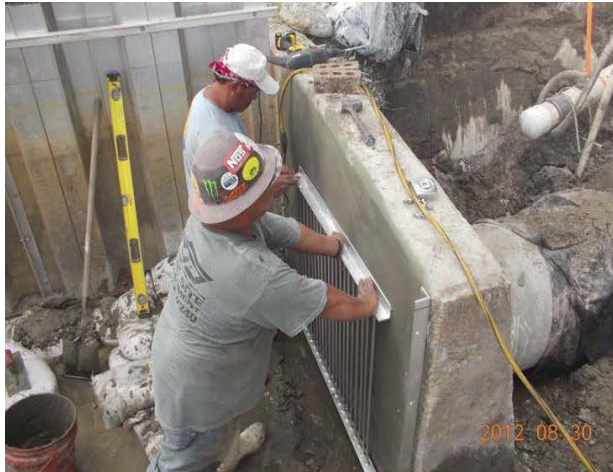
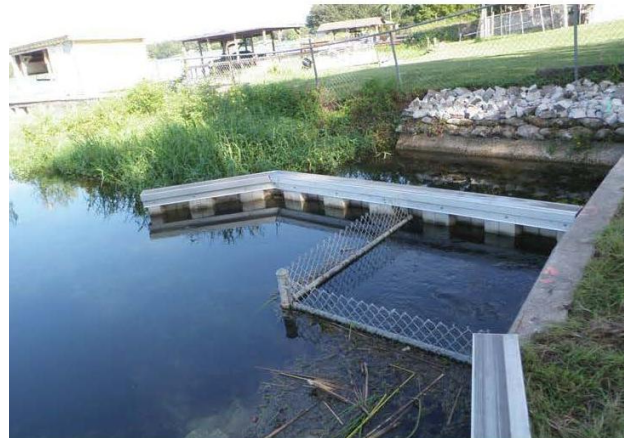
Attaching intake screen

Well intake structure
