EVALUATION OF THE CURRENT STATUS AND POTENTIAL WATER QUALITY IMPROVEMENT OPTIONS FOR LAKE HOLDEN

**Final Report
February 2010**

Orange County Environmental Protection Division
800 N. Mercy Drive – Suite 4
Orlando, FL 32808

Harvey H. Harper, Ph.D., P.E. – Project Director
Environmental Research and Design, Inc.
3419 Trentwood Blvd., Suite 102
Orlando, FL 32812
Phone: 407-855-9465

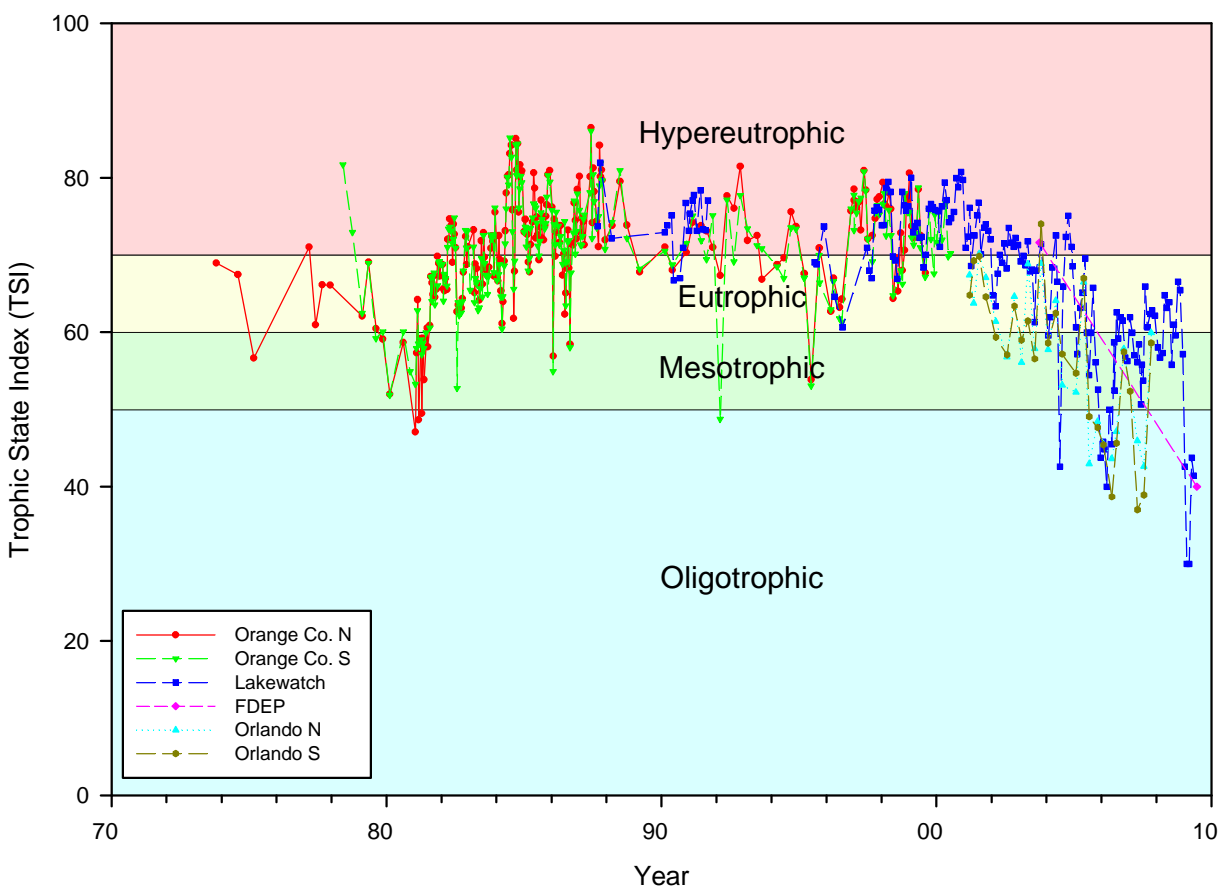
A graphical summary of calculated trophic state index (TSI) values in Lake Holden is given in Figure 3-5. Since TSI is a measure of primary productivity, TSI values are calculated using chlorophyll-a only. During the period from 1980-1990, Lake Holden was classified as a eutrophic or hypereutrophic lake system, with many calculated TSI values in excess of 80. A significant decrease in TSI values began to occur within the lake during 2000, with the TSI value gradually decreasing from hypereutrophic to eutrophic to mesotrophic, with highly oligotrophic conditions observed during 2007. Over the past 3-4 years, calculated TSI values in Lake Holden have indicated primarily either mesotrophic or oligotrophic conditions.

Figure 3-5. Summary of Historical Trophic State Indices (TSI) in Lake Holden.

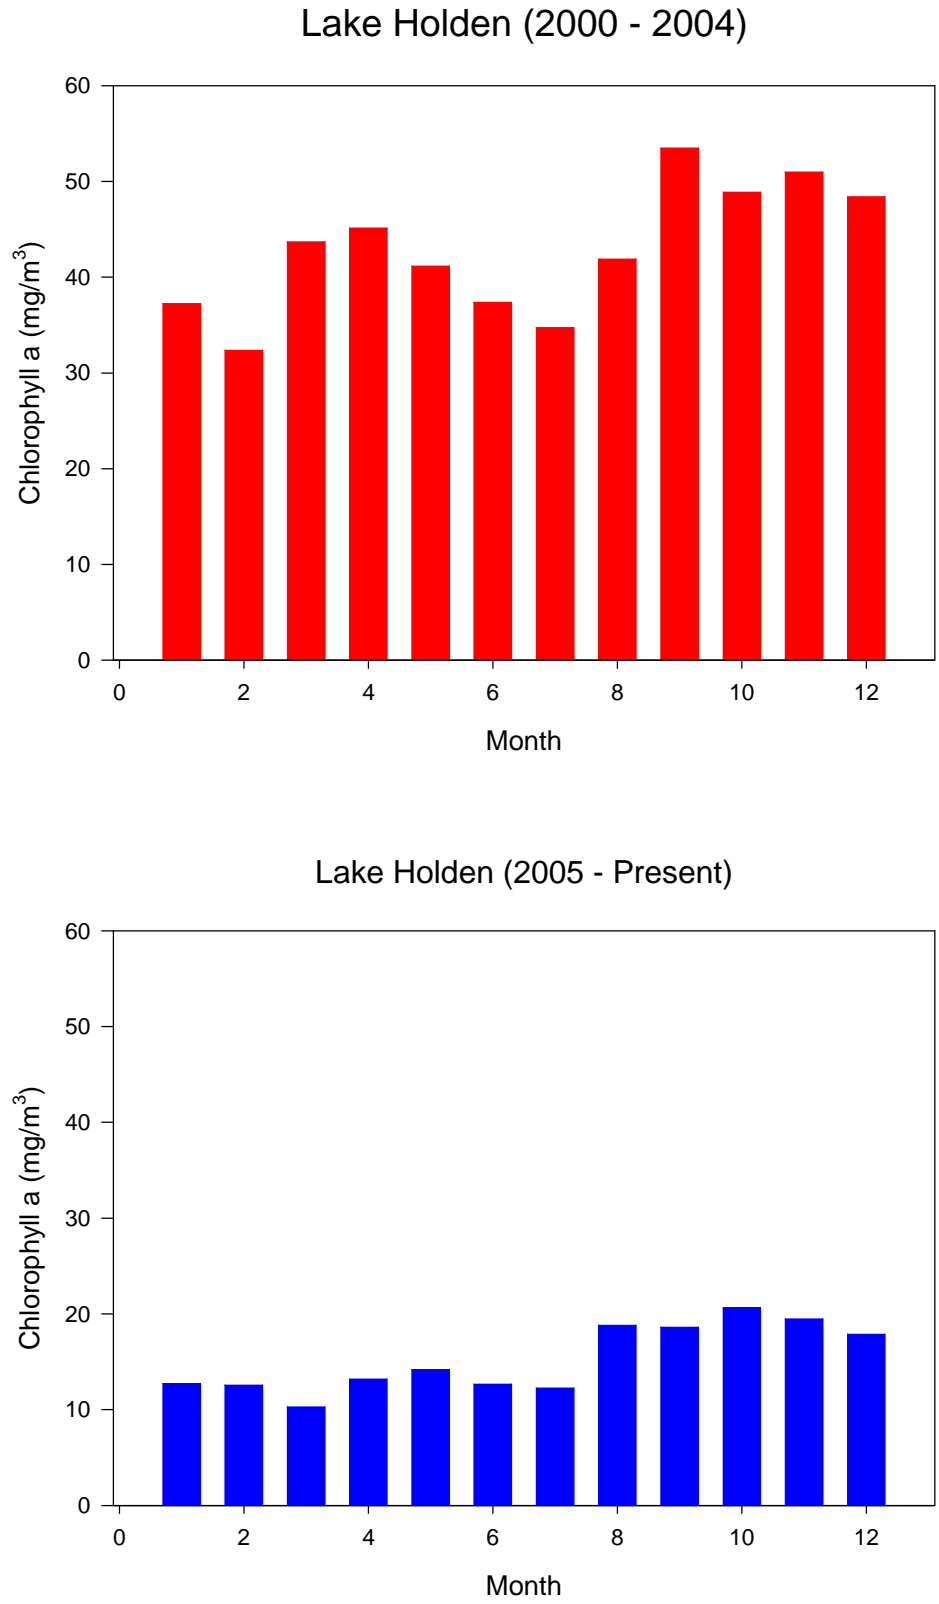
A comparison of mean monthly chlorophyll-a concentrations in Lake Holden from 2000 to the present is given in Figure 3-7. Similar to the trends observed for total phosphorus, the most elevated chlorophyll-a concentrations in Lake Holden during the period from 2000-2004 appear to occur during the fall and winter months in response to the elevated phosphorus concentrations which occur during these months.

A summary of mean monthly chlorophyll-a concentrations in Lake Holden from 2005 to the present is given at the bottom of Figure 3-7. In general, chlorophyll-a concentrations within the lake are substantially lower over the past several years than observed from 2000-2004. In addition, the elevated chlorophyll-a concentrations observed during the fall and winter months have been eliminated, with relatively consistent chlorophyll-a concentrations throughout the year.

Figure 3-7. Comparison of Mean Monthly Chlorophyll-a Concentrations in Lake Holden from 2000-Present.

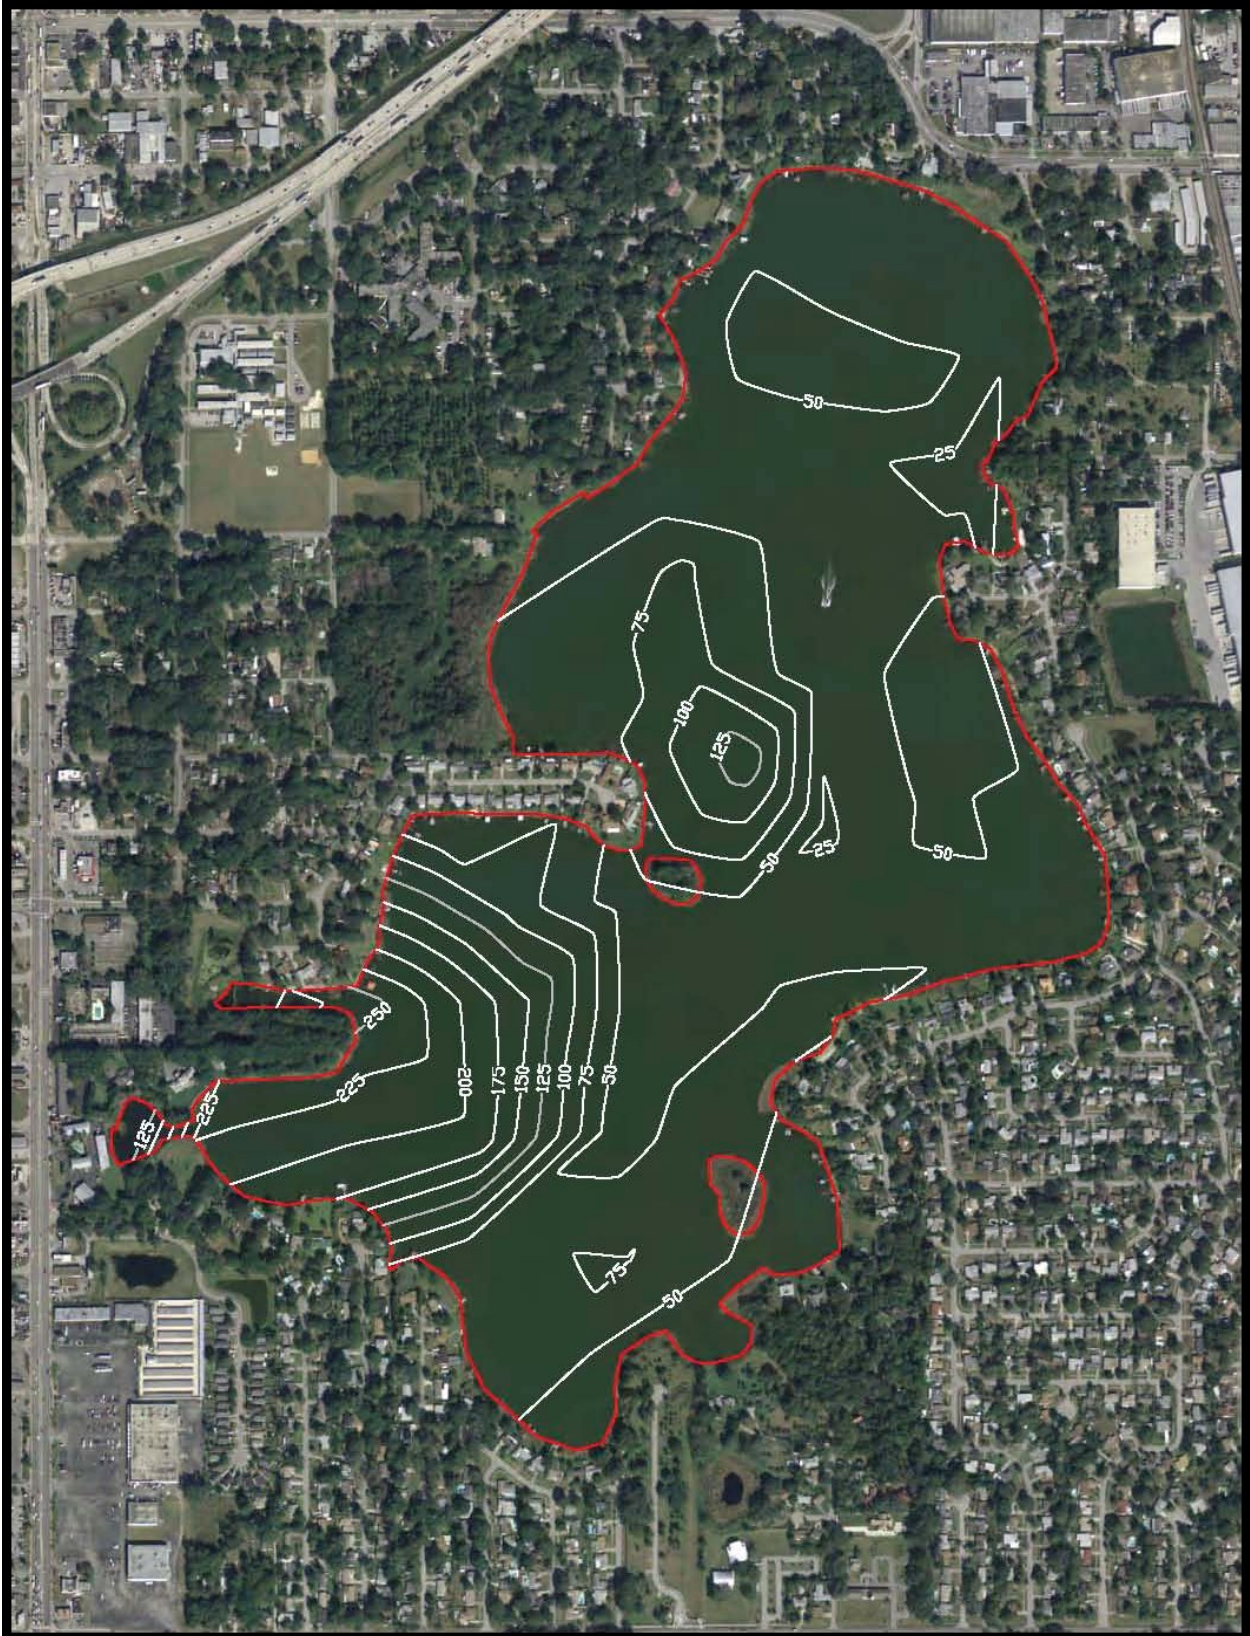
A summary of estimated total available phosphorus in the sediments of Lake Holden, based upon the November 2008 monitoring event, is given in Table 4-9 and estimated chemical requirements are provided for both 5:1 and 10:1 ratios. At this time, ERD recommends that the 5:1 ratio be used for the proposed future sediment inactivation event. At a 5:1 ratio, the alum requirement is approximately 149,786 gallons which is equivalent to approximately 33 tankers (rounded off). Application of this volume of alum will require at least 2 and possibly 3 treatments over a period of 6-12 months. There is increasing research evidence that multiple small applications are more effective than a single large application for sediment inactivation. As a result, it is recommended that a minimum period of approximately 3 months be used to separate the individual applications to allow each application adequate time to migrate into the lake sediments.

Figure 4-3. Isopleths of Total Available Phosphorus in the 0-10 cm of Sediments in Lake Holden Based on Sediment Core Samples Collected During November 2008.

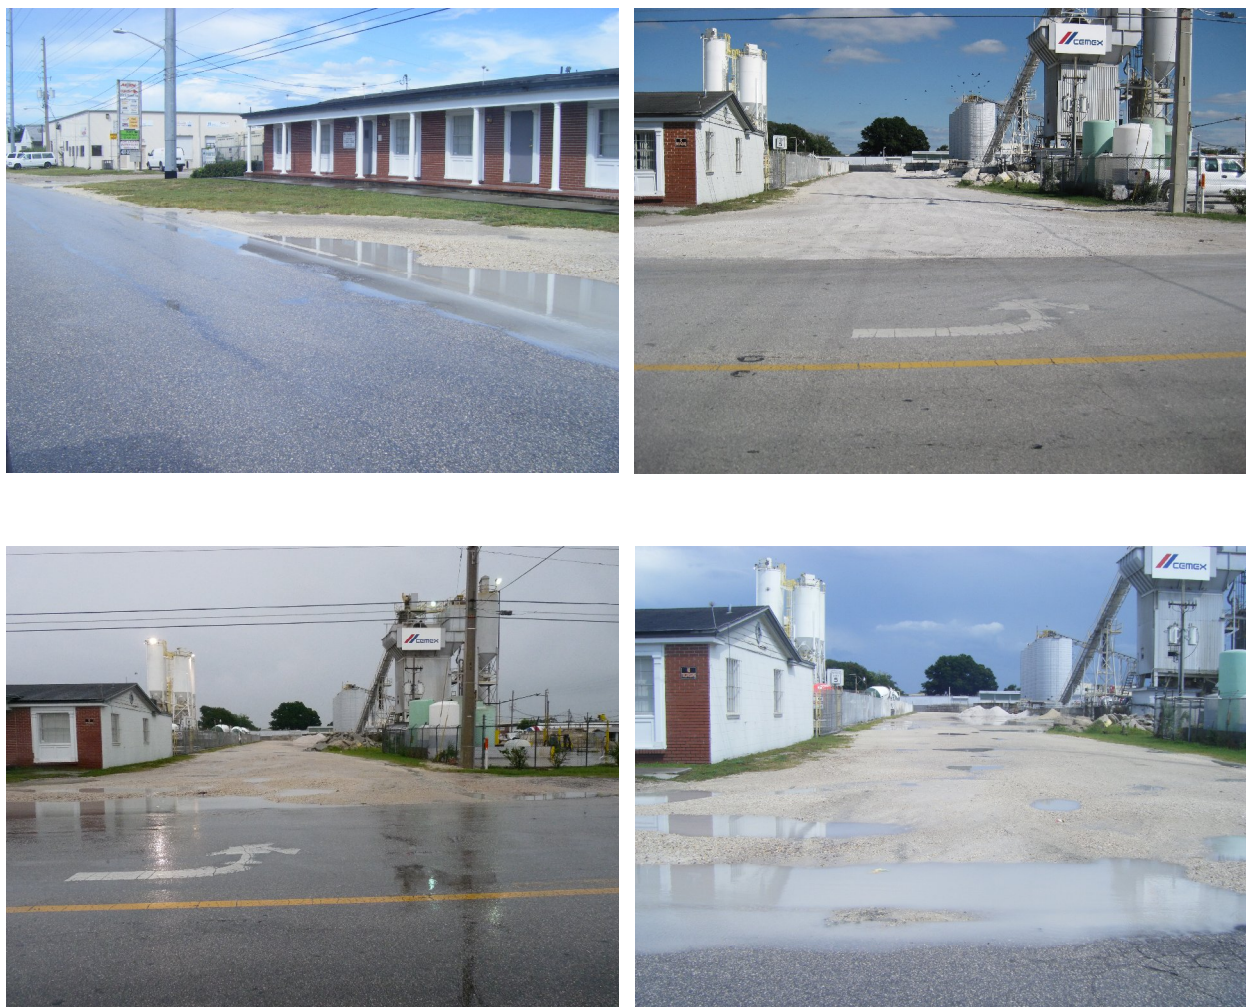
Photographs of existing conditions and sediment wash-off during storm events in Area 1-1 are given on Figure 5-4. This area consists of a limerock stabilized service road which is part of the Cemex facility and is utilized extensively on a daily basis. During rain events, wash-off from the roadway, which is often milky in appearance with a high turbidity and suspended solids loading, discharges in an east-to-west direction, ultimately entering the Division Avenue drainage system. This roadway area should be either stabilized with asphalt, regraded to drain away from Division Avenue, or replaced with a non-calcareous gravel material.

Figure 5-4. Photographs of Existing Conditions of Sediment Wash-off During Storm Events in Area 1-1.

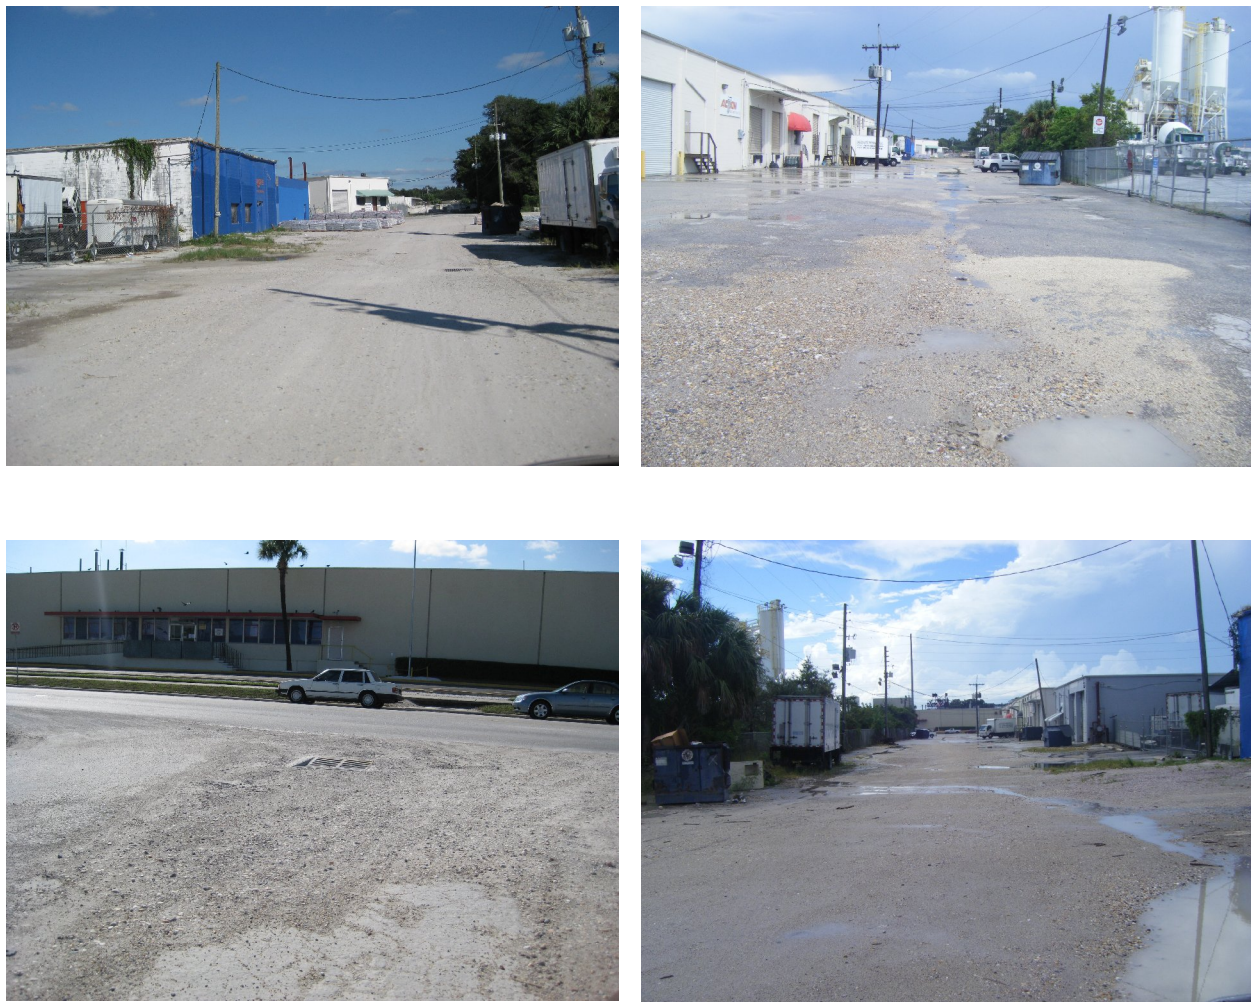
Figure 5-5. Photographs of Existing Conditions and Sediment Wash-Off During Storm Events in Area 1-2.

Elimination of the existing sediment transport could be achieved by either paving the surface to eliminate existing turbid runoff or replacement with a non-calcareous gravel material. Ideally, runoff generated within this area should be rerouted or stormwater treatment for this area should be provided within the basin. Sufficient room appears to exist in many portions of this area for construction of a roadside retention system to retain much of the generated runoff on-site.

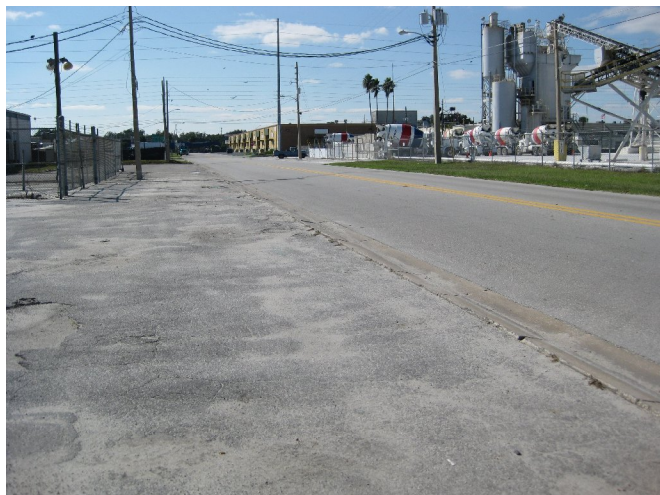
A photograph of existing conditions in Area 1-3, located on the south side of Grant Street, is given on Figure 5-6. The impervious areas on this site have accumulated a large amount of dirt, sediment, and debris which is susceptible to runoff during storm events. The land use activities within this area do not appear to have a high potential for generation of suspended solids, suggesting that the deposition of sediments within this area may originate from Grant Street, with roadway sediments transported onto the adjacent parcel by roadway activity. The current sediment problem on this parcel may be eliminated with better control of sediments along Grant Street and the Cemex property.

Photograph of Existing
Conditions in Area 1-3.

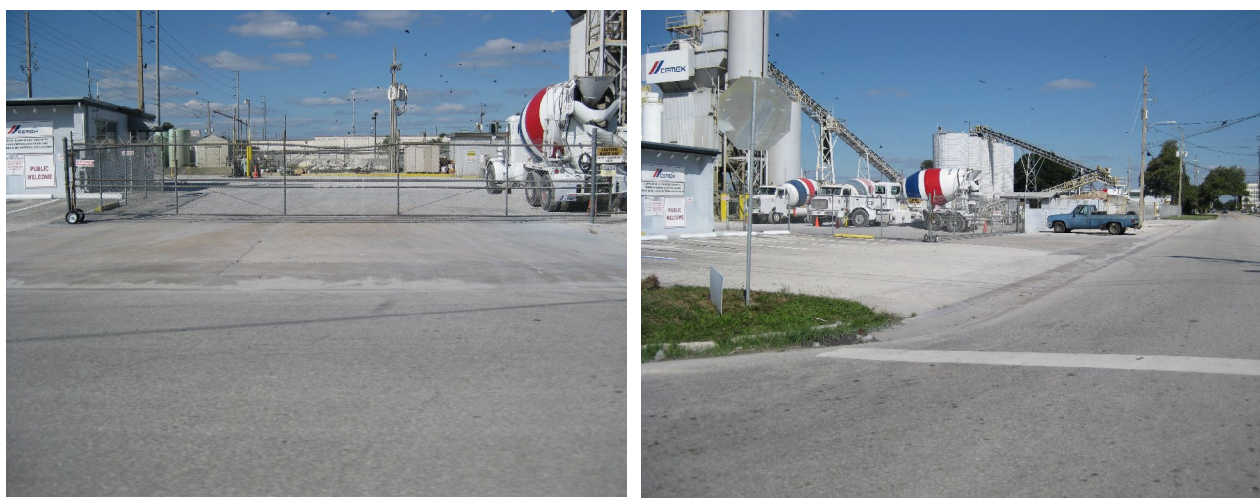
Area 1-4 consists primarily of the Cemex concrete facility located at the northeast intersection of Division Avenue and Grant Street. Photographs of existing conditions in Area 1-4 are given on Figure 5-7. This facility has taken measures in recent years to reduce off-site sediment discharge, and a wet detention pond has been constructed to contain portions of the runoff generated within the site. However, the constant movement of vehicles into and out of the property creates a constant deposition of sediments onto the Grant Street roadway. Accumulations of suspended solids are clearly visible in the photographs given on Figure 5-7. This material becomes mobilized with rain events and is transported directly into Lake Holden. Since the solid material accumulates within the roadway areas, the best method for reducing these inputs may be simply to initiate street sweeping within this area on a routine basis.

Figure 5-7. Photographs of Existing Conditions in Area 1-4.

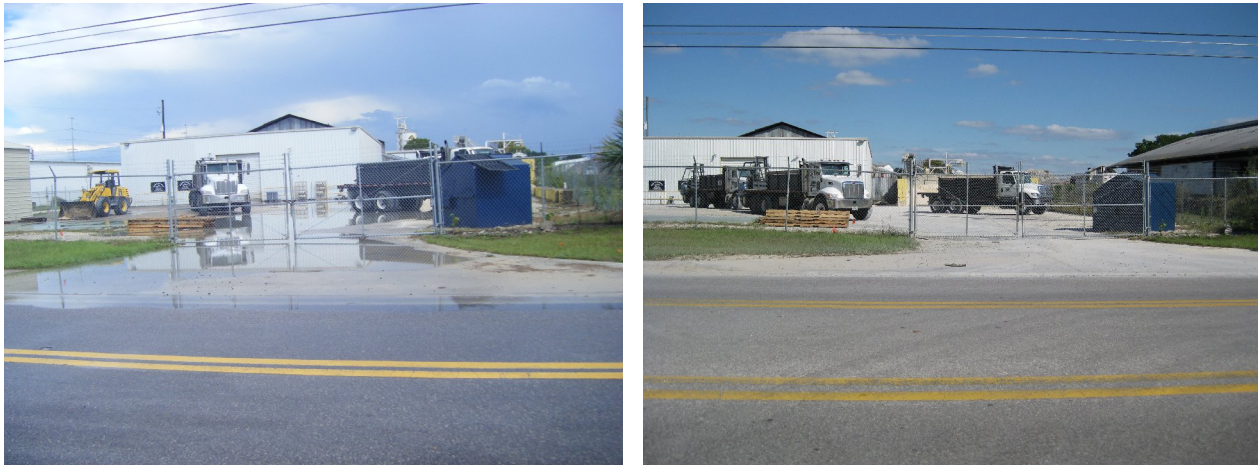
Area 1-5 is located on the east side of Division Avenue, approximately one block south of Kaley Street. This area contains an industrial or commercial business with frequent truck traffic into and out of the property. Movement of the vehicles into and out of the property creates a continuous deposition of solid material onto Division Avenue. Under rain event conditions, particularly when truck traffic occurs during the storm event, turbidity and suspended solids leave the property and enter the stormsewer system for Division Avenue. There appear to be several areas within the property, as well as within the right-of-way, which could be used for storage of stormwater runoff from this site. If storage of runoff is not possible, then either paving of the impervious surfaces or replacement with a non-calcareous rock media should be considered. Photographs of existing conditions in Area 1-5 are illustrated on Figure 5-8.

Figure 5-8. Photographs of Existing Conditions and Sediment Wash-off During Storm Events in Area 1-5.

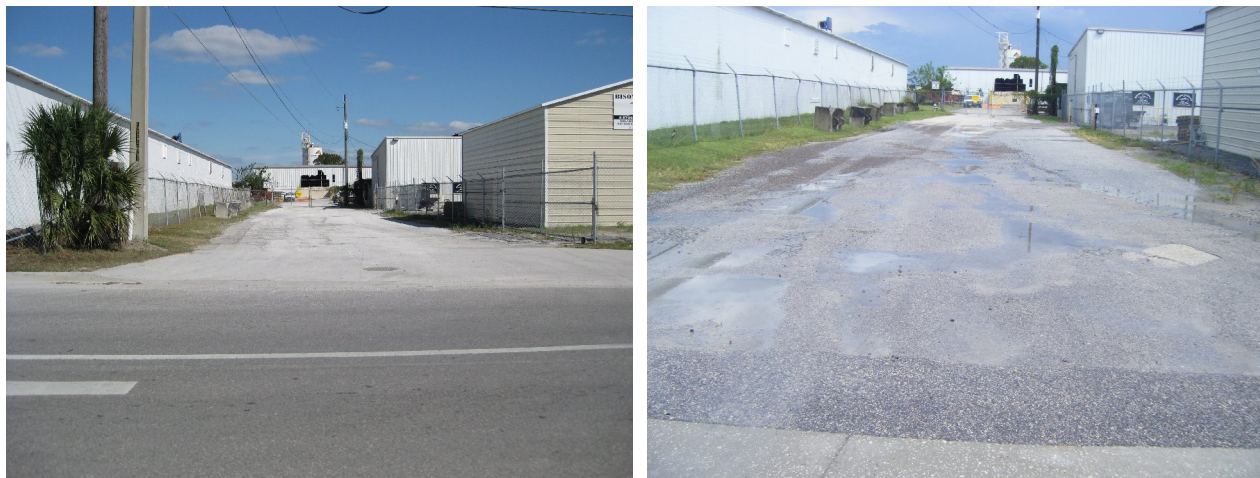
Area 1-6 is located north of Area 1-5 and consists of an access roadway into the large industrial and rock storage area adjacent to the CSX railroad. Frequent traffic along this corridor brings suspended material onto Division Avenue which is clearly visible during dry conditions. During rain events, substantial amounts of sediment and turbidity discharge from the site into the Division Avenue stormsewer system. Several options appear to be available for this area, including construction of swales along the sides of the roadway to capture water before it discharges into Division Avenue, as well as collection and diversion of the stormwater into other areas of the property. Photographs of existing conditions and sediment wash-off during storm events are given on Figure 5-9.

Figure 5-9. Photographs of Existing Conditions and Sediment Wash-off During Storm Events in Area 1-6.

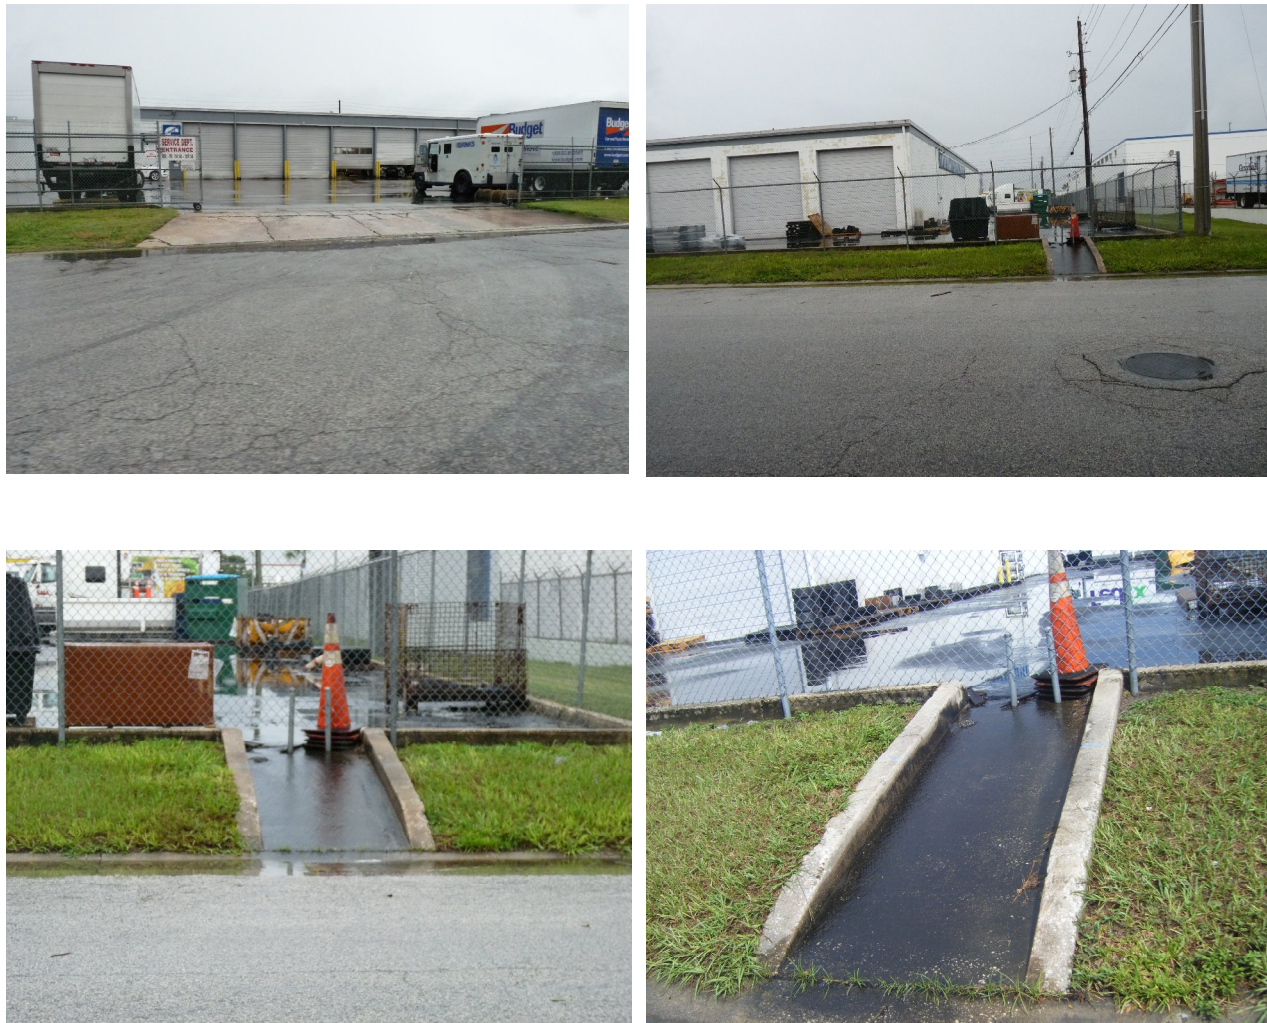
Area 1-7 is located at the southwest corner of Division Avenue and Grant Street. This area consists primarily of a repair facility for trucks and other vehicles. Photographs of existing conditions within this area are given on Figure 5-10. Virtually all of this parcel is currently paved and does not appear to be a significant contributor of either sediments or turbidity. However, this area does contribute visible loadings of oil and grease during storm events, as evidenced by the visible oily sheen in the runoff and the substantial staining of the concrete swale which discharges from the site. Runoff which is discharged from the site enters the Division Avenue stormsewer system. Potential sources of oil and grease within the property should be evaluated and eliminated to the extent practicable. In addition, an inlet insert with oil and grease scrubbers should be inserted inside the inlet where the runoff from the site enters the Division Avenue stormsewer system.

Figure 5-10. Photographs of Existing Conditions and Oil and Grease Wash-off During Storm Events in Area 1-7.

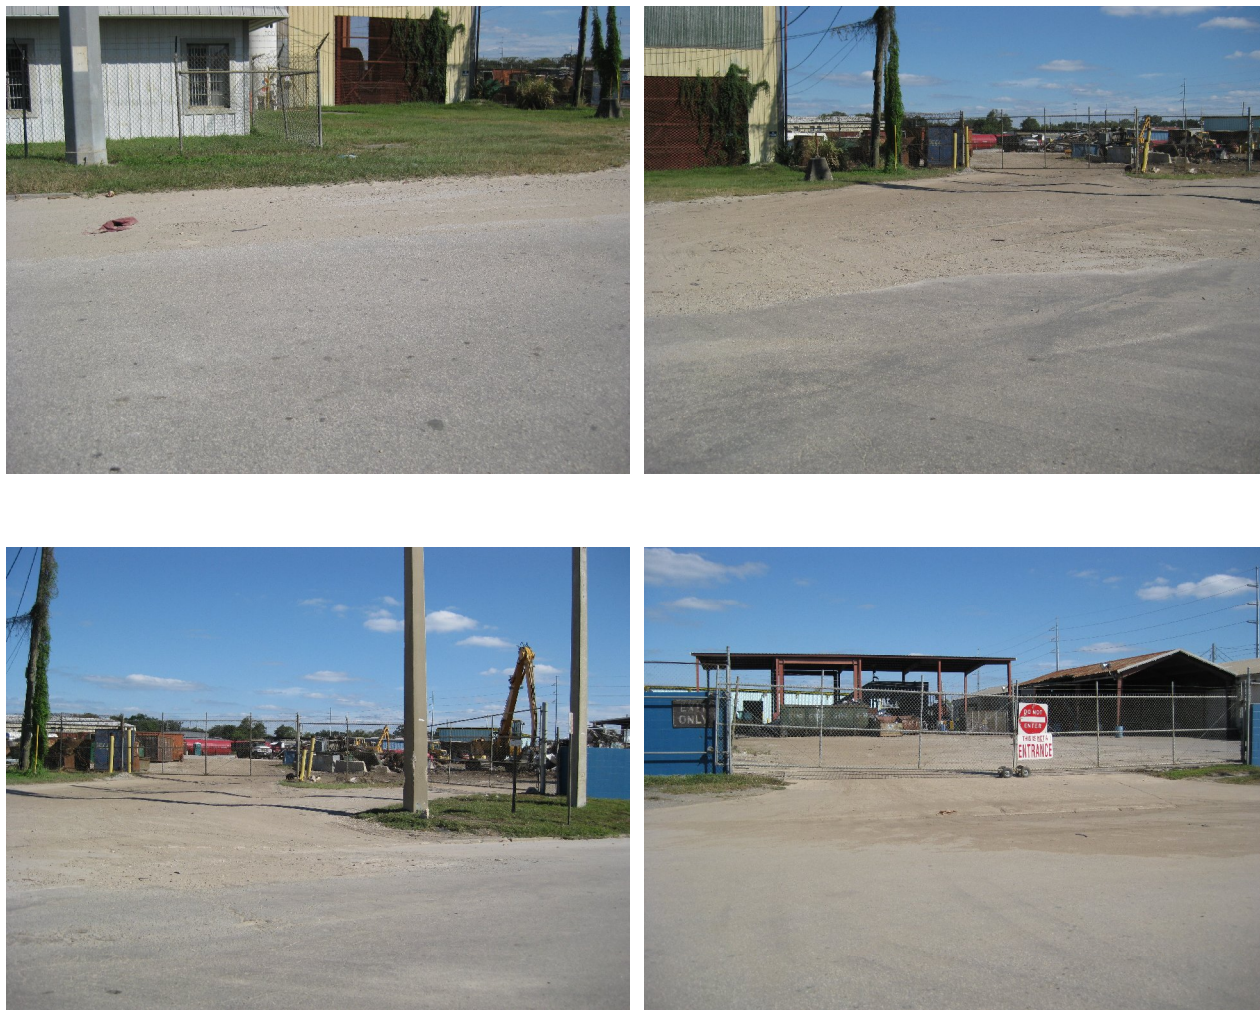
Figure 5-11. Photographs of Existing Conditions in Area 1-8.

Several opportunities are available to reduce sediment loadings from this area. First, exits from the property could be retrofitted with erosion control devices similar to those used for construction sites. These erosion control devices consist of either a gravel roadway or similar type device to remove soils from the vehicle tires before exiting the site. In addition, roadway areas adjacent to the site should be swept on a routine basis to remove accumulated materials.

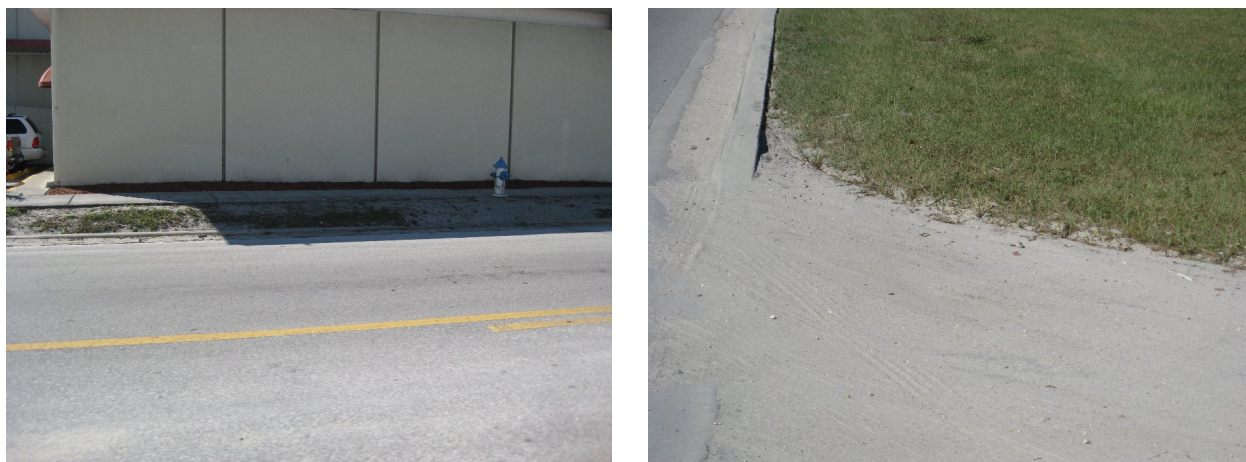
Area 1-9 is located near the southeast intersection of Kaley Street and Division Avenue. This area consists primarily of parking lots associated with the adjacent commercial and industrial activities. Photographs of existing conditions in Area 1-9 are given on Figure 5-12. Accumulations of soils and sediments are clearly visible in these photographs, including soils which have migrated from the site and filled the adjacent roadway gutter. The existing parking lot areas do not appear to be significant contributors themselves of sediments and soils, suggesting that the observed conditions originate from adjacent parcels. Sources for the soils and sediments should be evaluated, and if possible, retrofit opportunities should be taken to reduce these loadings. If nothing else can be done, the situation can be corrected fairly easily with routine street sweeping operations.

Figure 5-12. Photographs of Existing Conditions in Area 1-9.

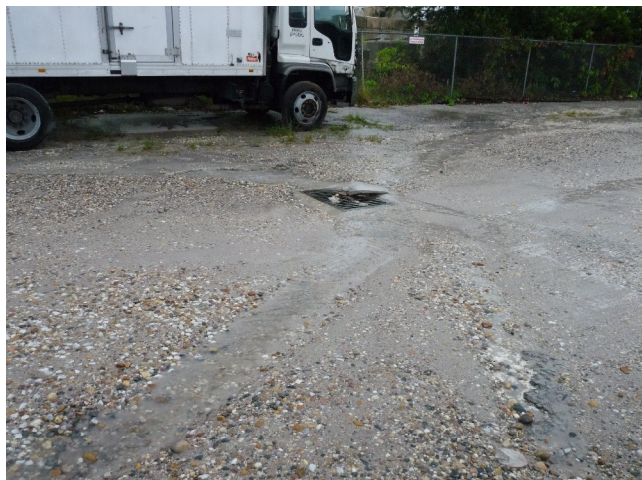
Figure 5-15.

Photograph of Potential
Erosion Issues in Area 2-1.

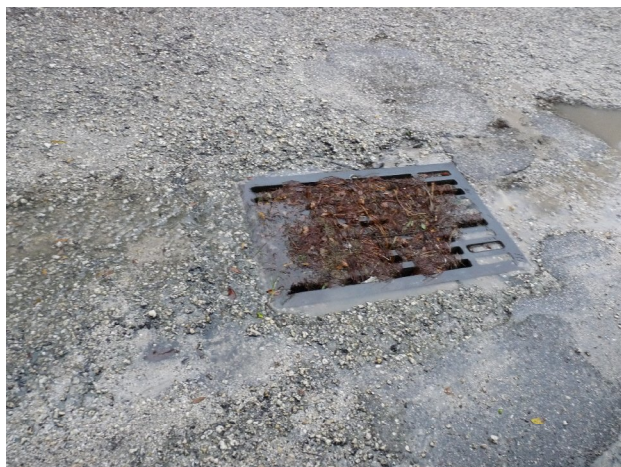
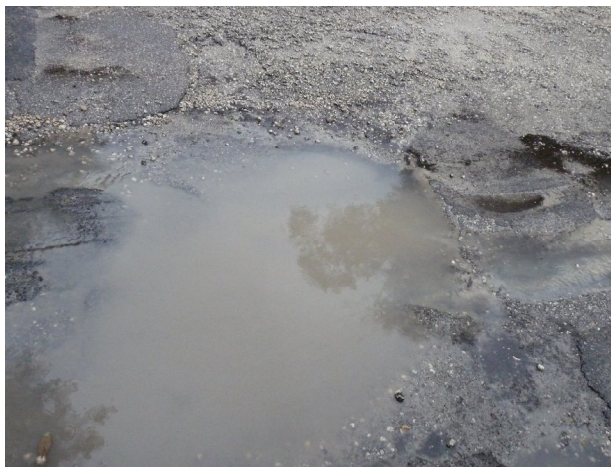
Area 2-2 consists of the Lake Holden Terrace roadway. Many portions of this roadway are in disrepair, and some areas are subject to erosion during storm events. Photographs of potential erosion and sediment transport on Lake Holden Terrace are given on Figure 5-16. Most portions of this roadway slope directly toward Lake Holden, with the generated runoff discharging onto grassed areas adjacent to the roadway. As a result, only a relatively small portion of the generated runoff volume actually enters the stormsewer system associated with Sub-basin 2. For this reason, this area is a less significant contributor of sediments and nutrient loadings to Lake Holden than areas previously discussed along Division Avenue. The existing erosion problems within this basin could be solved relatively easily by paving the existing roadway and providing a shallow swale system on the downstream side of the road for collection of stormwater runoff.

Photographs of Existing Conditions
and Sediment Sources in Area 2-2.

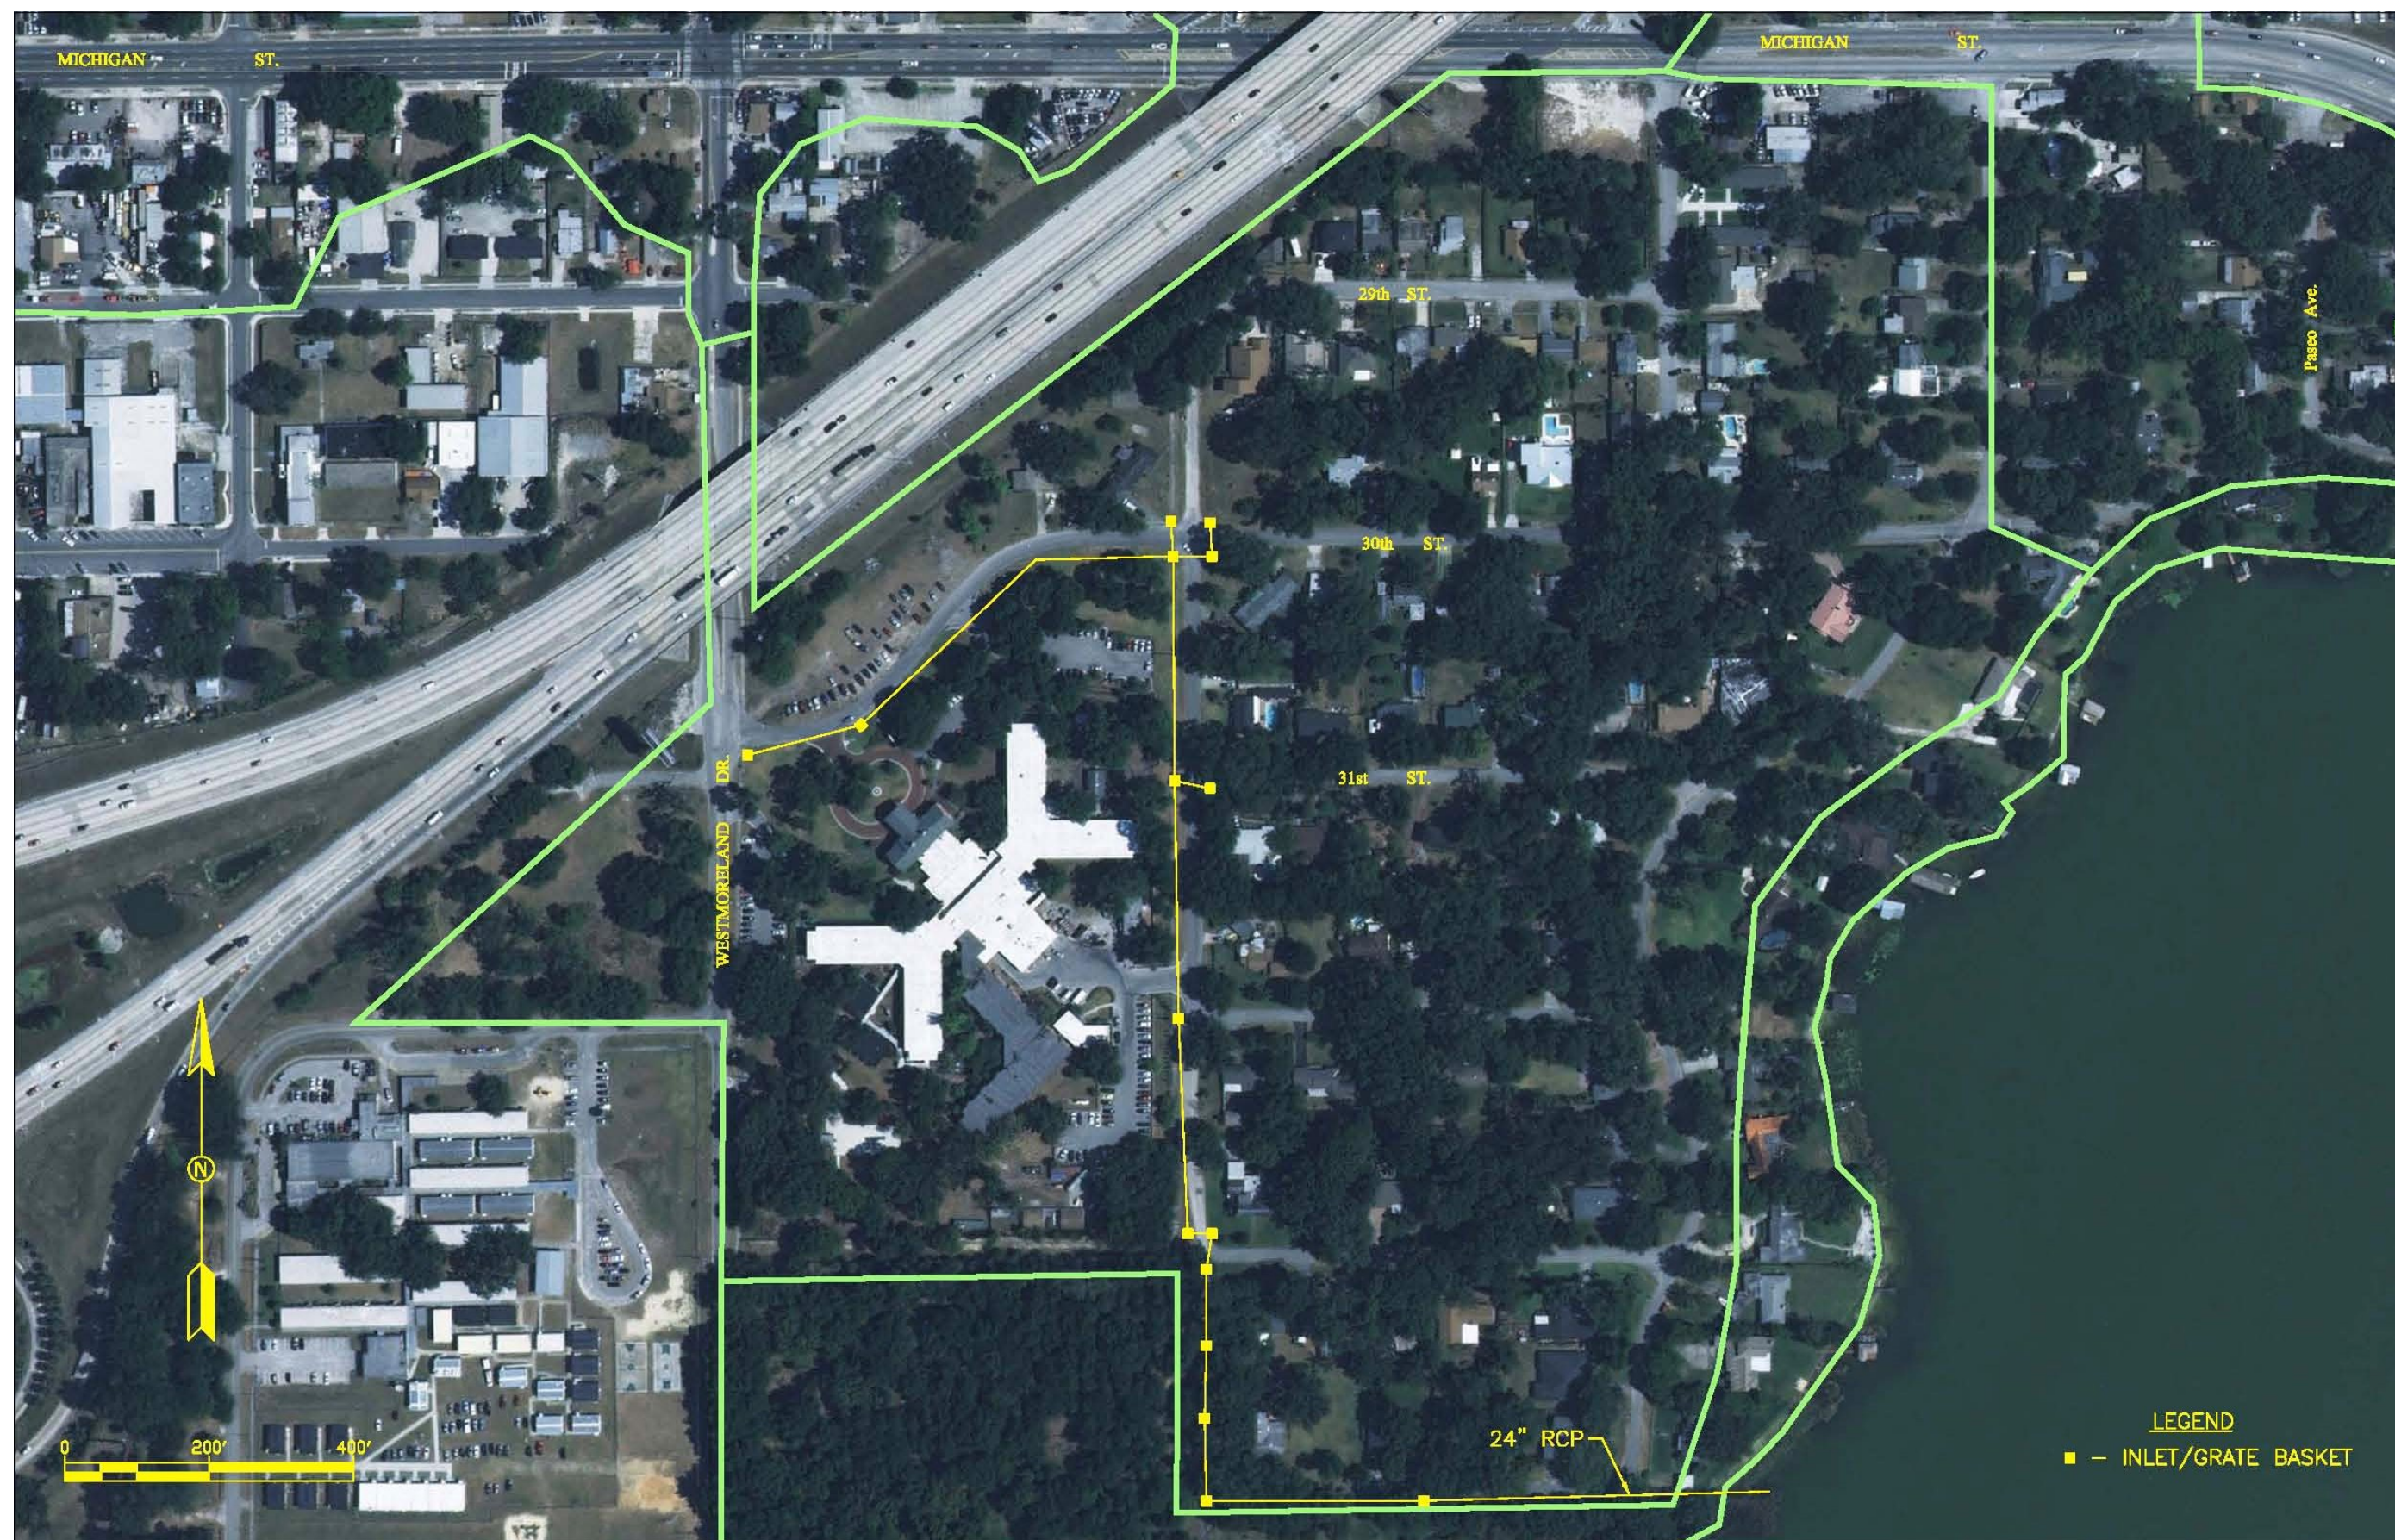
Figure 5-19. Overview of Sub-basin 20.

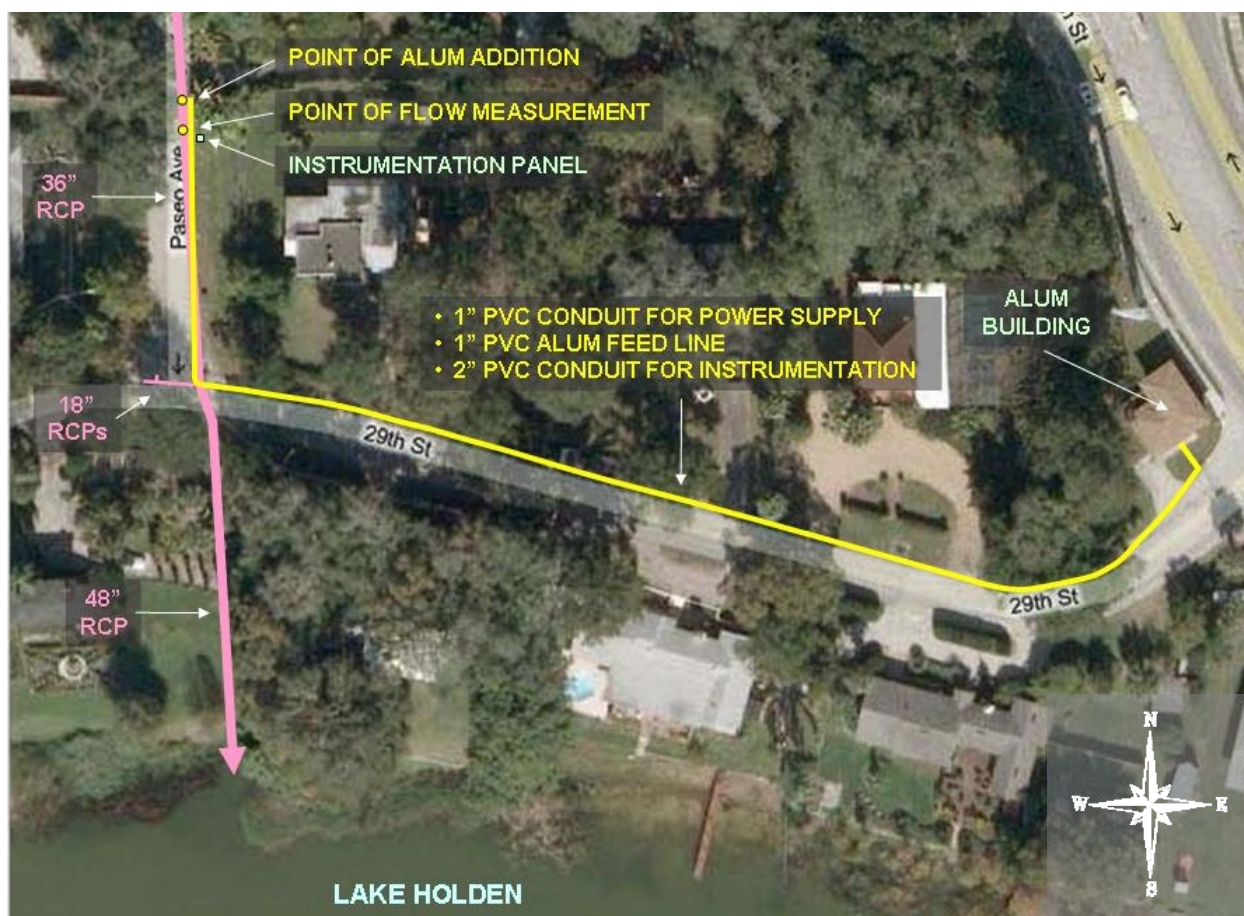
Within the instrumentation panel, the 4-20 mA analog signal is converted for use in a fiber-optic cable and transferred back to the alum building through a 2-inch conduit located along the eastern side of Paseo Avenue and the northern side of 29th Street. Once inside the alum building, this optic signal is converted back to a 4-20 mA signal within the alum pump control panel which controls the alum pump operations. Alum is pumped from the building through a 1-inch Sch. 80 PVC alum feed line to the 36-inch RCP at a location upstream of the point of flow measurement. The amount of alum pumped to the point of addition varies, depending on the measured flow rate through the 36-inch stormsewer, so that alum is always added at a specific dose on a flow-proportional basis relative to the measured stormwater flows.

Figure 2-1. Alum Treatment System No. 1.
