EVALUATION OF THE CURRENT STATUS AND POTENTIAL WATER QUALITY IMPROVEMENT OPTIONS FOR LAKE HOLDEN

**Final Report
February 2010**

Orange County Environmental Protection Division
800 N. Mercy Drive – Suite 4
Orlando, FL 32808

Harvey H. Harper, Ph.D., P.E. – Project Director
Environmental Research and Design, Inc.
3419 Trentwood Blvd., Suite 102
Orlando, FL 32812
Phone: 407-855-9465

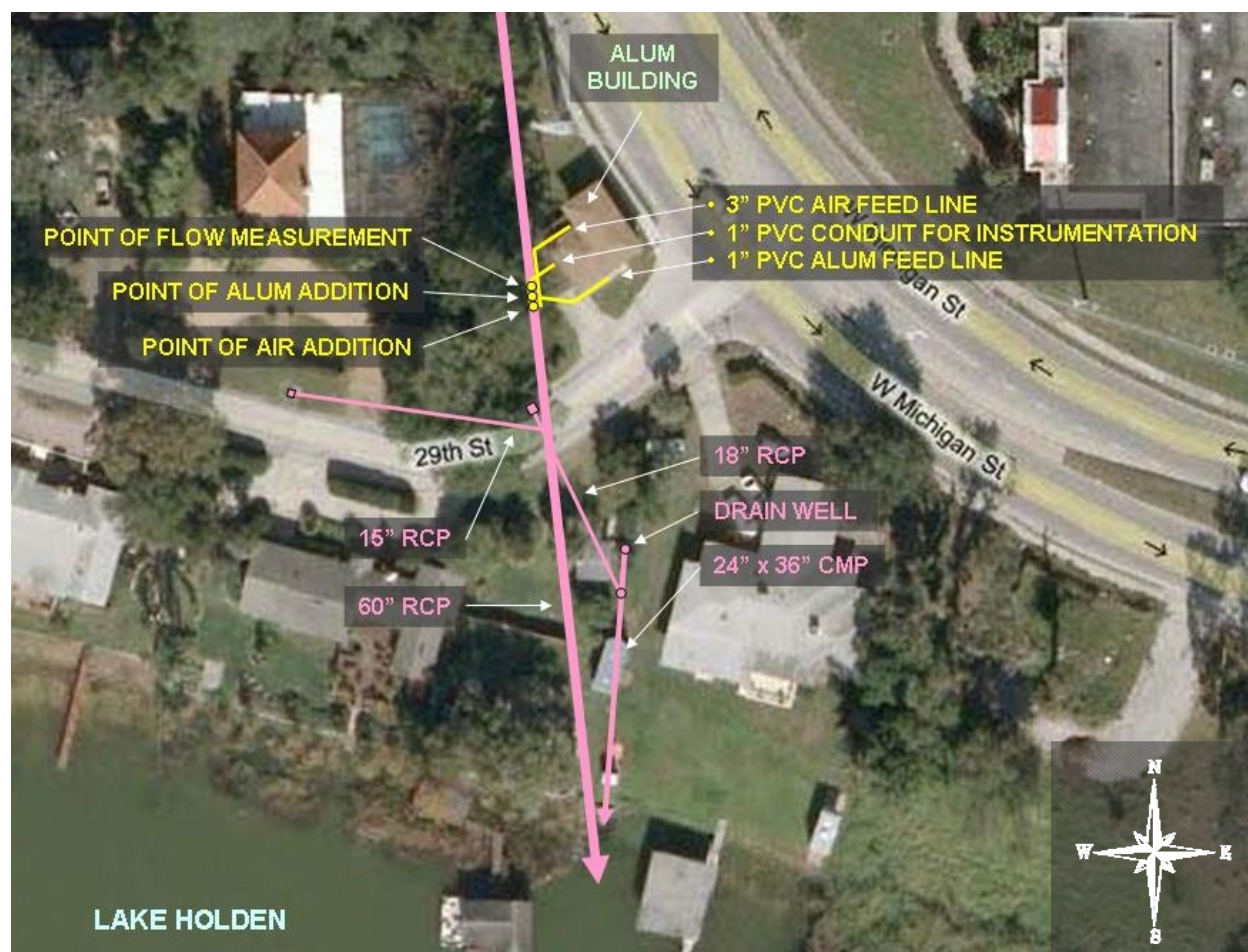
Within the alum building, the stormwater flow rate is communicated to the alum control panel which regulates the alum dose to the point of addition. The rate of alum addition is varied on a flow proportional basis based on stormwater flows. The point of alum addition is located within the 60-inch RCP directly downstream of the point of flow measurement. To facilitate adequate mixing of alum and stormwater within the 60-inch RCP, compressed air is added to agitate the mixture. The compressed air originates from a blower within the alum building and is transferred through a 3-inch Sch. 80 PVC air line to the point of air addition downstream of the point of alum addition.

Figure 2-2. Alum Treatment System No. 2.

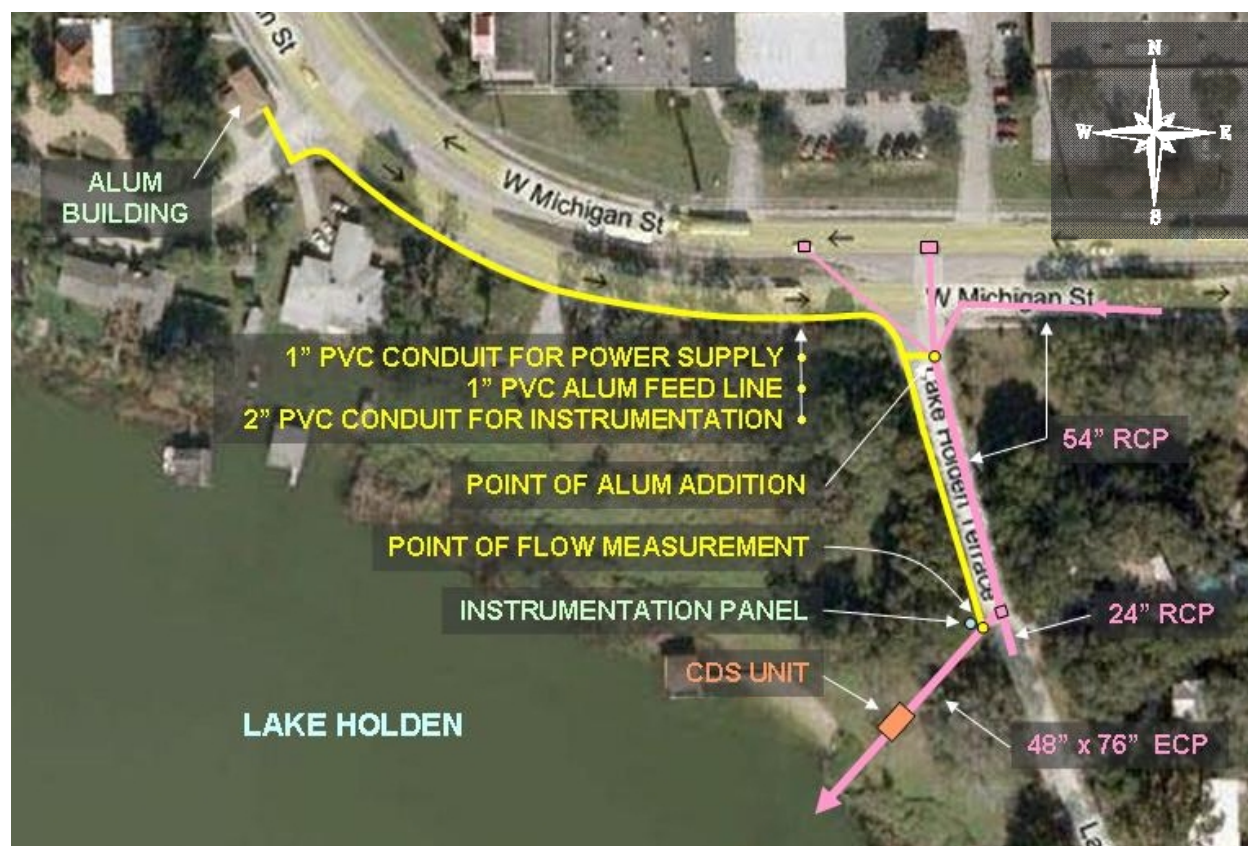
Figure 2-3. Alum Treatment System No. 3.

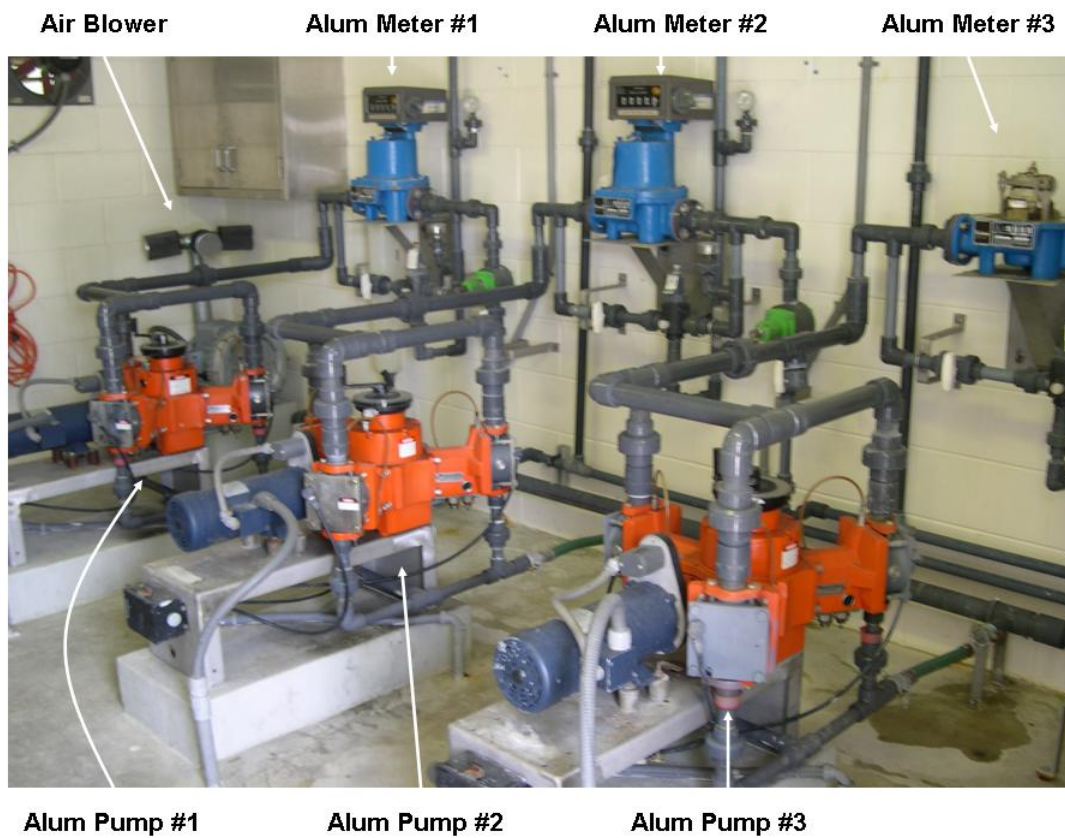
Figure 2-4. Alum Pumps and Meters.

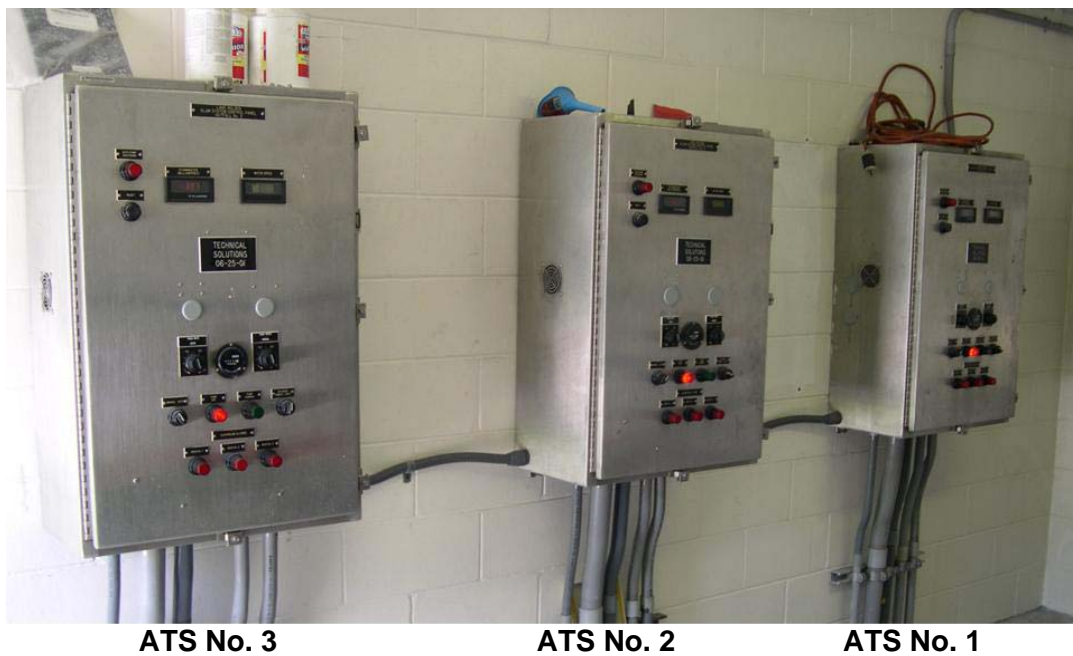
Figure 2-5. Alum Pump Control Panels.
