# Lake Holden Revised Hydrologic / Nutrient Budget and Management Plan

Final Report

July 2004

**Environmental Research & Design, Inc.**

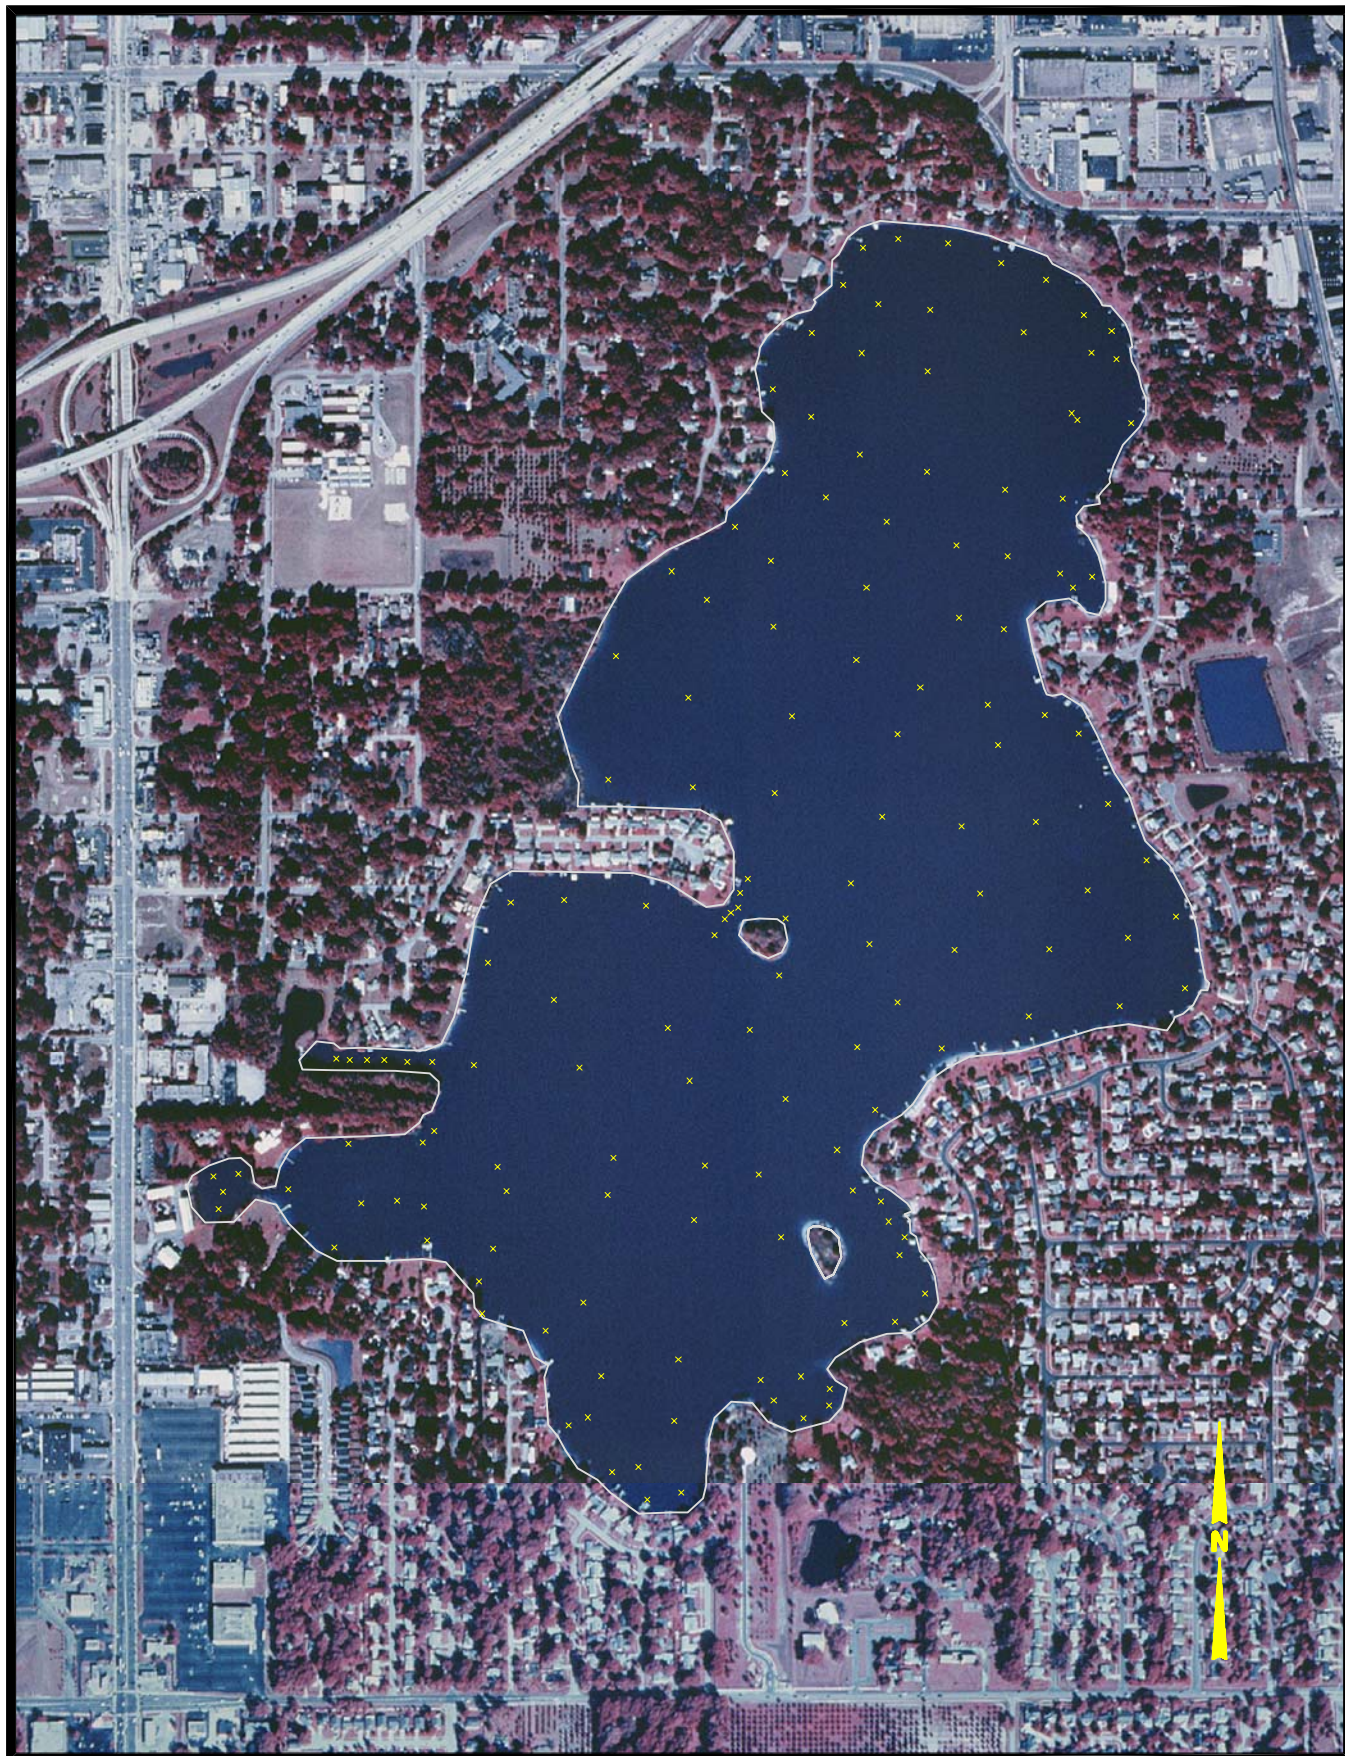
Water depth at each of the data collection sites was determined by lowering a 20-cm diameter Secchi disk attached to a graduated line until resistance from the sediment layer was encountered. The depth on the graduated line corresponding to the water surface was recorded in the field and is defined as the water depth at each site. After measurement of the water depth at each site, a 1.5-inch graduated aluminum pole was then lowered into the water column and forced into the sediments until a firm bottom material, typically sand or clay, was encountered. The depth corresponding to the water surface is defined as the depth to the firm lake bottom. The difference between the depth to the firm lake bottom and the water depth at each site is defined as the depth of unconsolidated sediments.

Figure 2-1. Probing Locations for Water and Muck Depth in Lake Holden.

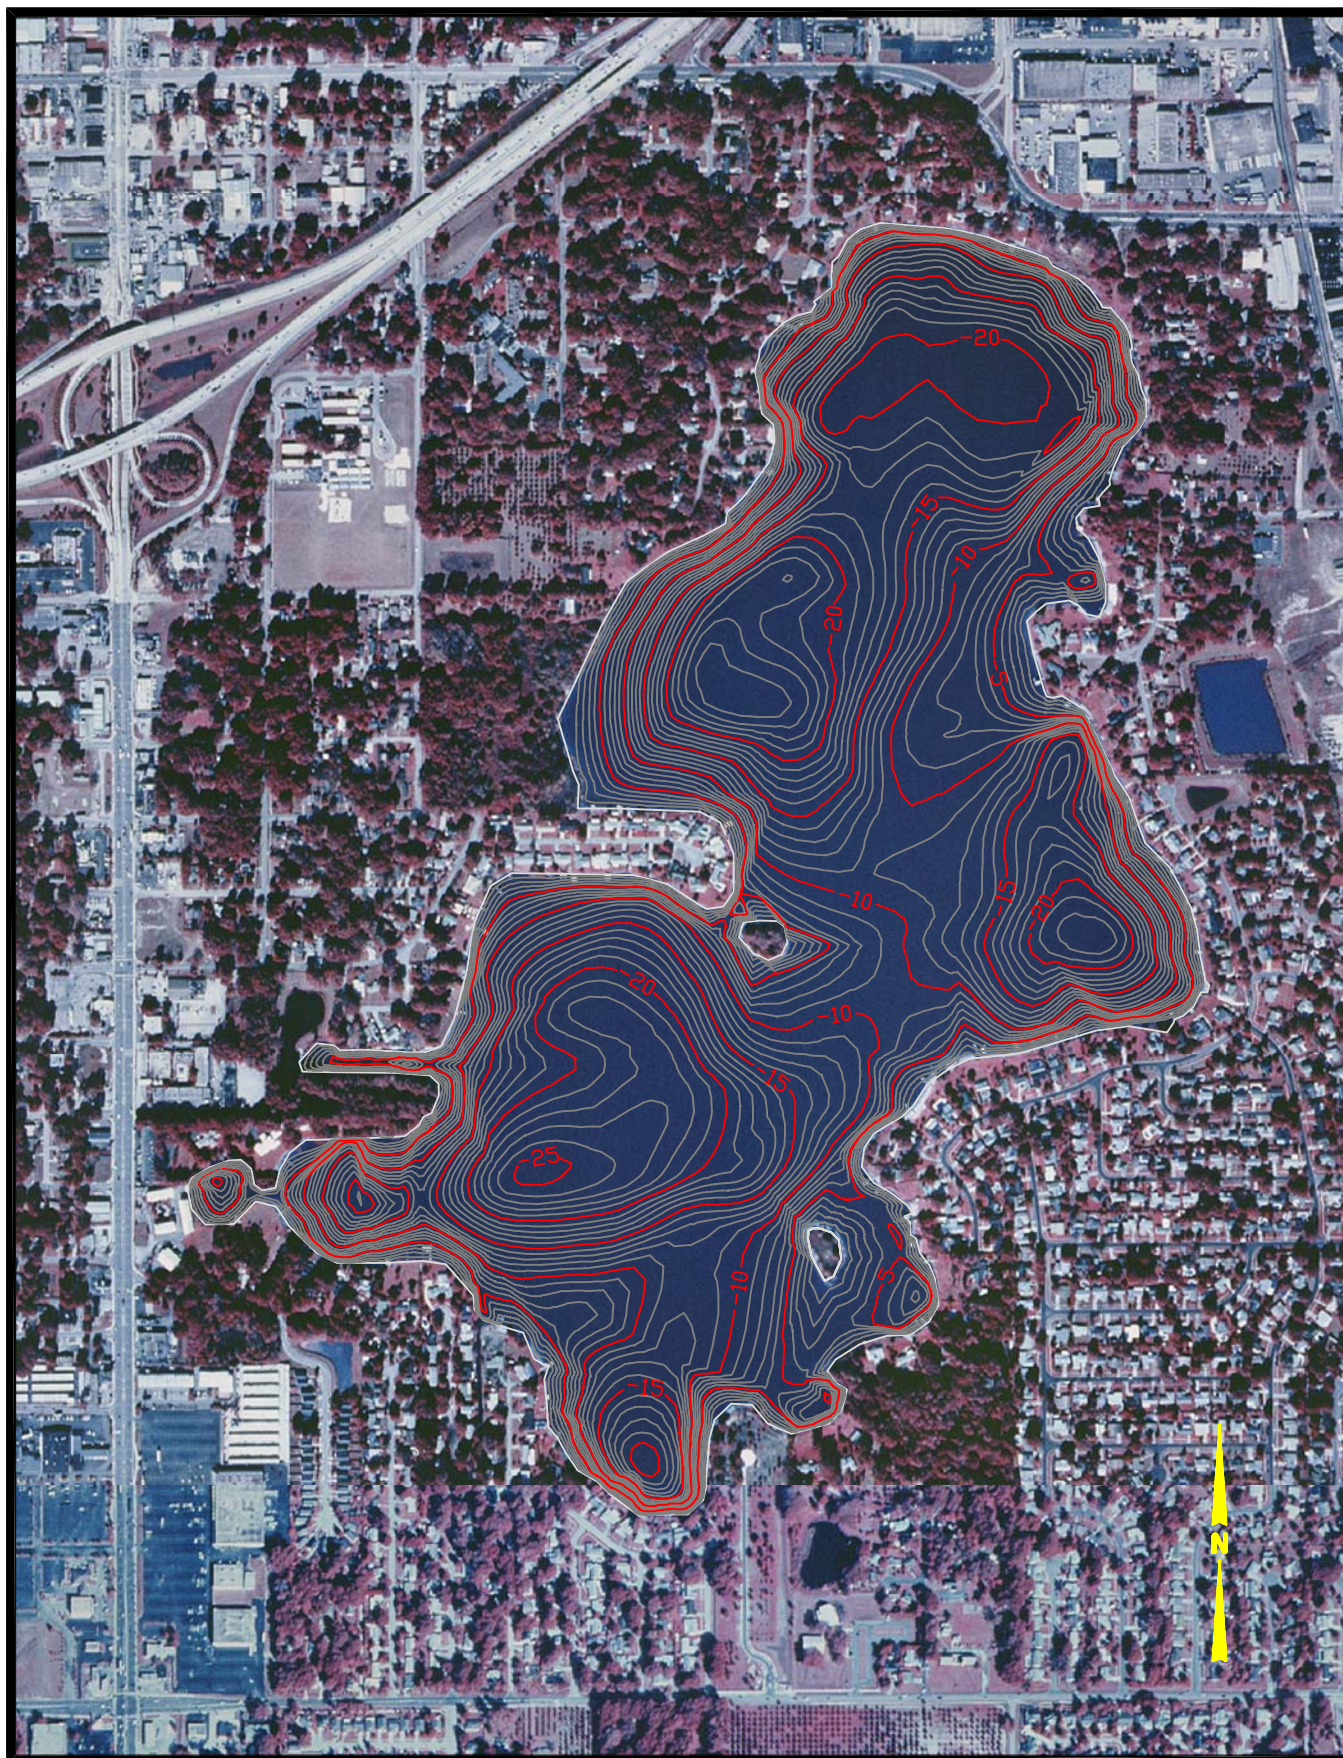
Figure 2-2. Lake Holden Water Depth Contours (ft) on September 15, 2003.  
(Water Surface Elev. = 90.61 ft.)

The generated field data was converted into bathymetric maps for both water depth and unconsolidated sediment depth in Lake Holden using AutoCAD 2002. Estimates of water volume and unconsolidated sediment volume within Lake Holden were generated using the Autodesk Land Desktop 2004 Module.

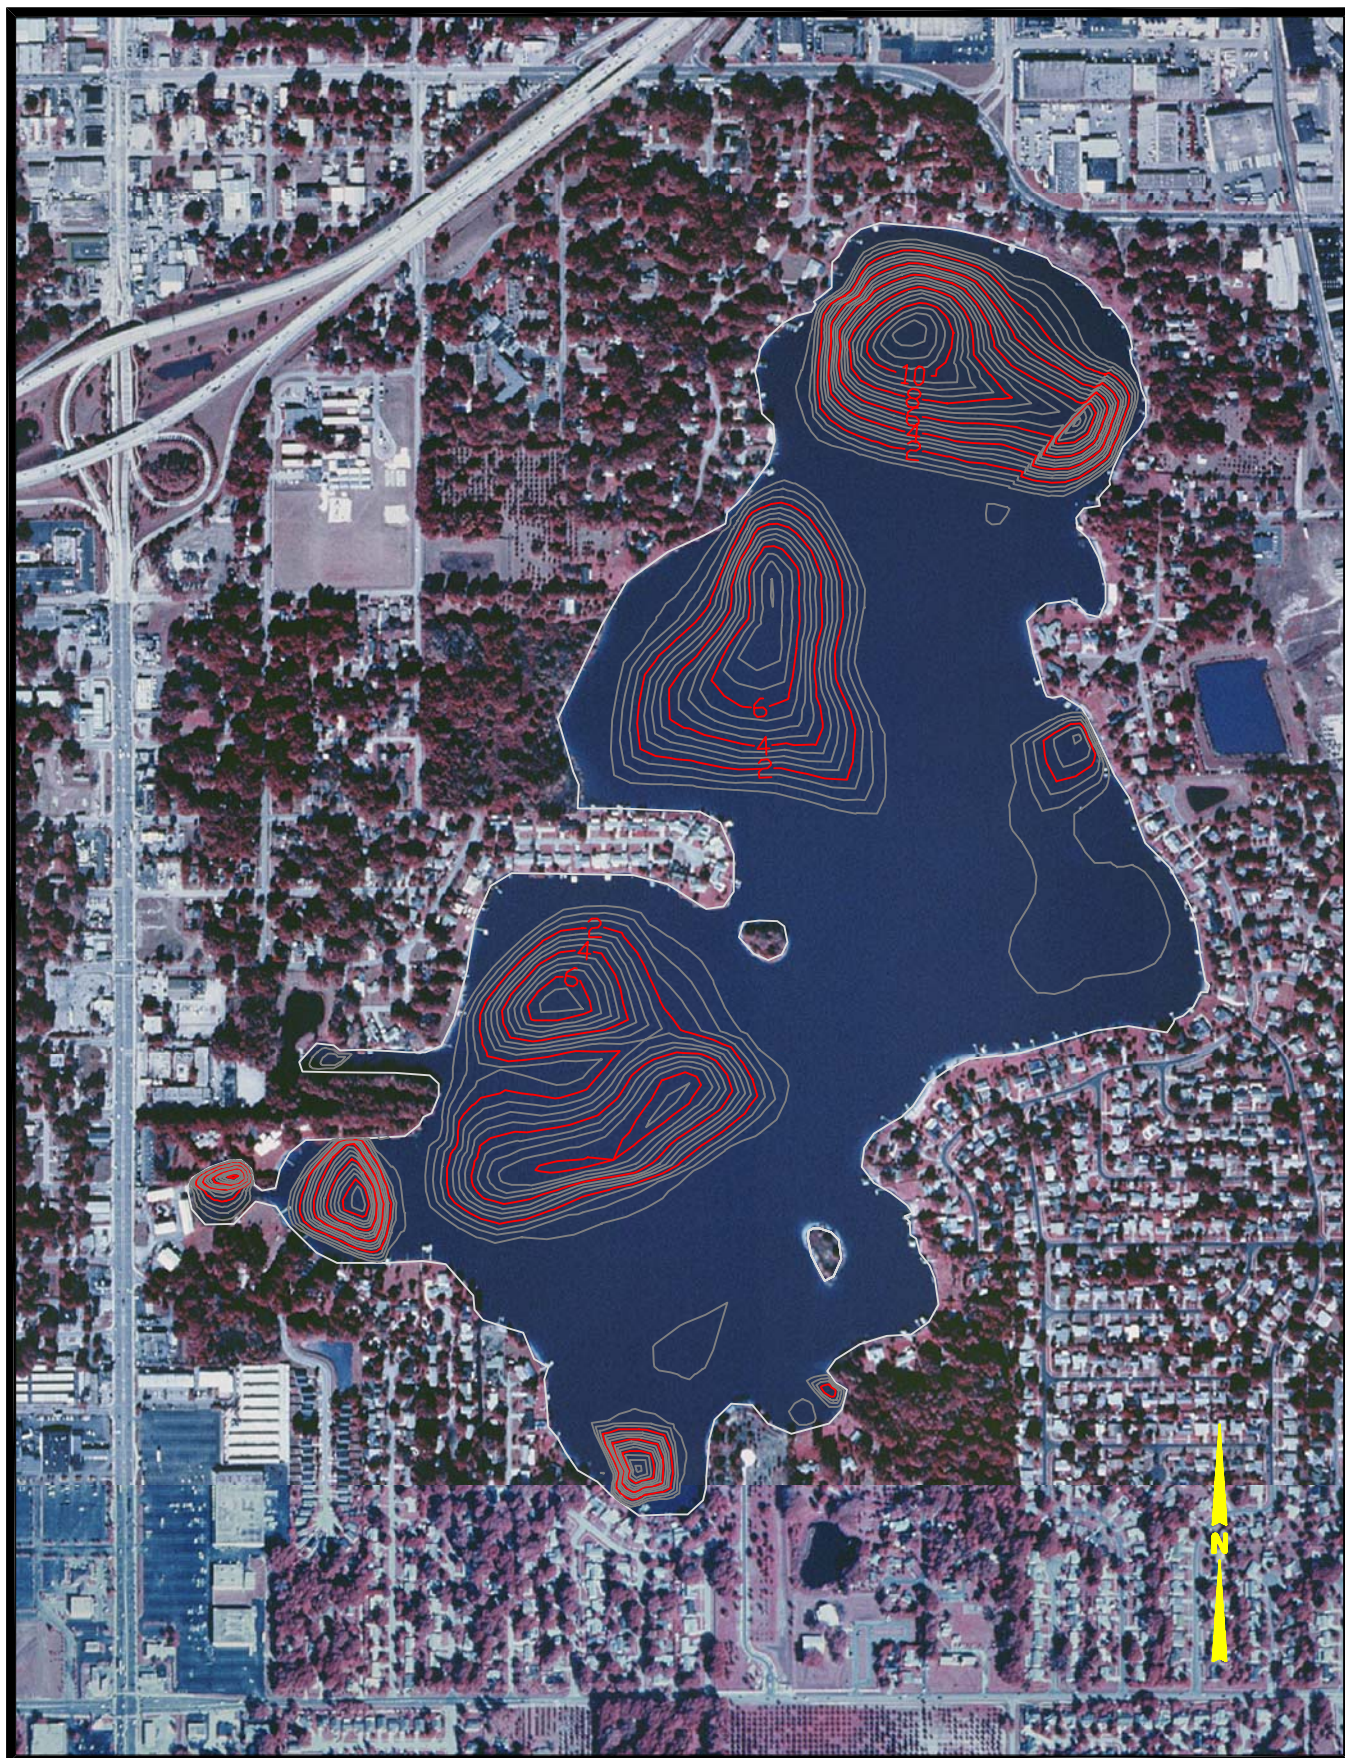
A bathymetric contour map of the depth of unconsolidated organic sediments in Lake Holden is given in Figure 2-3. A substantial accumulation of organic muck is apparent in the northern portion of the lake where muck depths exceed 13 ft. Muck depths of approximately 9-10 ft were observed in north-central portions of the lake, with accumulations exceeding 6-8 ft in western portions of the lake. The remaining portions of the lake appear to have organic muck depths of approximately 1 ft or less.

Figure 2-3. Unconsolidated Muck Depth Contours in Lake Holden (ft.).

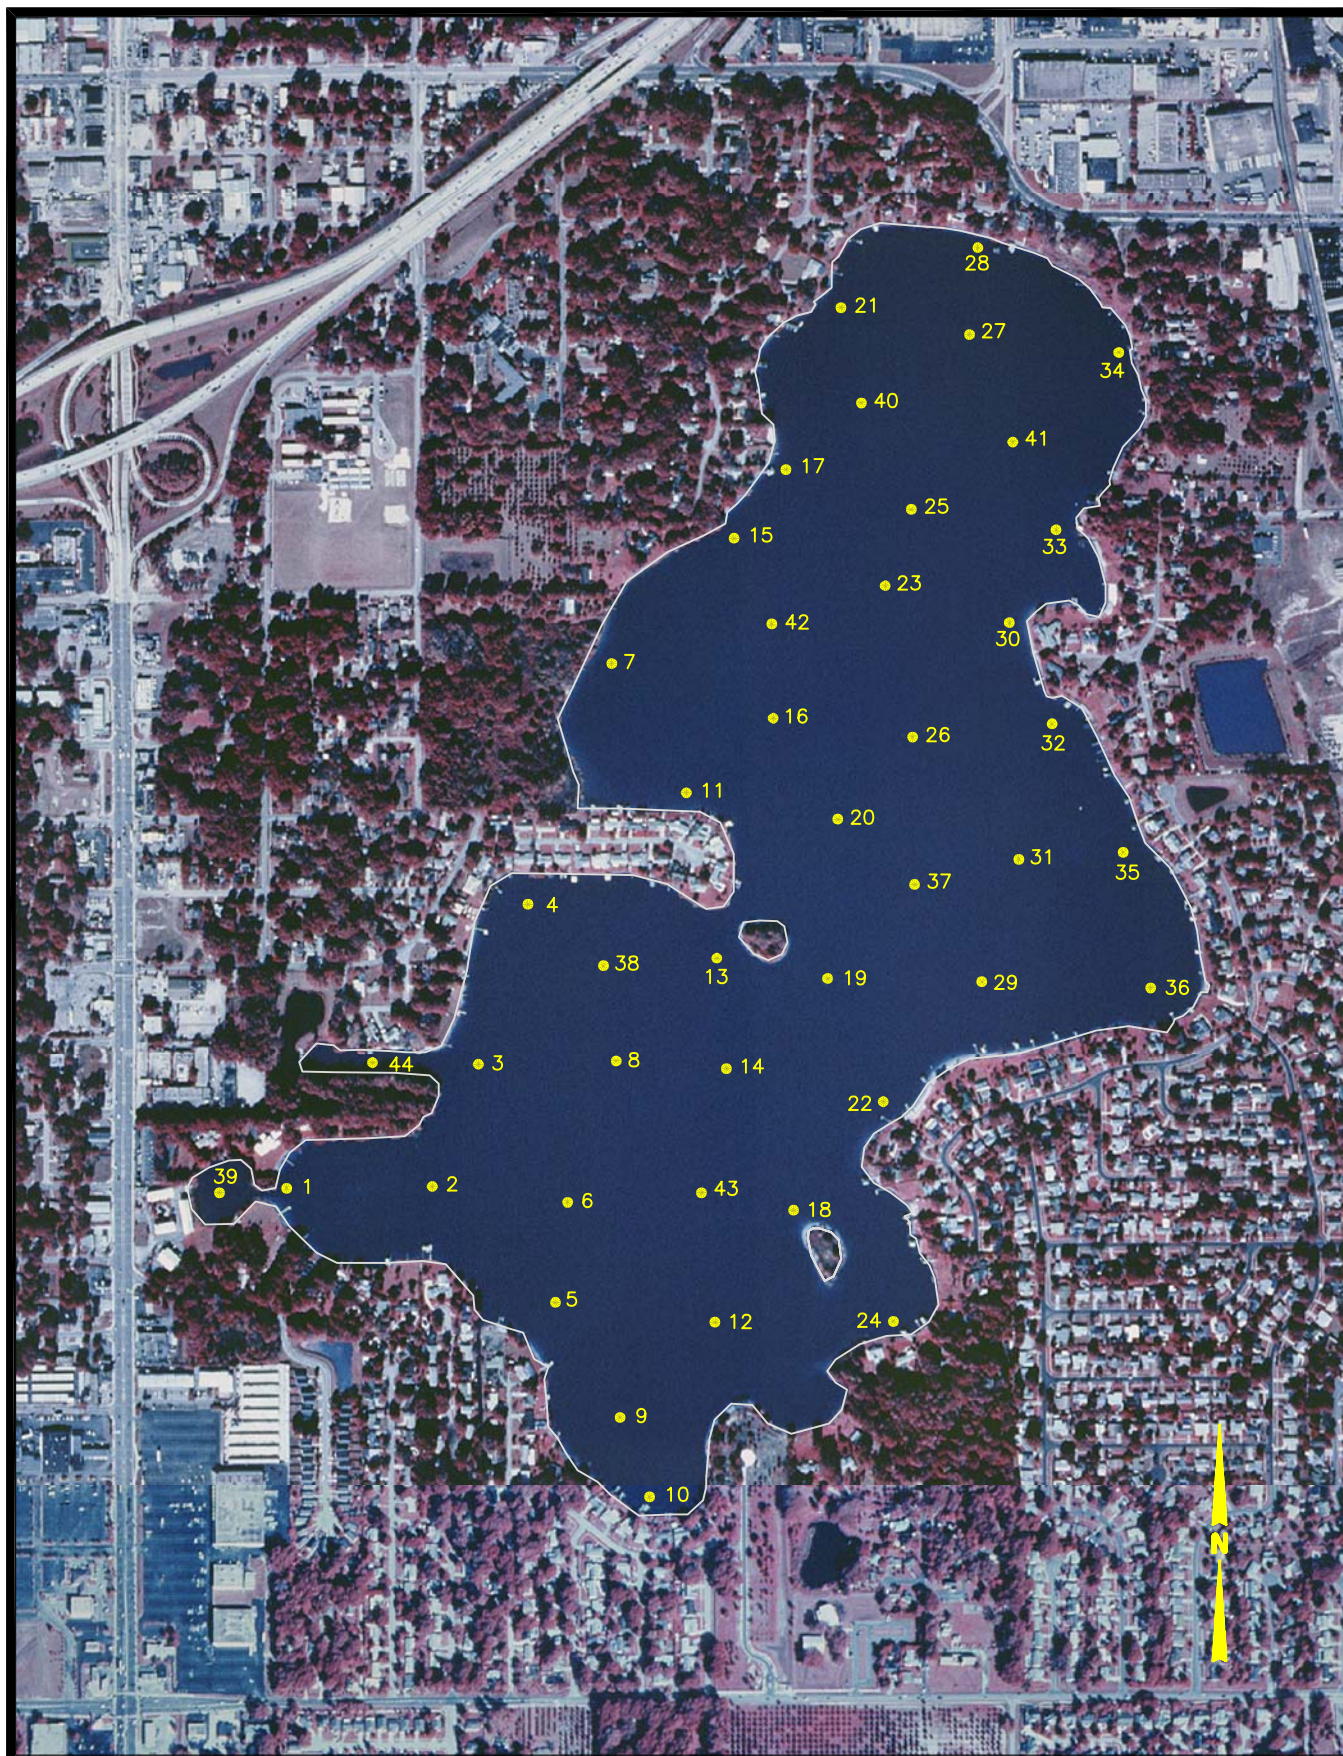
Sediment samples were collected at each of the 44 monitoring sites using a stainless steel split-spoon core device, which was penetrated into the sediments at each location to a minimum distance of approximately 0.5 m. After retrieval of the sediment sample, any overlying water was carefully decanted before the split-spoon device was opened to expose the collected sample. Visual characteristics of each sediment core sample were recorded, and the 0-10 cm layer was carefully sectioned off and placed into a polyethylene container for transport to the ERD laboratory. Duplicate core samples were collected at each site, and the 0-10 cm layers were combined together to form a single composite sample for each of the 44 monitoring sites. The polyethylene containers utilized for storage of the collected samples were filled completely so no air space was present in the storage container above the composite sediment sample. Each of the collected samples was stored on ice and returned to the ERD laboratory for physical and chemical characterization.

Figure 2-4. Locations of Sediment Sampling Sites in Lake Holden.

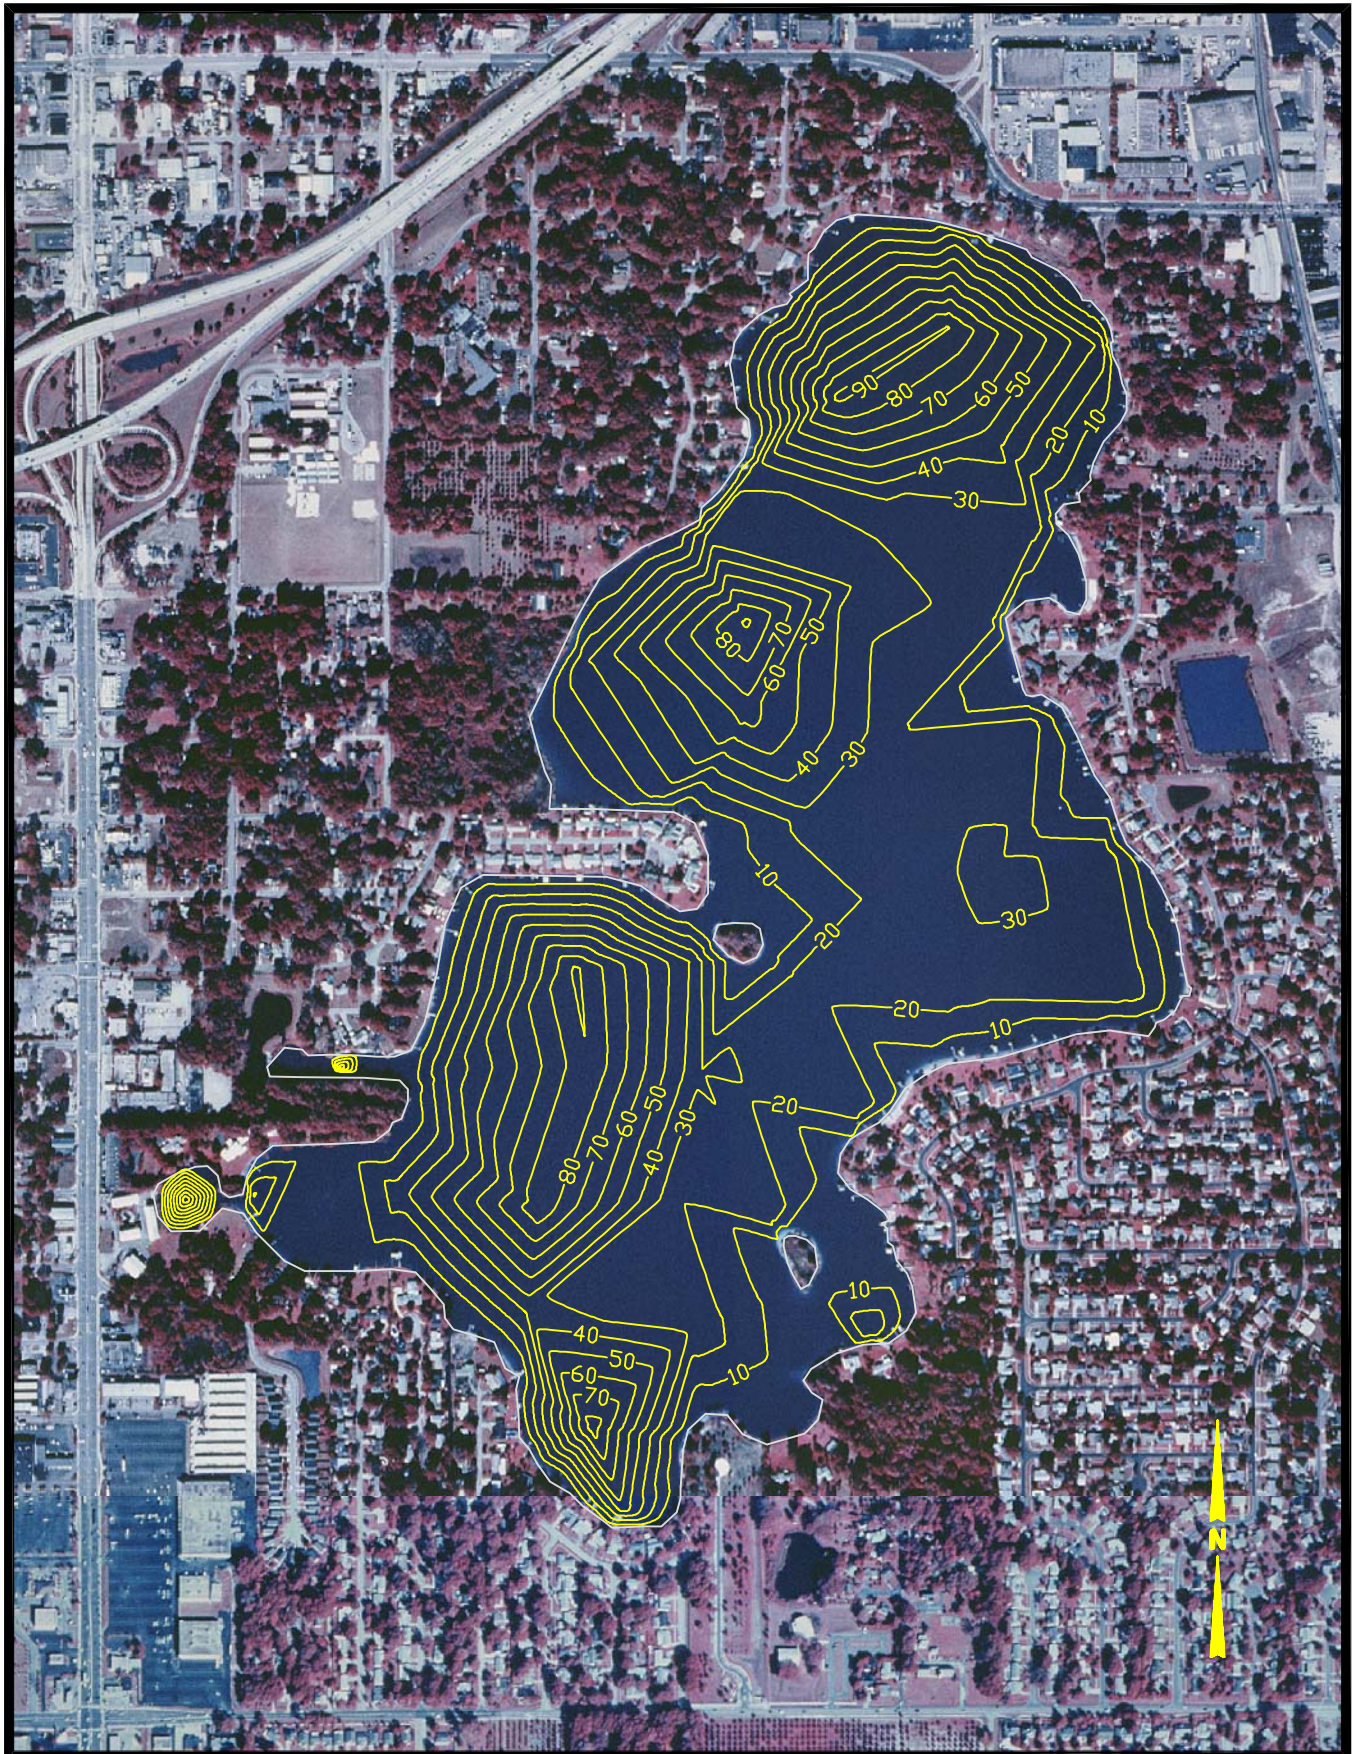
Isopleths of sediment moisture content in Lake Holden are summarized in Figure 2-6 based upon the information provided in Table 2-6. Areas of elevated moisture content are present in northern, central, and western portions of the lake. Sediment moisture contents in excess of 50% are often indicative of highly organic sediments, while moisture contents less than 50% reflect either sand or mixtures of sand and muck.

Figure 2-6. Isopleths of Sediment Moisture Content (%) in the Top 10 cm of Lake Holden.

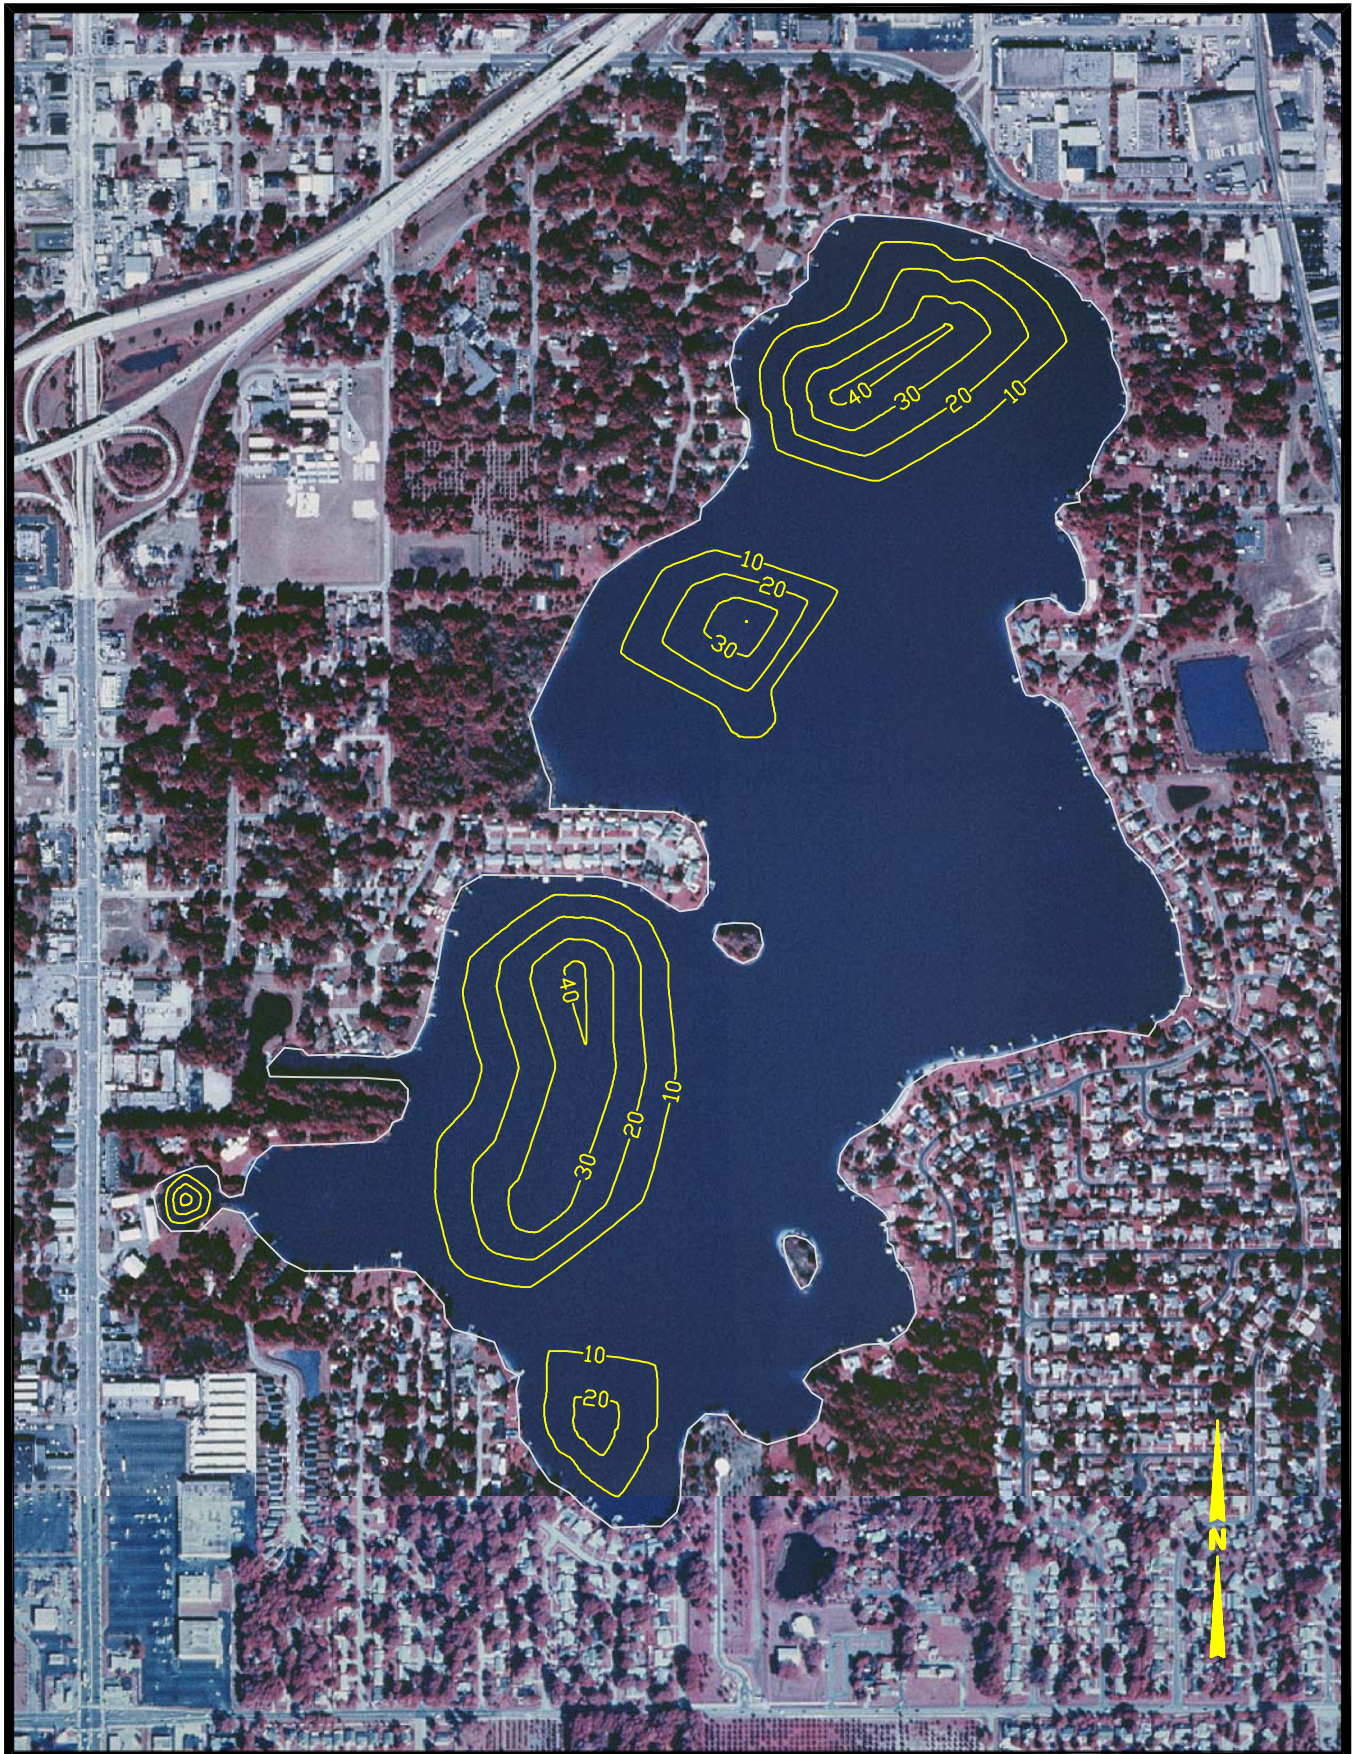
Figure 2-7. Isopleths of Sediment Organic Content (%) in the Top 10 cm in Lake Holden.

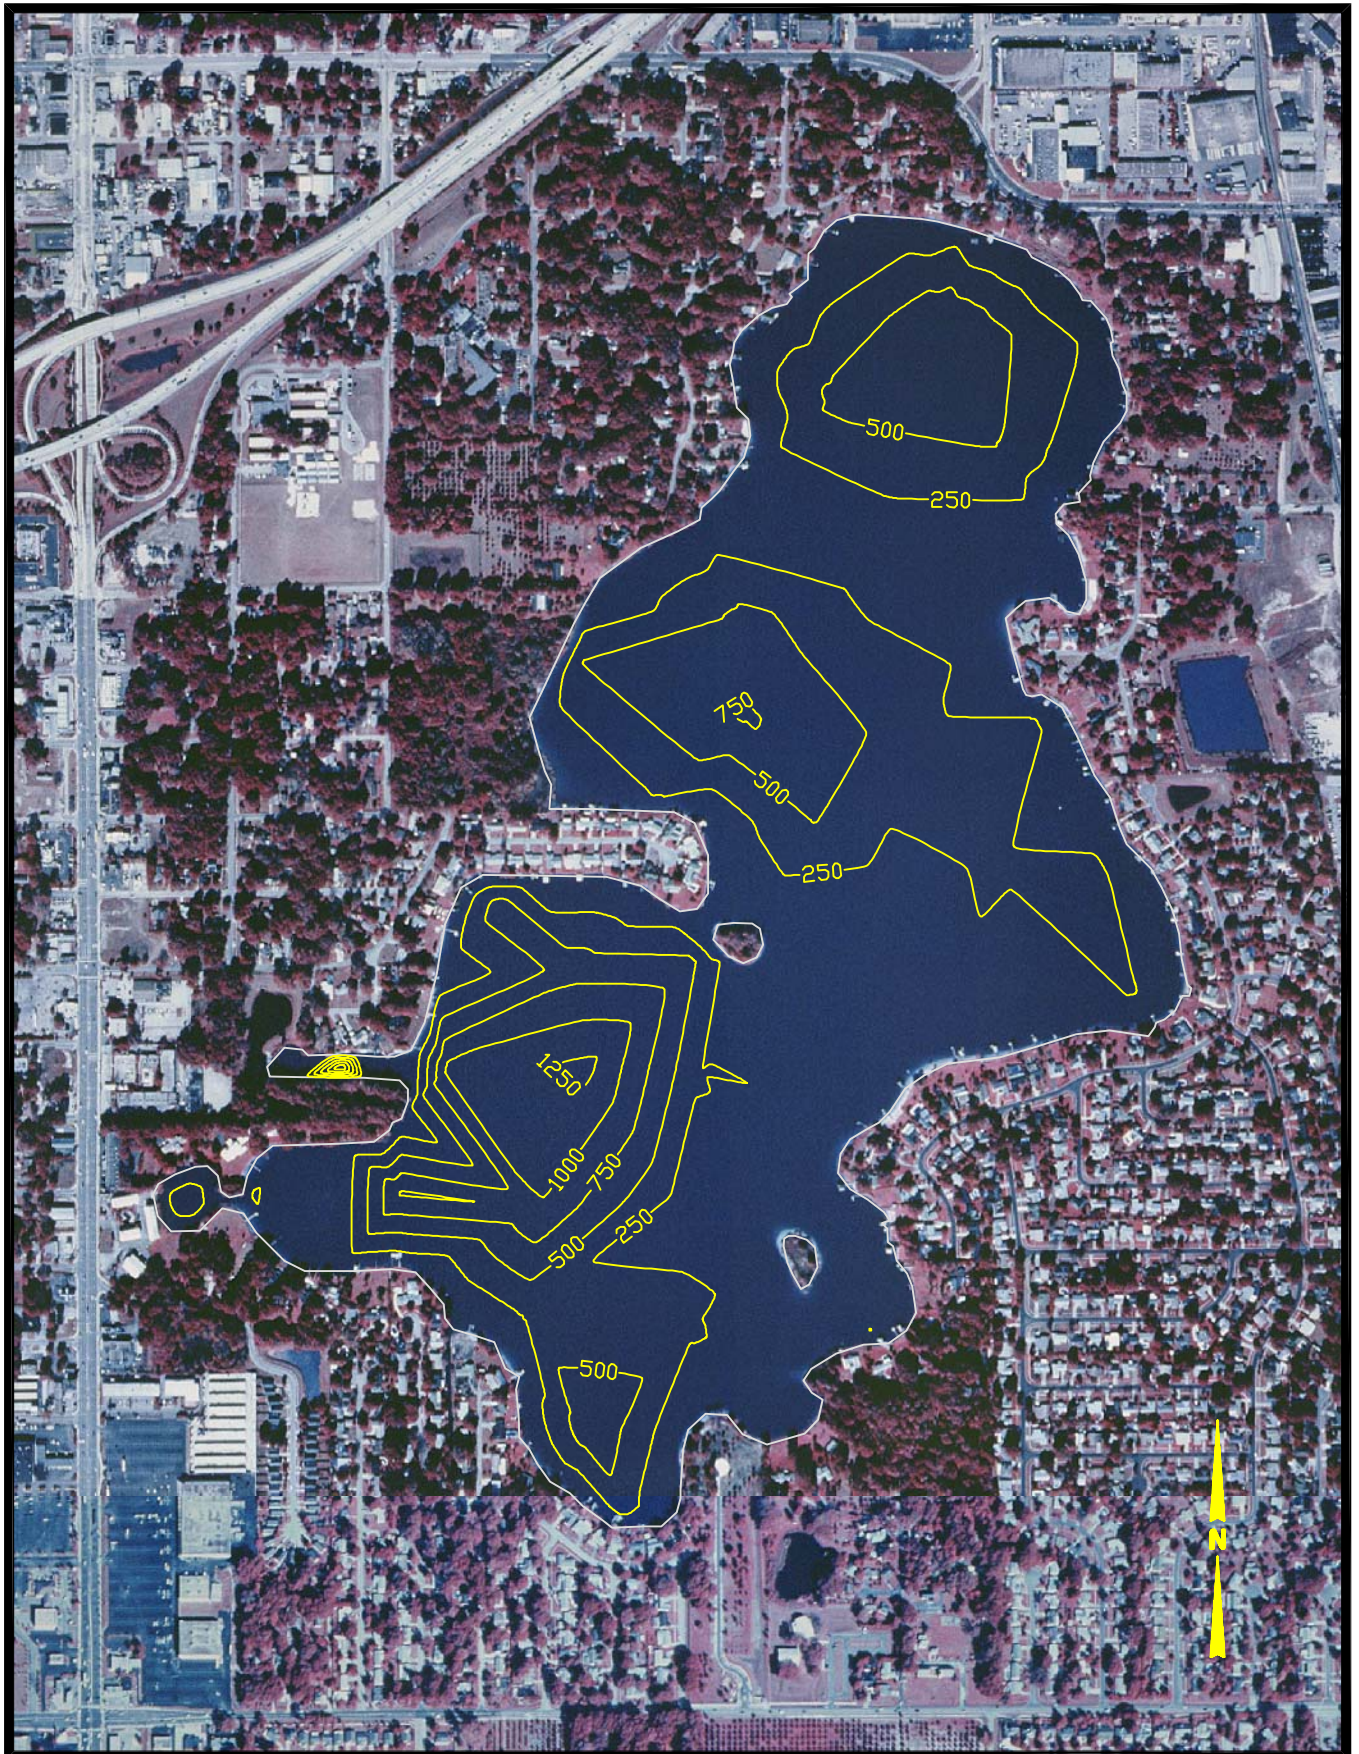
Isopleths of sediment phosphorus concentrations in Lake Holden are presented on Figure 2-8, based on information contained in Table 2-6. Areas of elevated sediment phosphorus concentrations are present in the northern, central, and western portions of the lake, similar to the areas of elevated moisture and organic content illustrated on Figures 2-6 and 2-7, respectively. In general, overall total phosphorus concentrations observed in Lake Holden appear to be somewhat elevated compared with phosphorus sediment concentrations typically observed in urban lakes.

Figure 2-8. Isopleths of Total Phosphorus ( $\mu\text{g/g}$  wet wt.) in the Top 10 cm of Sediments in Lake Holden.

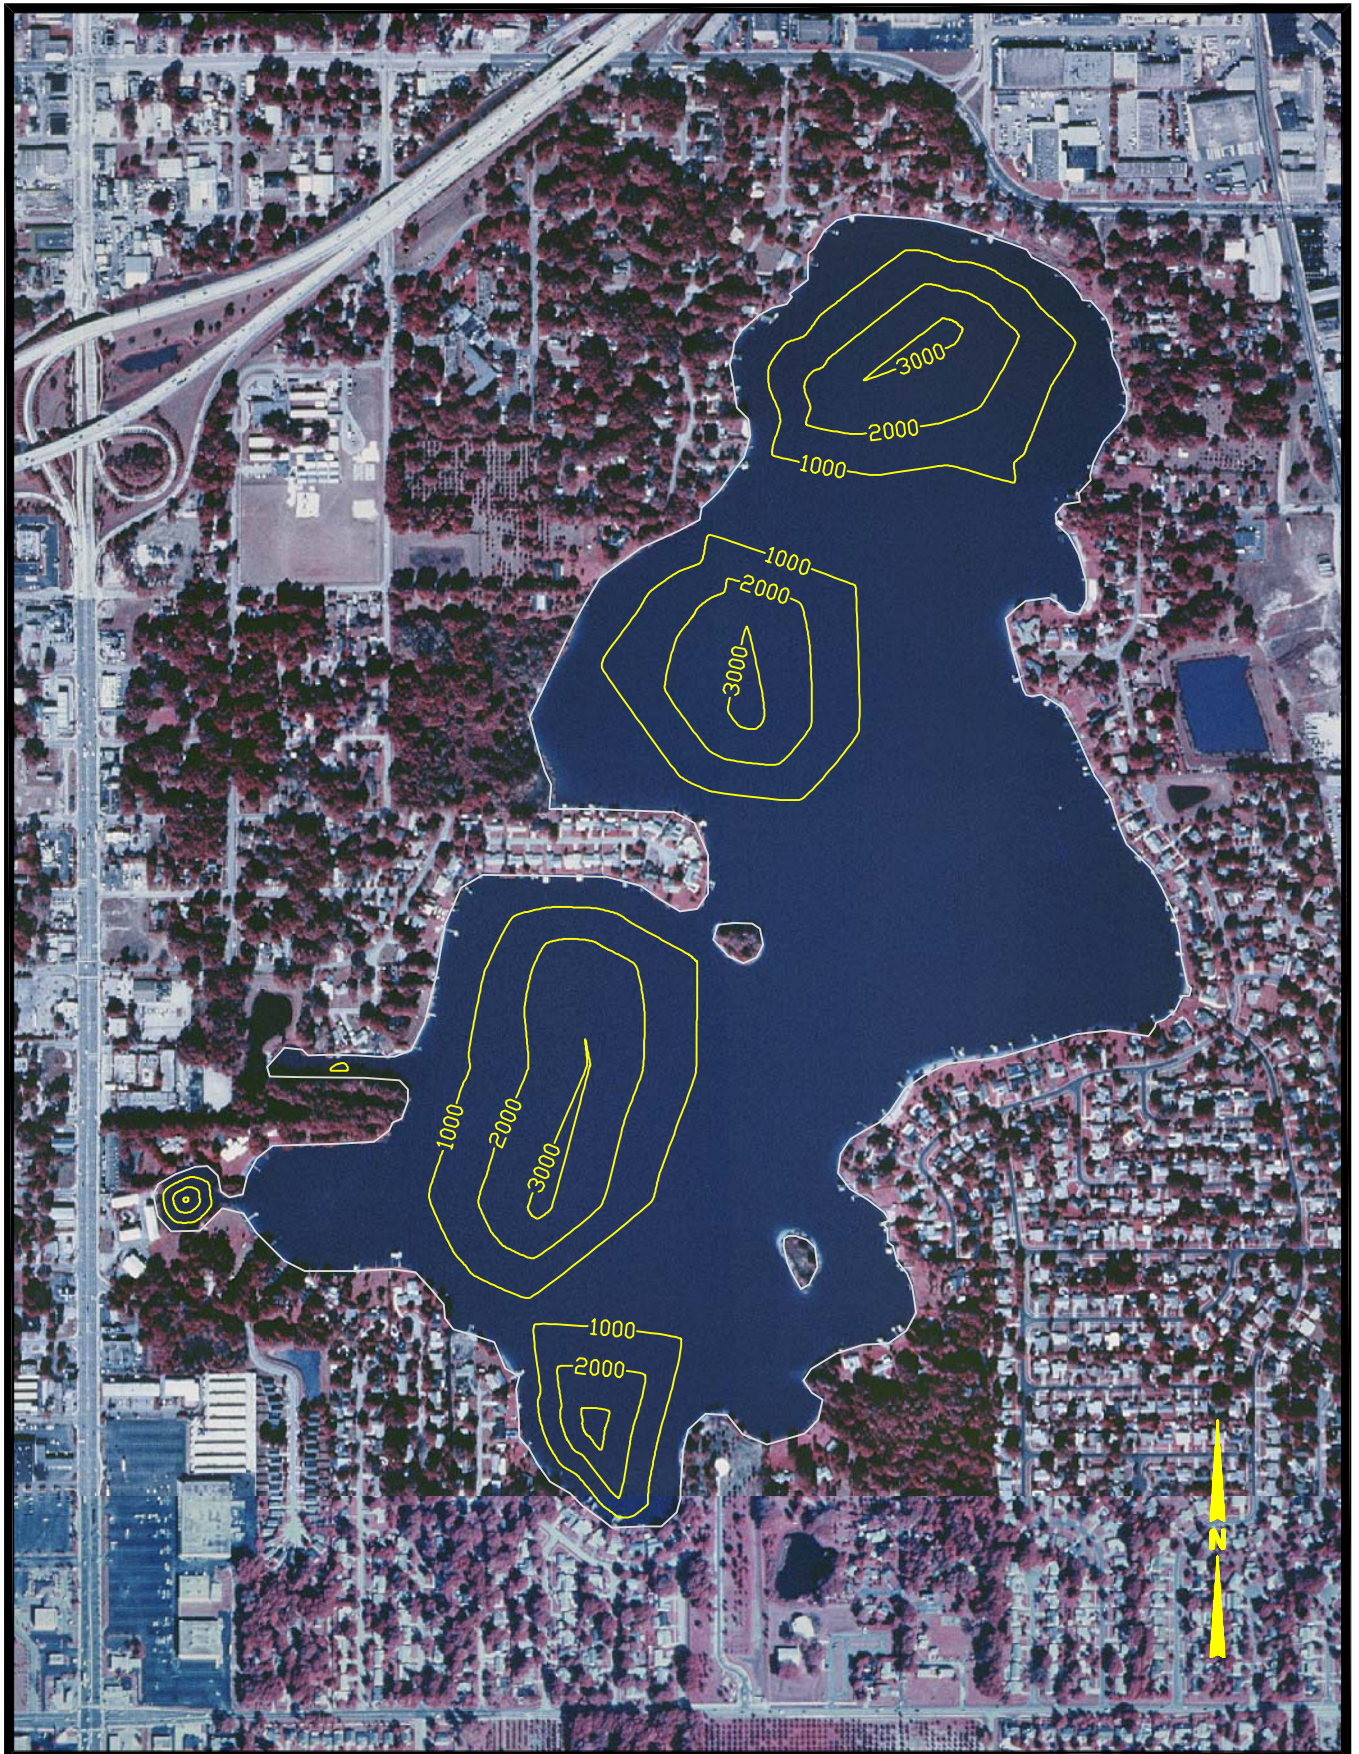
Isopleths of sediment nitrogen concentrations in Lake Holden are illustrated on Figure 2-9. In general, patterns of elevated nitrogen concentrations are similar to the patterns exhibited by total phosphorus.

Figure 2-9. Isopleths of Total Nitrogen ( $\mu\text{g/g}$  wet wt.) in the Top 10 cm of Sediments in Lake Holden.

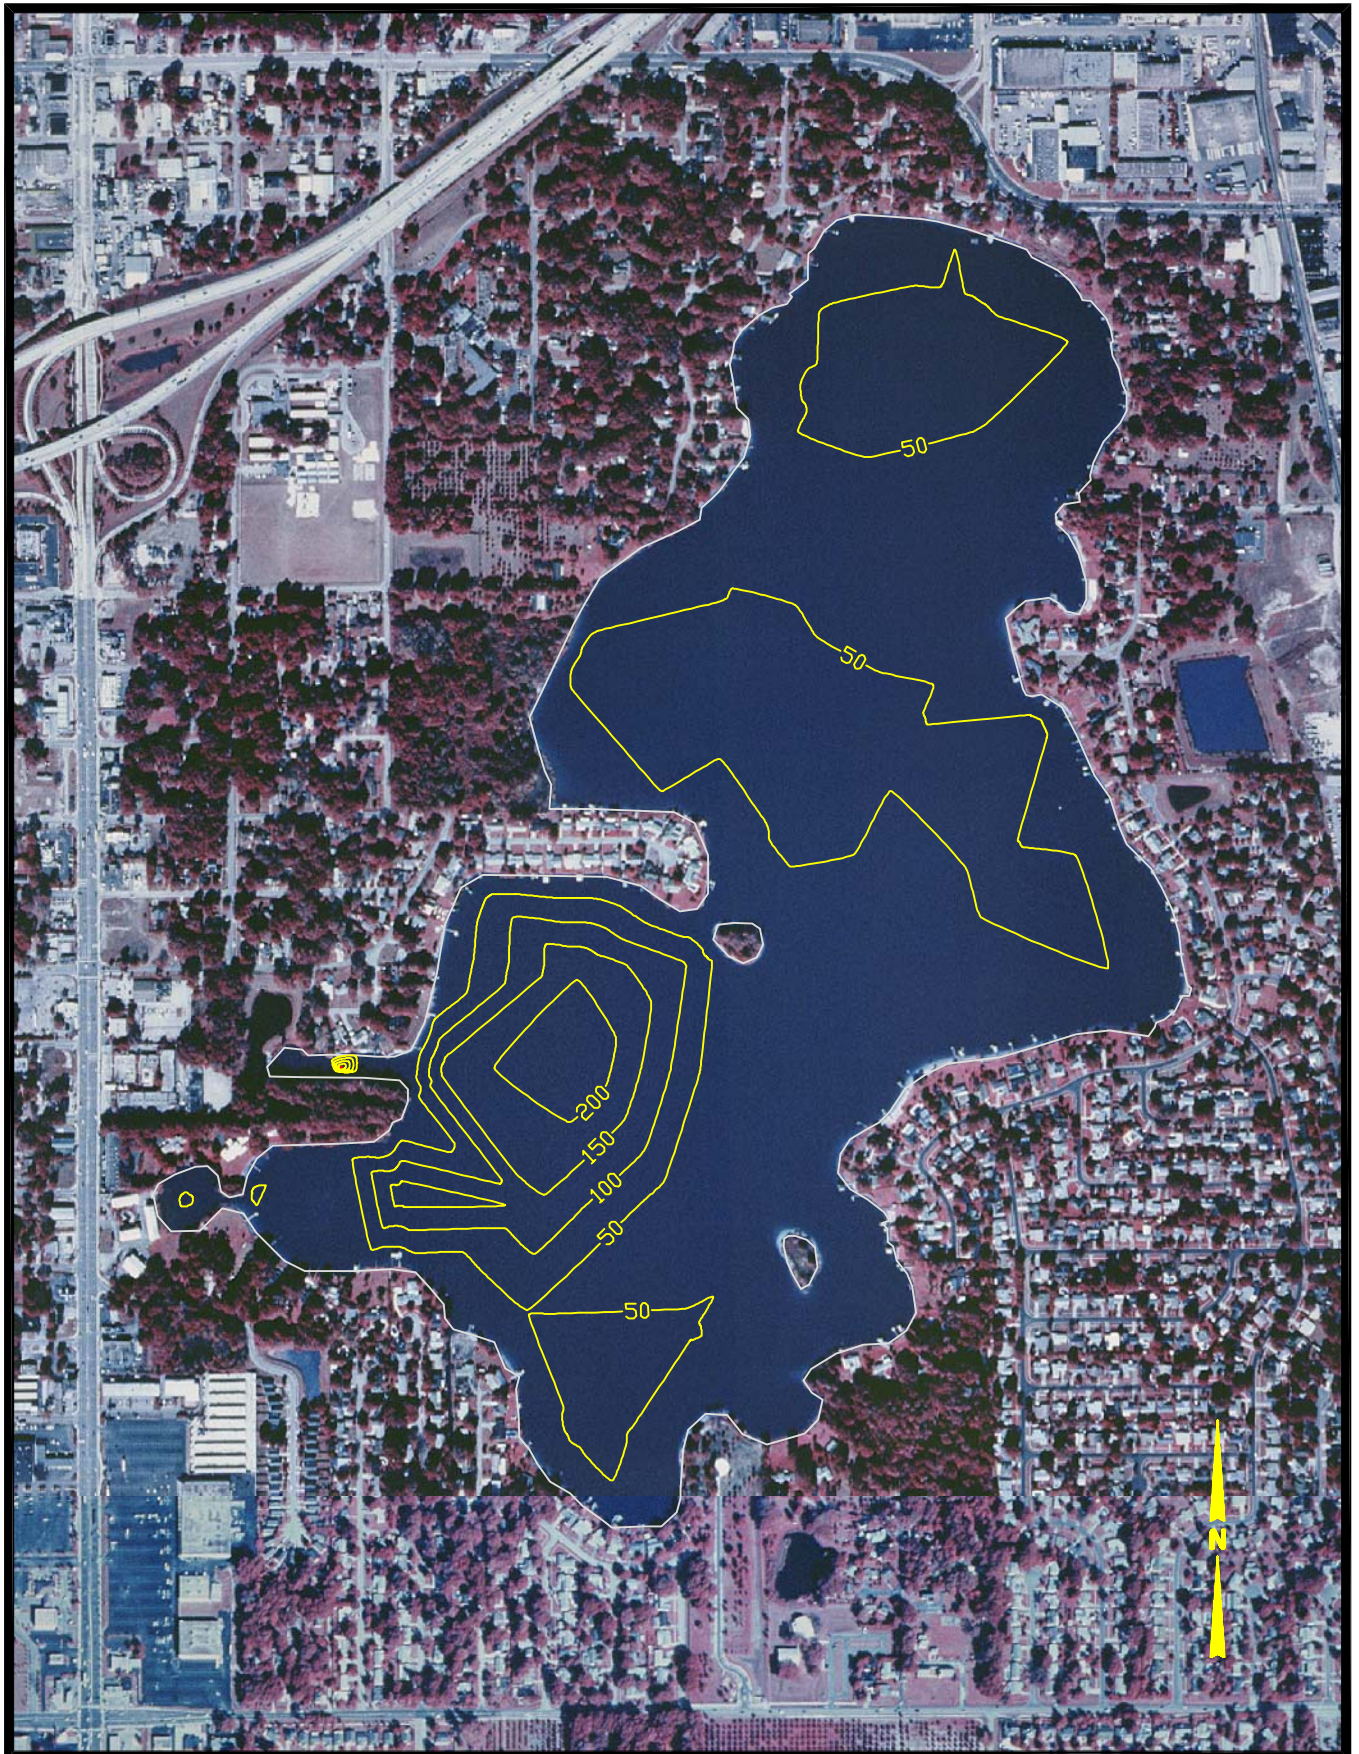
Figure 2-10. Isopleths of Total Available Phosphorus ( $\mu\text{g/g}$  wet wt.) in the Top 10 cm of Sediments in Lake Holden.

Total available phosphorus represents the sum of the saloid-bound phosphorus and iron-bound phosphorus associations in each sediment core sample. Since the saloid-bound phosphorus is immediately available, and the iron-bound phosphorus is available under reduced conditions, the sum of these speciations represents the total phosphorus which is potentially available within the sediments. This information can be utilized as a guide for future sediment inactivation procedures.
