# Lake Holden Revised Hydrologic / Nutrient Budget and Management Plan

Final Report

July 2004

**Environmental Research & Design, Inc.**

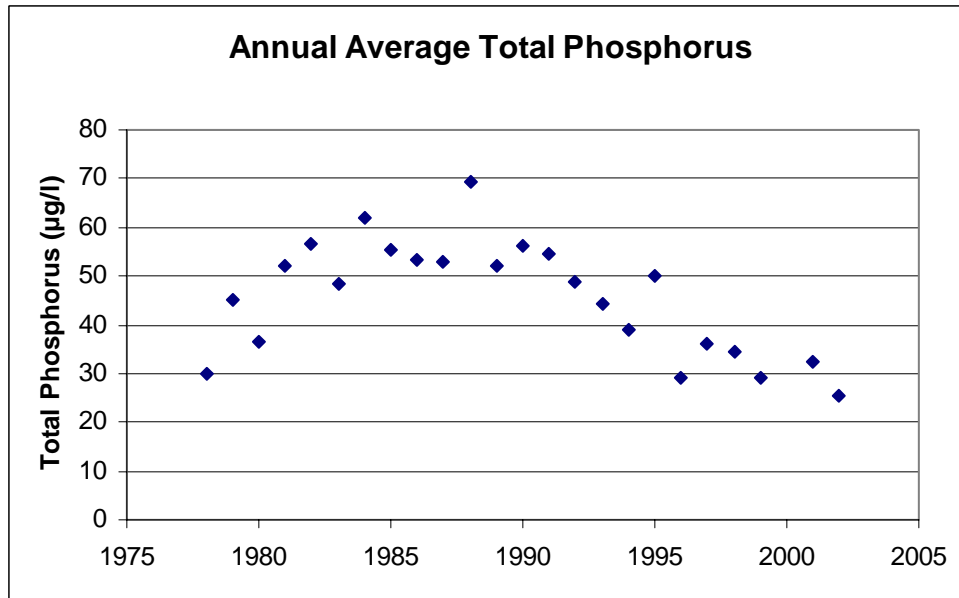
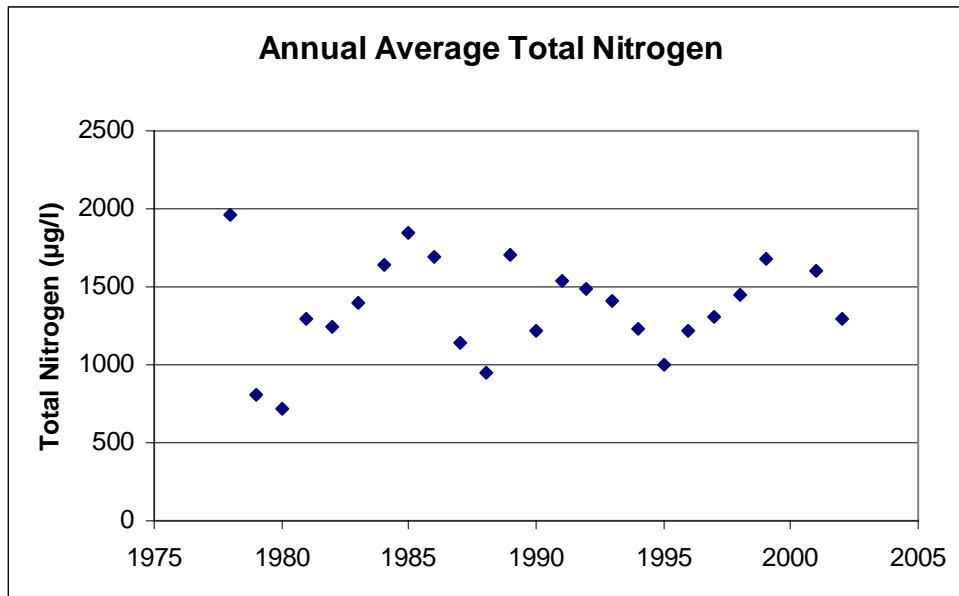
Figure 2-11. Annual Average Concentrations of Total P and Total N in Lake Holden from 1977 -2003.

in Secchi disk depth are apparent from 1980 until the present. Unfortunately, the obvious trend of decreasing phosphorus concentrations in the lake, illustrated on Figure 2-11, does not coincide with a corresponding increase in water column transparency within the lake.

Current water quality characteristics in Lake Holden were evaluated by examining mean water quality characteristics within the lake from 1995-2003. As seen in Figure 2-11, total phosphorus concentrations within Lake Holden appear to have been relatively consistent from 1995 to the present with substantially lower levels than have existed in the lake during the 1980s or early-1990s. The lower total phosphorus concentrations observed since 1995 appear to reflect new equilibrium conditions within the lake as a result of recent water quality improvement projects. Since water quality appears to be relatively stable over this period, mean water quality characteristics in Lake Holden from 1995-2003 are used to represent existing ambient conditions within the lake.

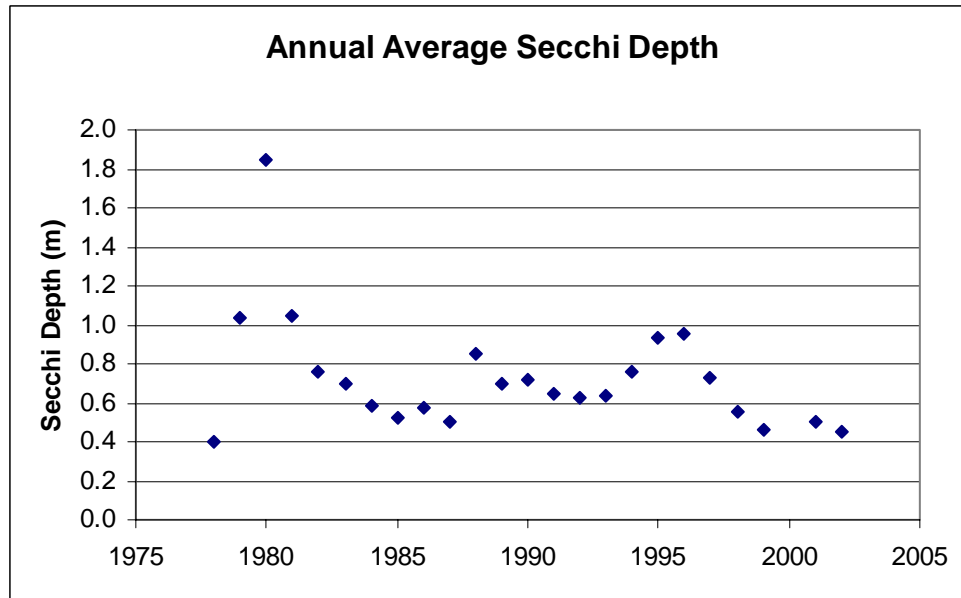
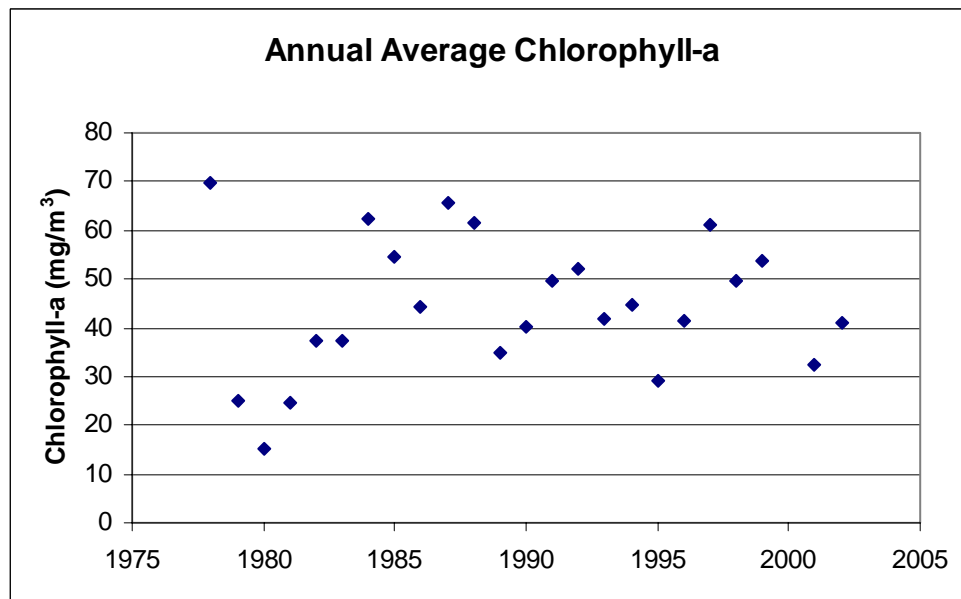
Figure 2-12. Annual Average Concentrations of Secchi Depth and Chlorophyll-a in Lake Holden from 1977 -2003.

Annual average chlorophyll-a concentrations in Lake Holden from 1977-2003 are also illustrated on Figure 2-12. A minimum in chlorophyll-a concentrations in Lake Holden was observed during 1980, corresponding to the maximum Secchi disk depth for the lake. However, since approximately 1985, chlorophyll-a concentrations within Lake Holden have averaged between 30-60 mg/m<sup>3</sup>. No apparent trend of increasing or decreasing values is apparent for chlorophyll-a concentrations during this period, although since 2000, annual average chlorophyll-a concentrations within the lake have ranged between 30-40 mg/m<sup>3</sup>.

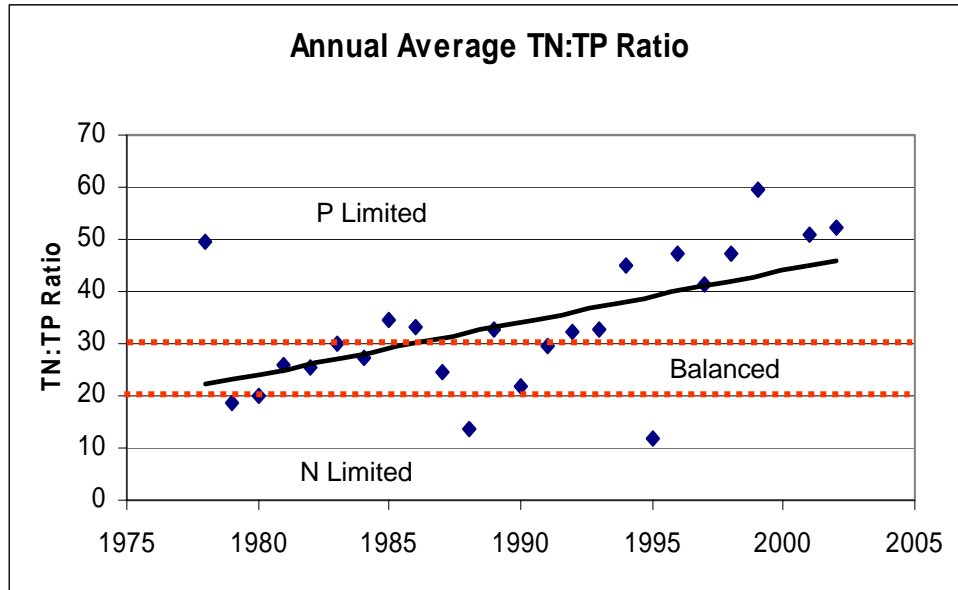
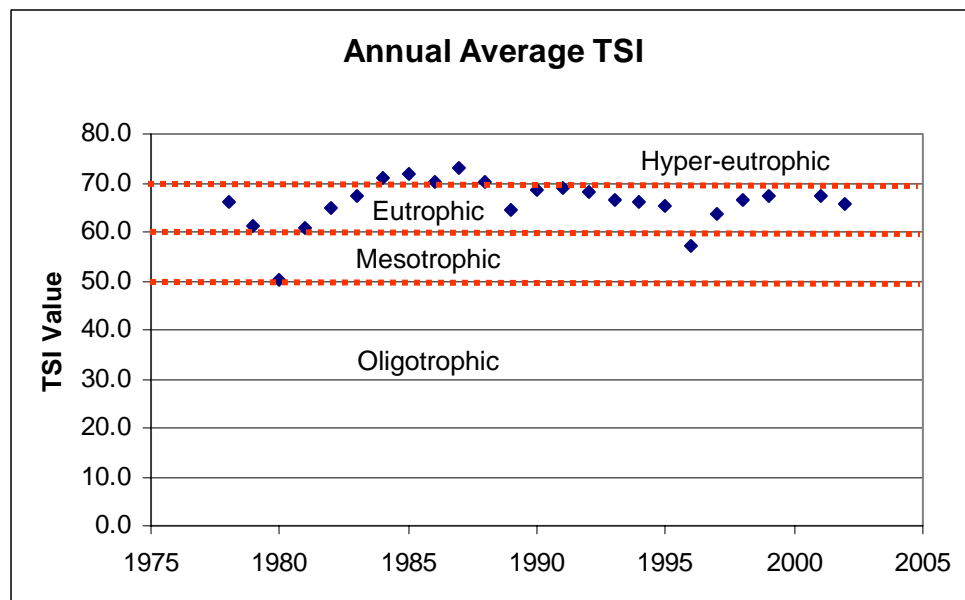
Annual average TN/TP ratios in Lake Holden from 1977-2003 are illustrated on Figure 2-13. Annual average TN/TP ratios appear to exhibit a pronounced upward trend from 1980 until the present, indicating that Lake Holden is becoming more phosphorus-limited as time goes on. This conclusion follows closely with the trend of decreasing total phosphorus concentrations within the lake, suggesting that phosphorus is becoming more limited as phosphorus reduction efforts continue within the watershed. In general, TN/TP ratios less than 20 indicate nitrogen-limited conditions, with ratios between 20-30 indicating nutrient-balanced conditions, and ratios in excess of 30 indicating phosphorus-limited conditions. Based upon the annual average TN/TP ratios from 1995 to the present, it appears that Lake Holden is a strongly phosphorus-limited ecosystem.

Annual average TSI values in Lake Holden from 1977-2003 are also summarized in Figure 2-13. In general, Lake Holden exhibited borderline mesotrophic/oligotrophic conditions during 1980, followed by a rapid decline in water quality to eutrophic and hypereutrophic conditions during the 1980s. Since approximately 1990, Lake Holden has exhibited eutrophic water quality characteristics, with mesotrophic characteristics exhibited during 1995. A gradual trend of improving TSI value in Lake Holden is apparent since approximately 1985.

Figure 2-13. Annual Average TN:TP Ratios and TSI Values in Lake Holden from 1977 -2003.

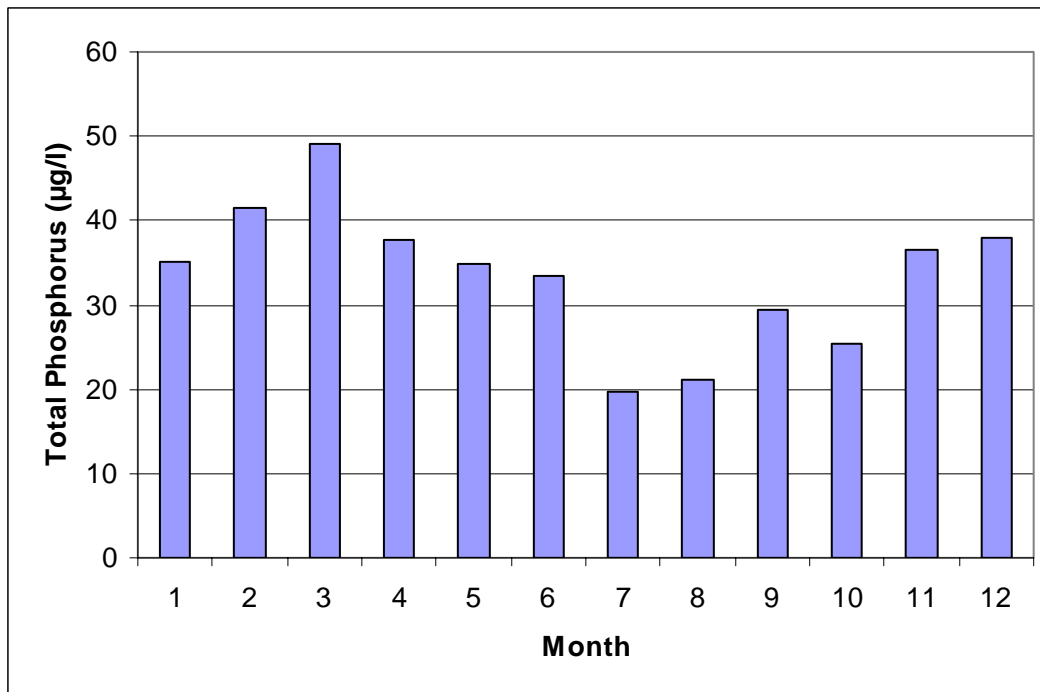
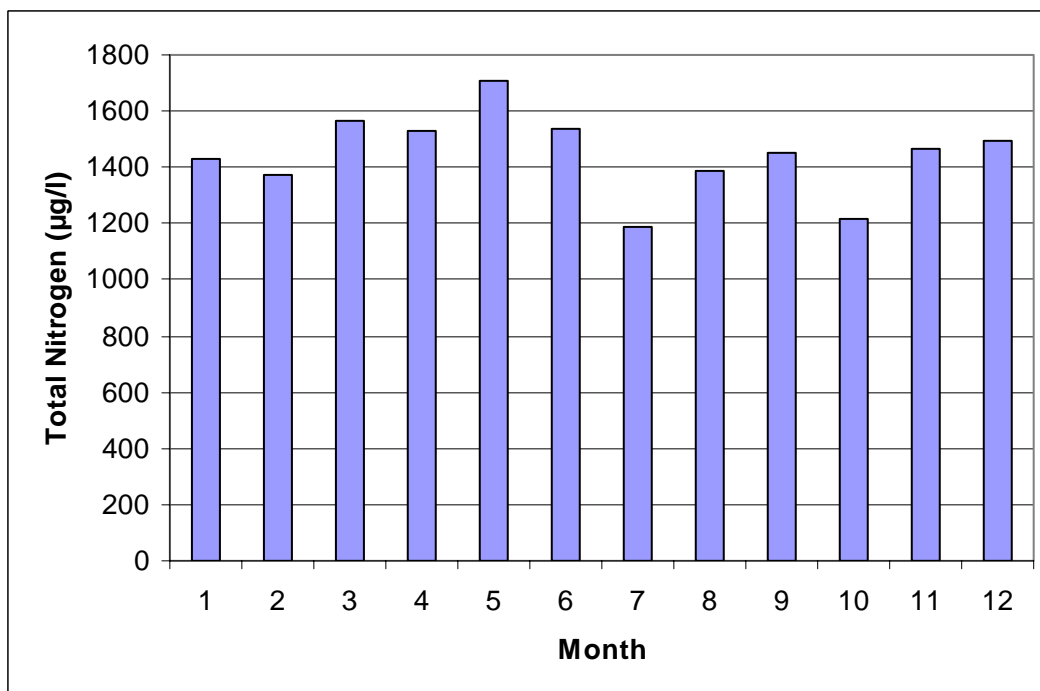
Average monthly concentrations of total phosphorus in Lake Holden, based upon 1995-2003 data, are illustrated on Figure 2-14. In general, it appears that phosphorus concentrations in Lake Holden are lower during wet season months and higher during dry season conditions. If stormwater runoff were a primary contributor to phosphorus loadings in Lake Holden, it would be expected that total phosphorus concentrations would increase substantially during the wet season when runoff inputs are greatest, and a decrease in phosphorus concentrations would be observed during dry season conditions when runoff inputs are minimal. The trend apparent for total phosphorus in Figure 2-14 suggests that significant internal recycling may be occurring in Lake Holden. During late-spring through early-fall, lakes in Central Florida typically become stratified, with anoxic conditions developing in lower portions of the lake. This often causes the release of phosphorus from anoxic bottom sediments which begins to accumulate in lower isolated portions of the waterbody. During late-fall and winter conditions, when temperatures cool off and the water column begins to circulate readily, the accumulated phosphorus concentrations in lower layers of the lake migrate throughout the entire water column, resulting in substantial increases in phosphorus concentrations within the lake. The trend exhibited by total phosphorus for Lake Holden suggests that significant internal recycling, and subsequent resuspension during dry periods, may be occurring within the lake.

Average monthly concentrations of total nitrogen in Lake Holden from 1995-2003 are also indicated on Figure 2-14. No significant trends are apparent in total nitrogen during either wet season or dry season conditions. Since nitrogen is not substantially recycled from bottom sediments, the influence of this internal process is not apparent as it is for total phosphorus.

Figure 2-14. Average Monthly Concentrations of Total P and Total N in Lake Holden from 1995 -2003.

Average monthly concentrations for chlorophyll-a in Lake Holden are illustrated on Figure 2-15. Chlorophyll-a concentrations within the lake appear to correspond closely to the phosphorus concentrations indicated on Figure 2-14, with concentrations lowest during the wet season period and highest during dry season conditions.

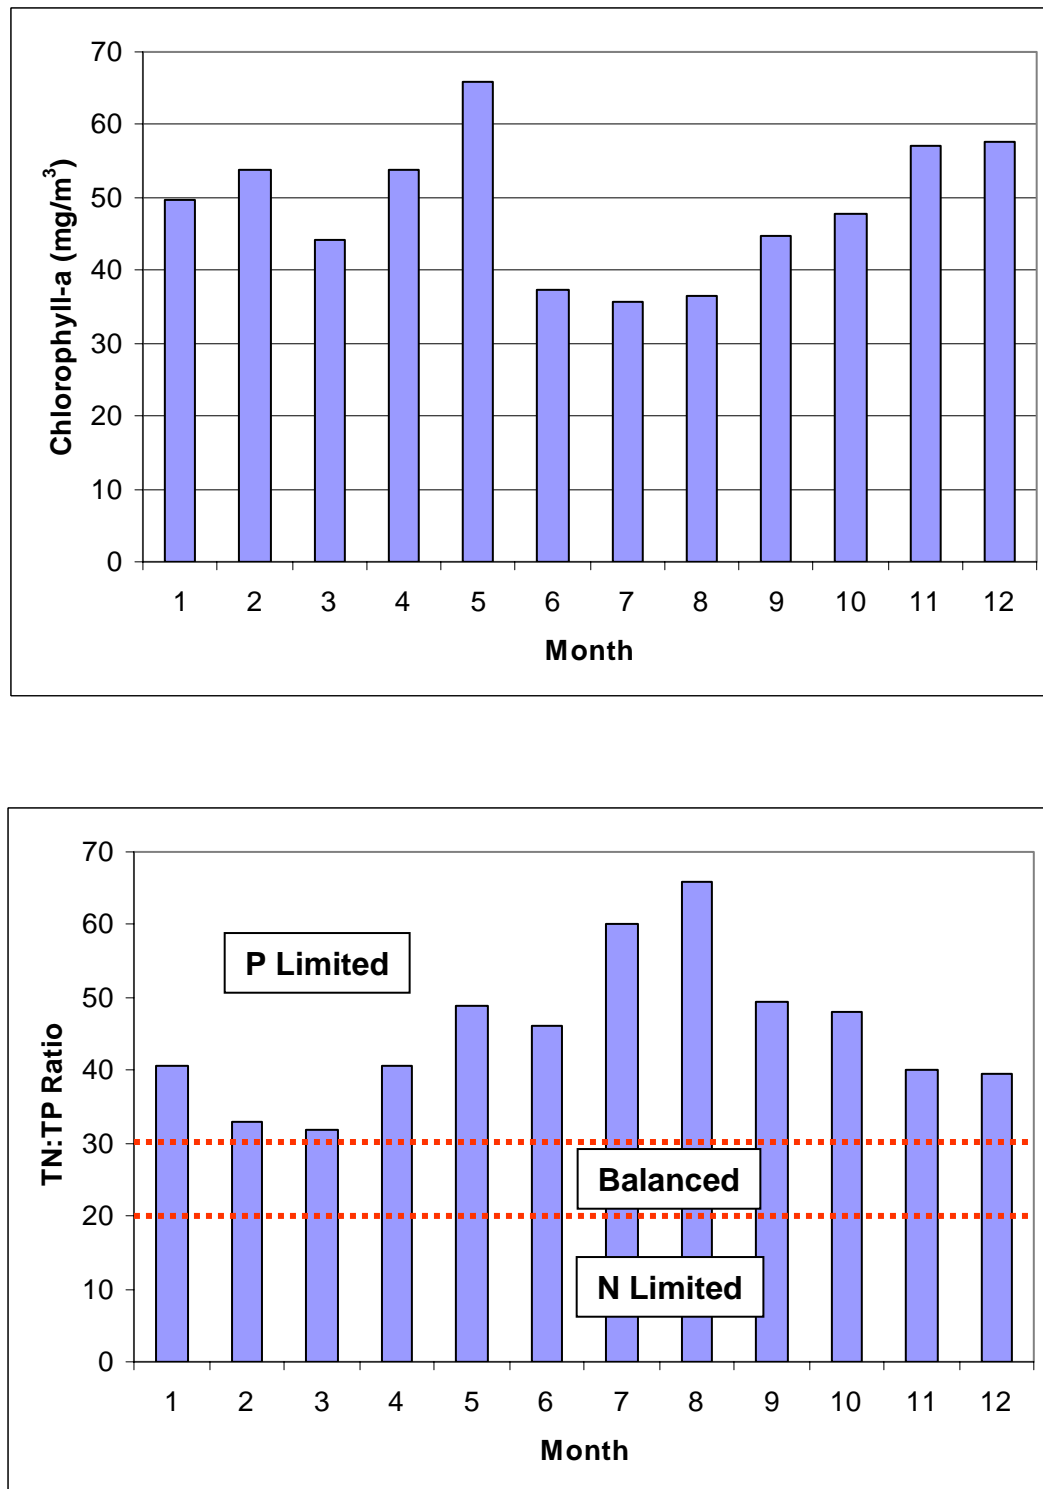
Average monthly TN/TP ratios in Lake Holden from 1995-2003 are also illustrated on Figure 2-15. Phosphorus limitation increases during wet season conditions as phosphorus concentrations decrease within the lake. However, during other portions of the year, when phosphorus concentrations increase, the TN/TP ratio decreases, indicating that phosphorus is less

Figure 2-15. Average Monthly Concentrations of Chlorophyll-a and TN:TP Ratios in Lake Holden from 1995 -2003.

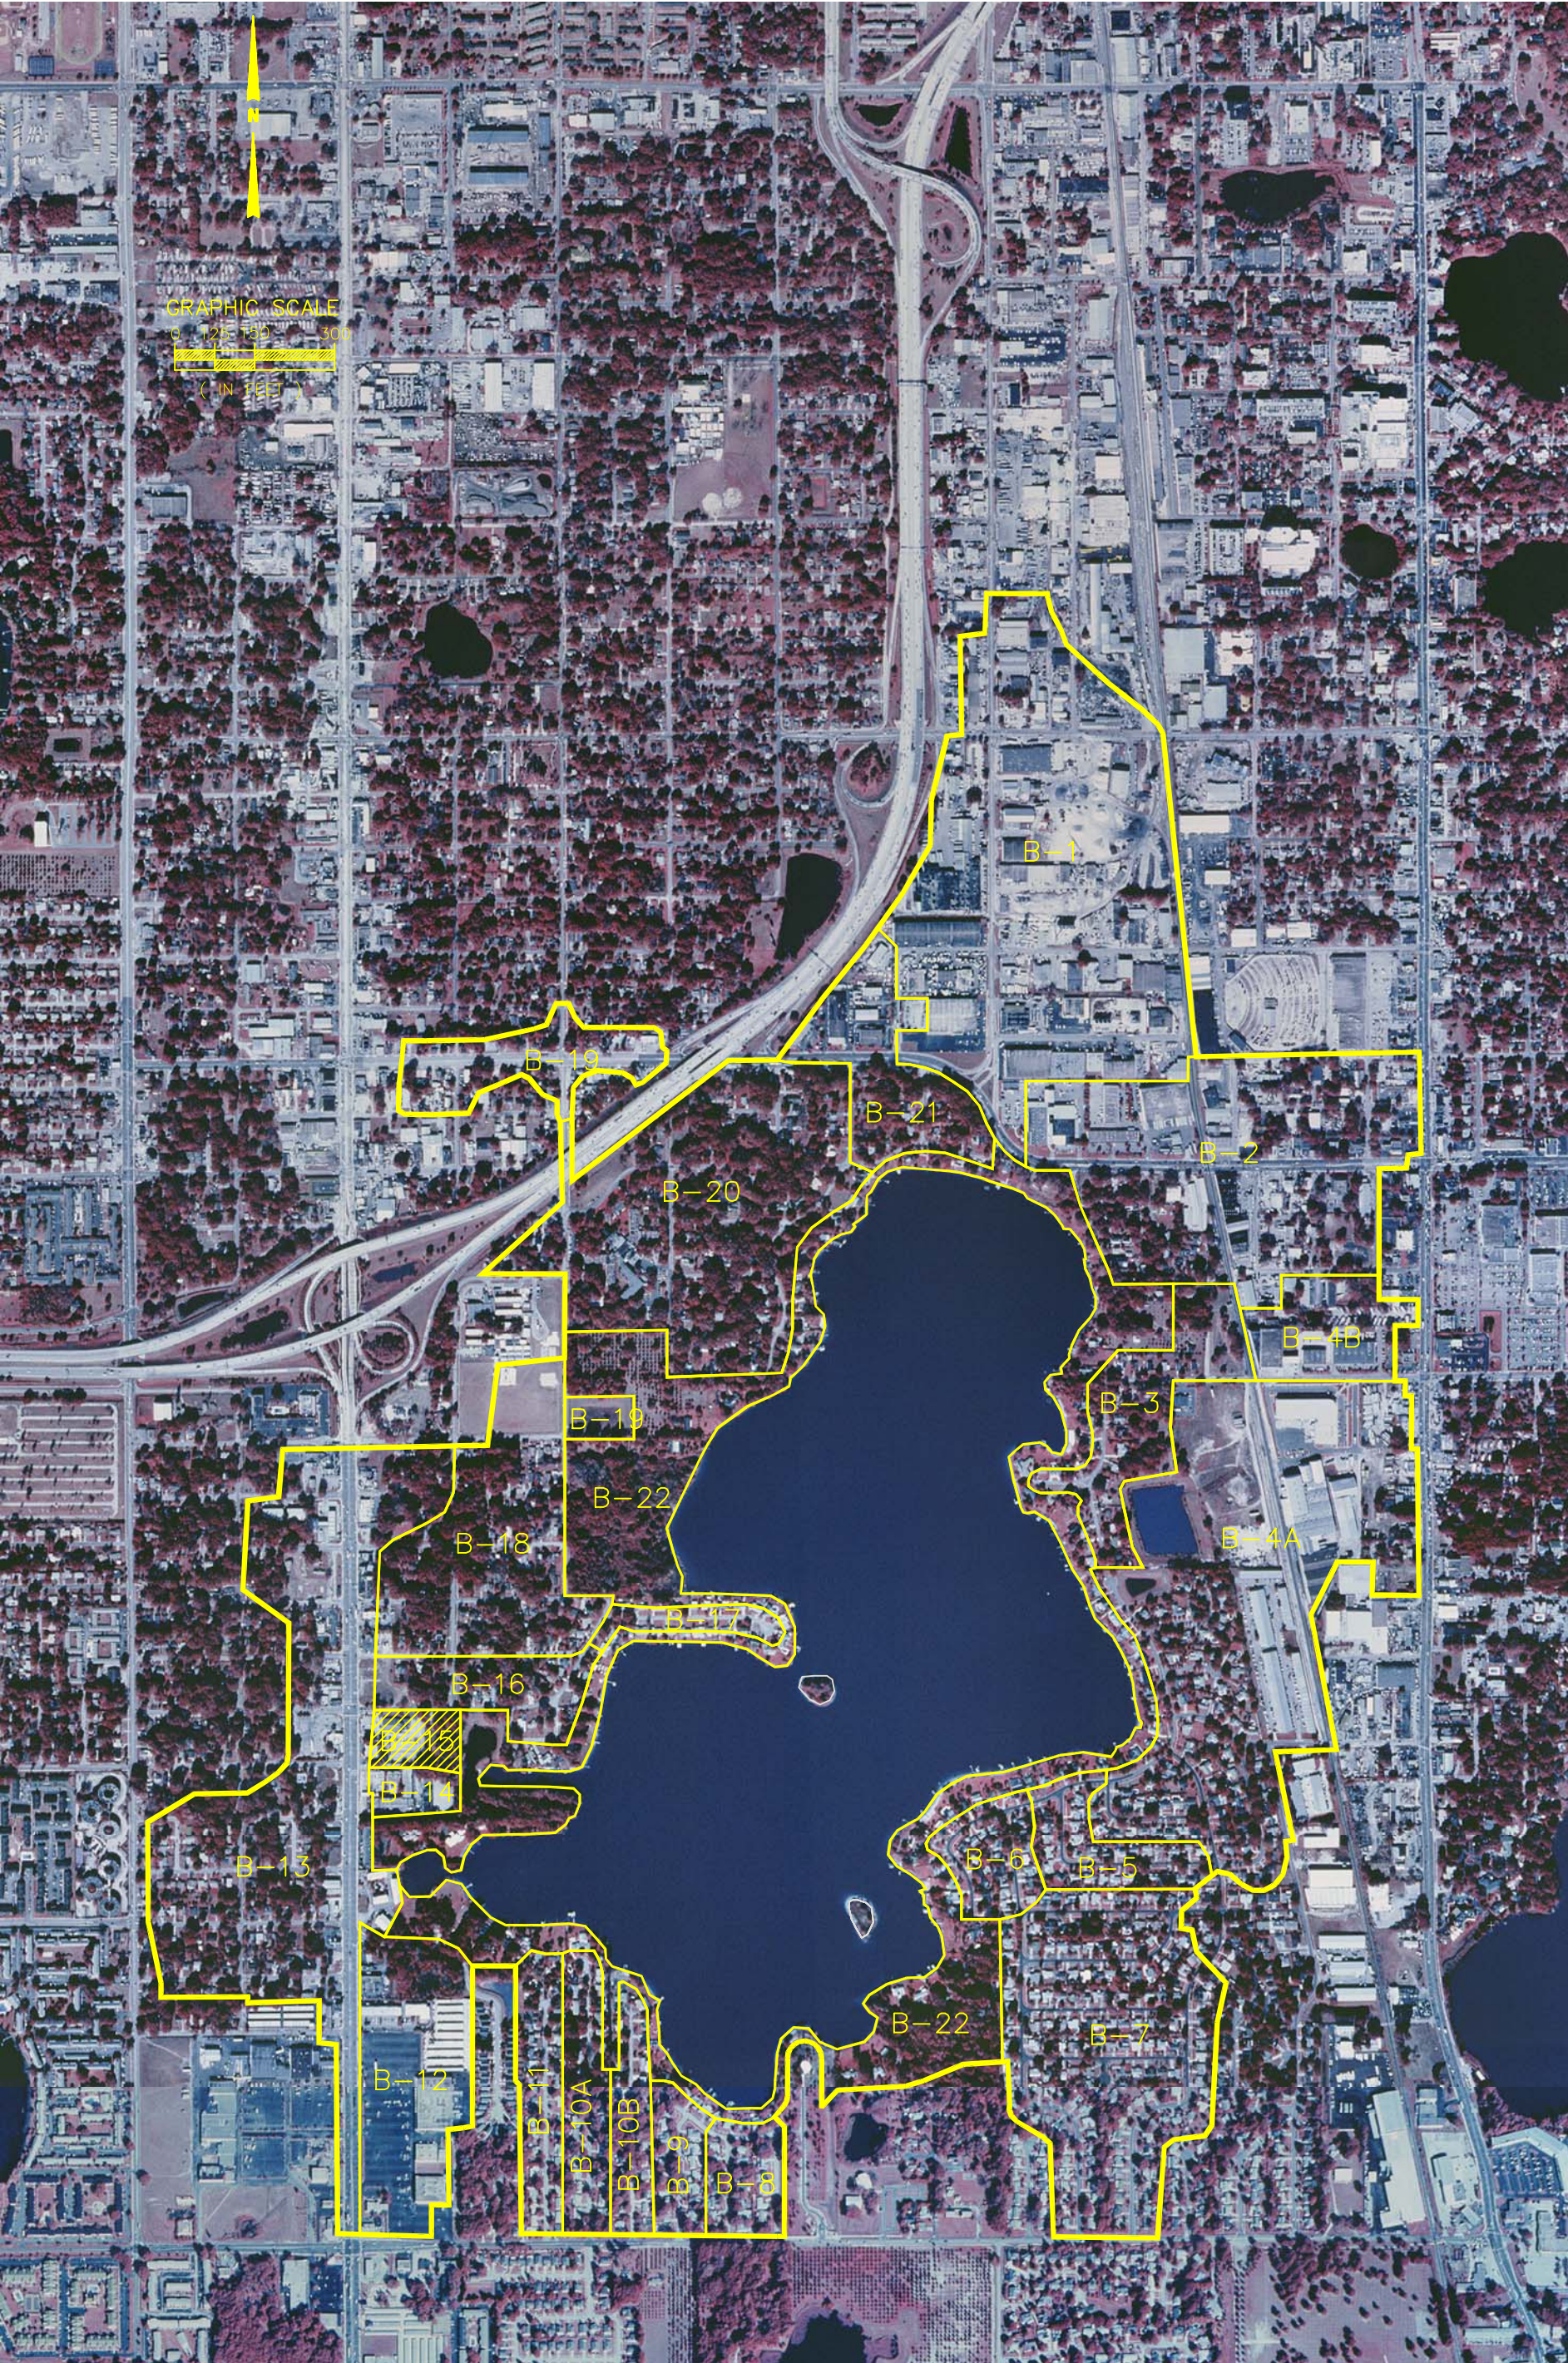
Figure 3-1. Drainage Sub-Basin Areas Discharging to Lake Holden.

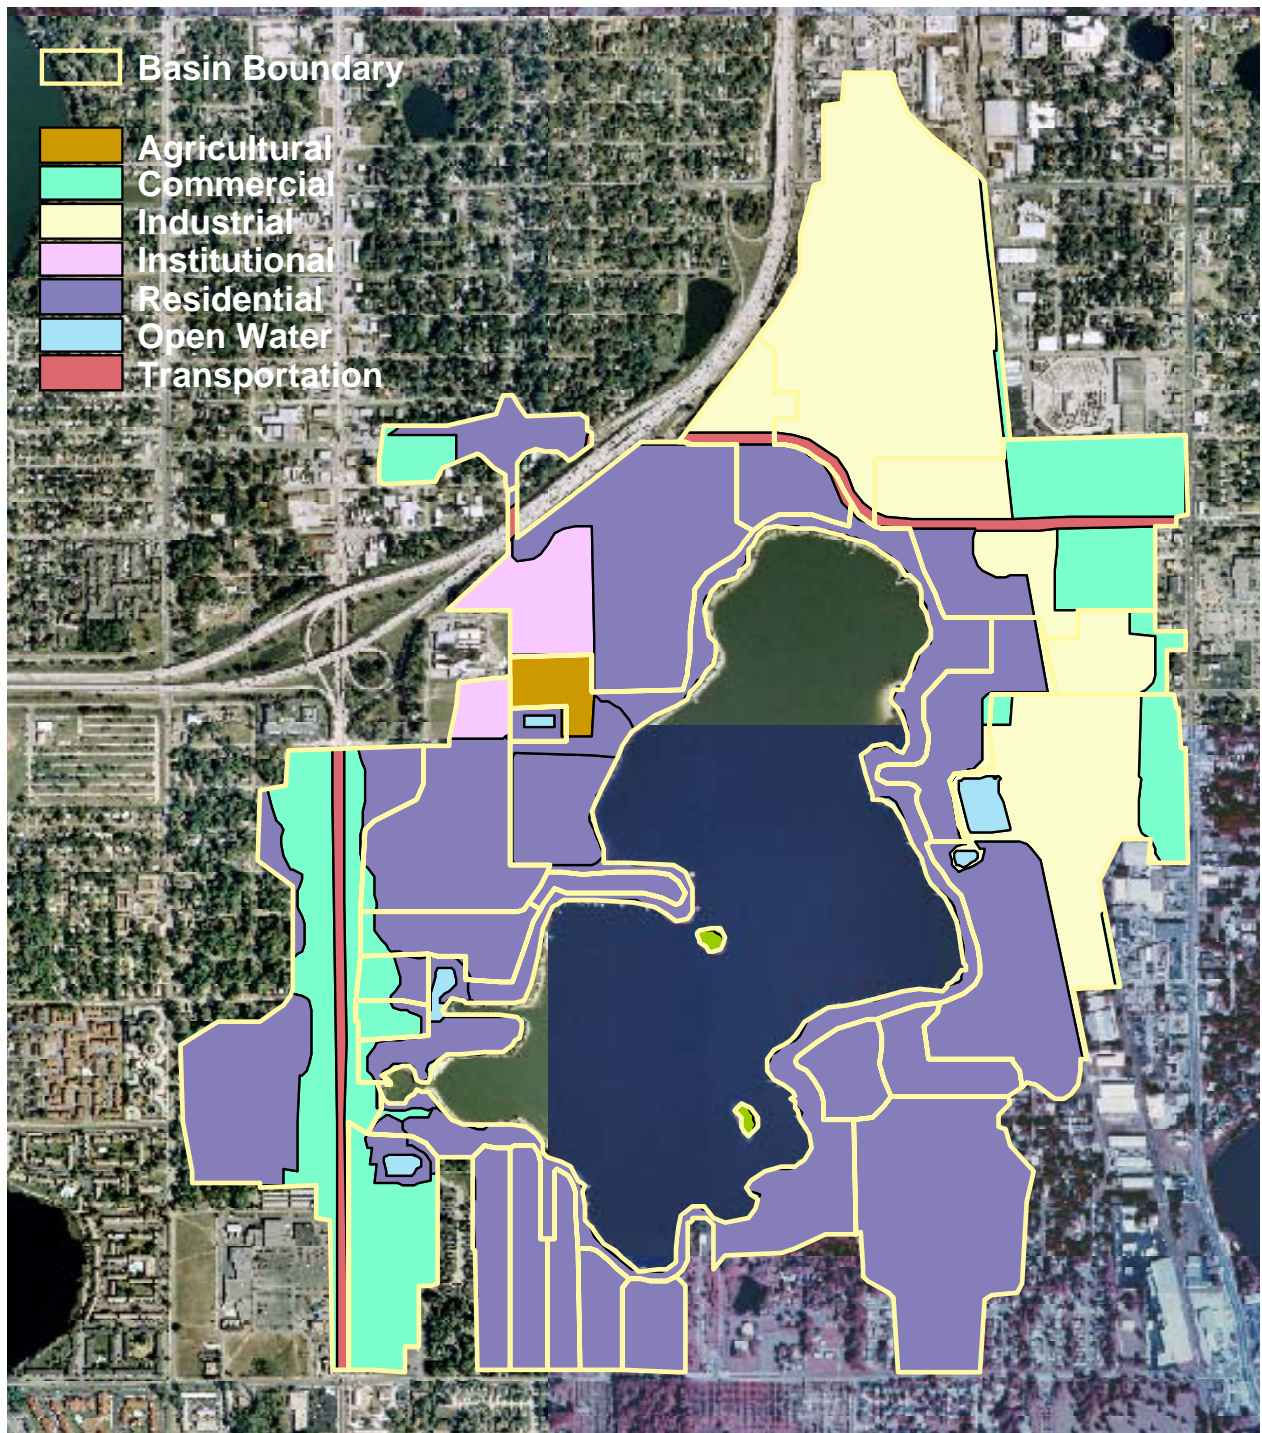
Figure 3-2. Land Use in the Lake Holden Drainage Basin.

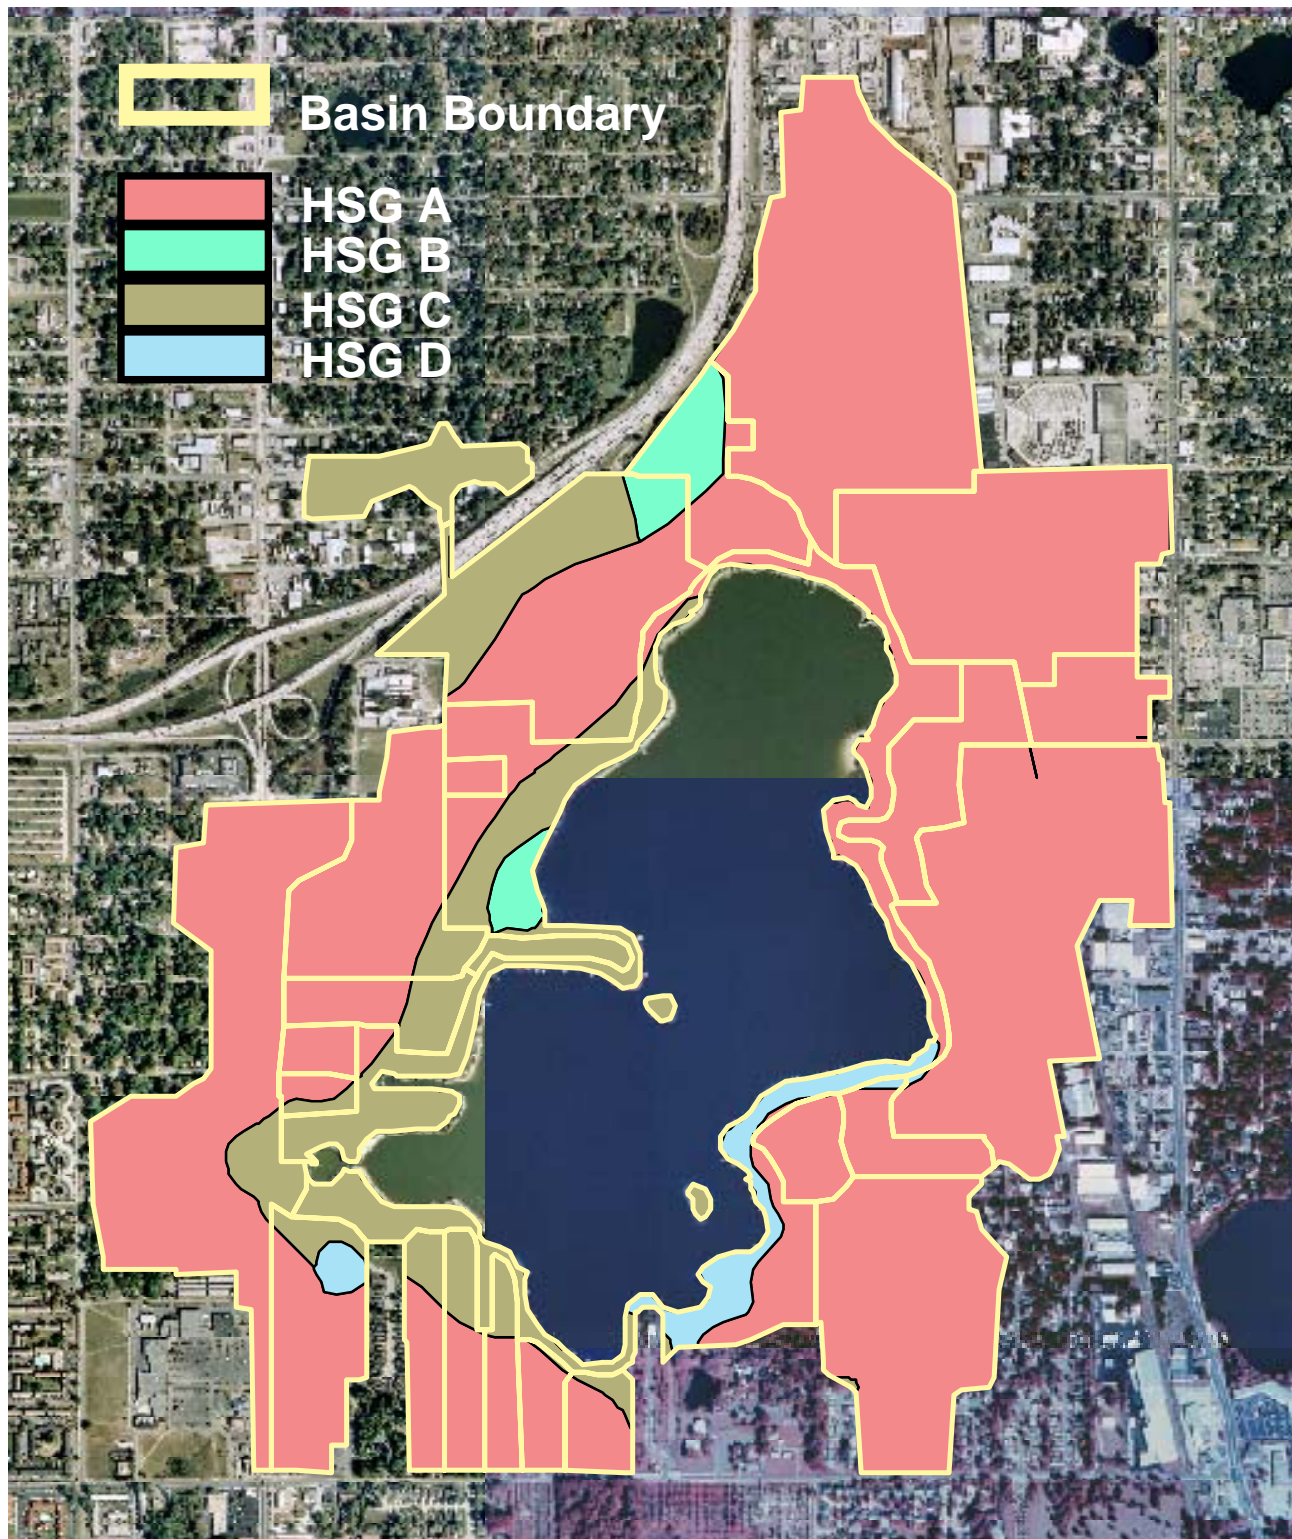
General soil characteristics in the Lake Holden basin, presented in the form of Hydrologic Soil Groups (HSG) is given in Figure 3-3. Characteristics of hydrologic soil groups are summarized in Table 3-3. Soils classified in HSG A consist primarily of deep sandy soils, with high infiltration rates and a low runoff potential. Soils classified in HSG B exhibit moderate infiltration rates and a moderate runoff potential. Soils classified in HSG C consist primarily of sandy clay loams, with a low infiltration rate and a high runoff potential. Soils classified in HSG D consist primarily of clay or clay mixtures, with very low infiltration rates and a very high runoff potential.

As seen in Figure 3-3, the dominant soil group in the Lake Holden watershed is HSG A, indicating deep sandy soils with a low runoff potential. Many of these areas were historically used for agricultural and citrus activities prior to development into the existing land use categories. Areas adjacent to the western shoreline of Lake Holden exhibit soils in HSG C, with small pockets in HSG B. A small fringe of soils in HSG D are located along the southeastern shoreline of the lake.

Figure 3-3. Hydrologic Soil Groups in the Lake Holden Drainage Basin.

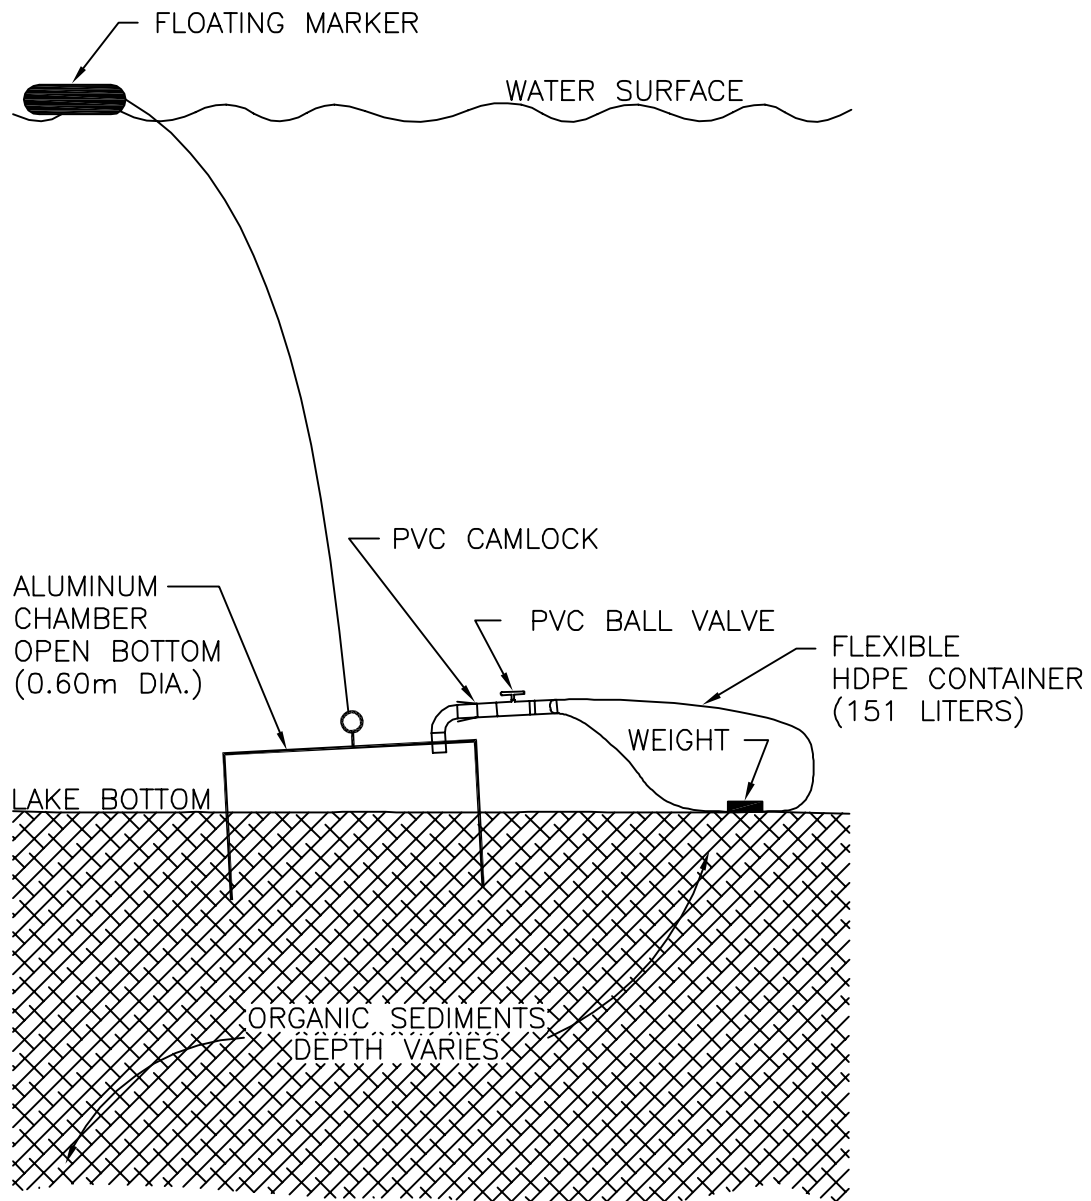
## Typical Seepage Meter Installation

Figure 3-4. Typical Seepage Meter Installation.

A 0.75-inch threaded PVC fitting was threaded into the top of each aluminum container. The 0.75-inch PVC fitting was attached to a female quick-disconnect PVC camlock fitting. A flexible polyethylene bag, with an approximate volume of 40 gallons, was attached to the seepage meters using a quick-disconnect PVC male camlock fitting with a terminal ball valve. Each of the collection bags was constructed of black polyethylene to prevent light penetration into the bag. Light could potentially stimulate photosynthetic activity within the sample prior to collection and result in an undesirable alteration of the chemical characteristics of the sample.

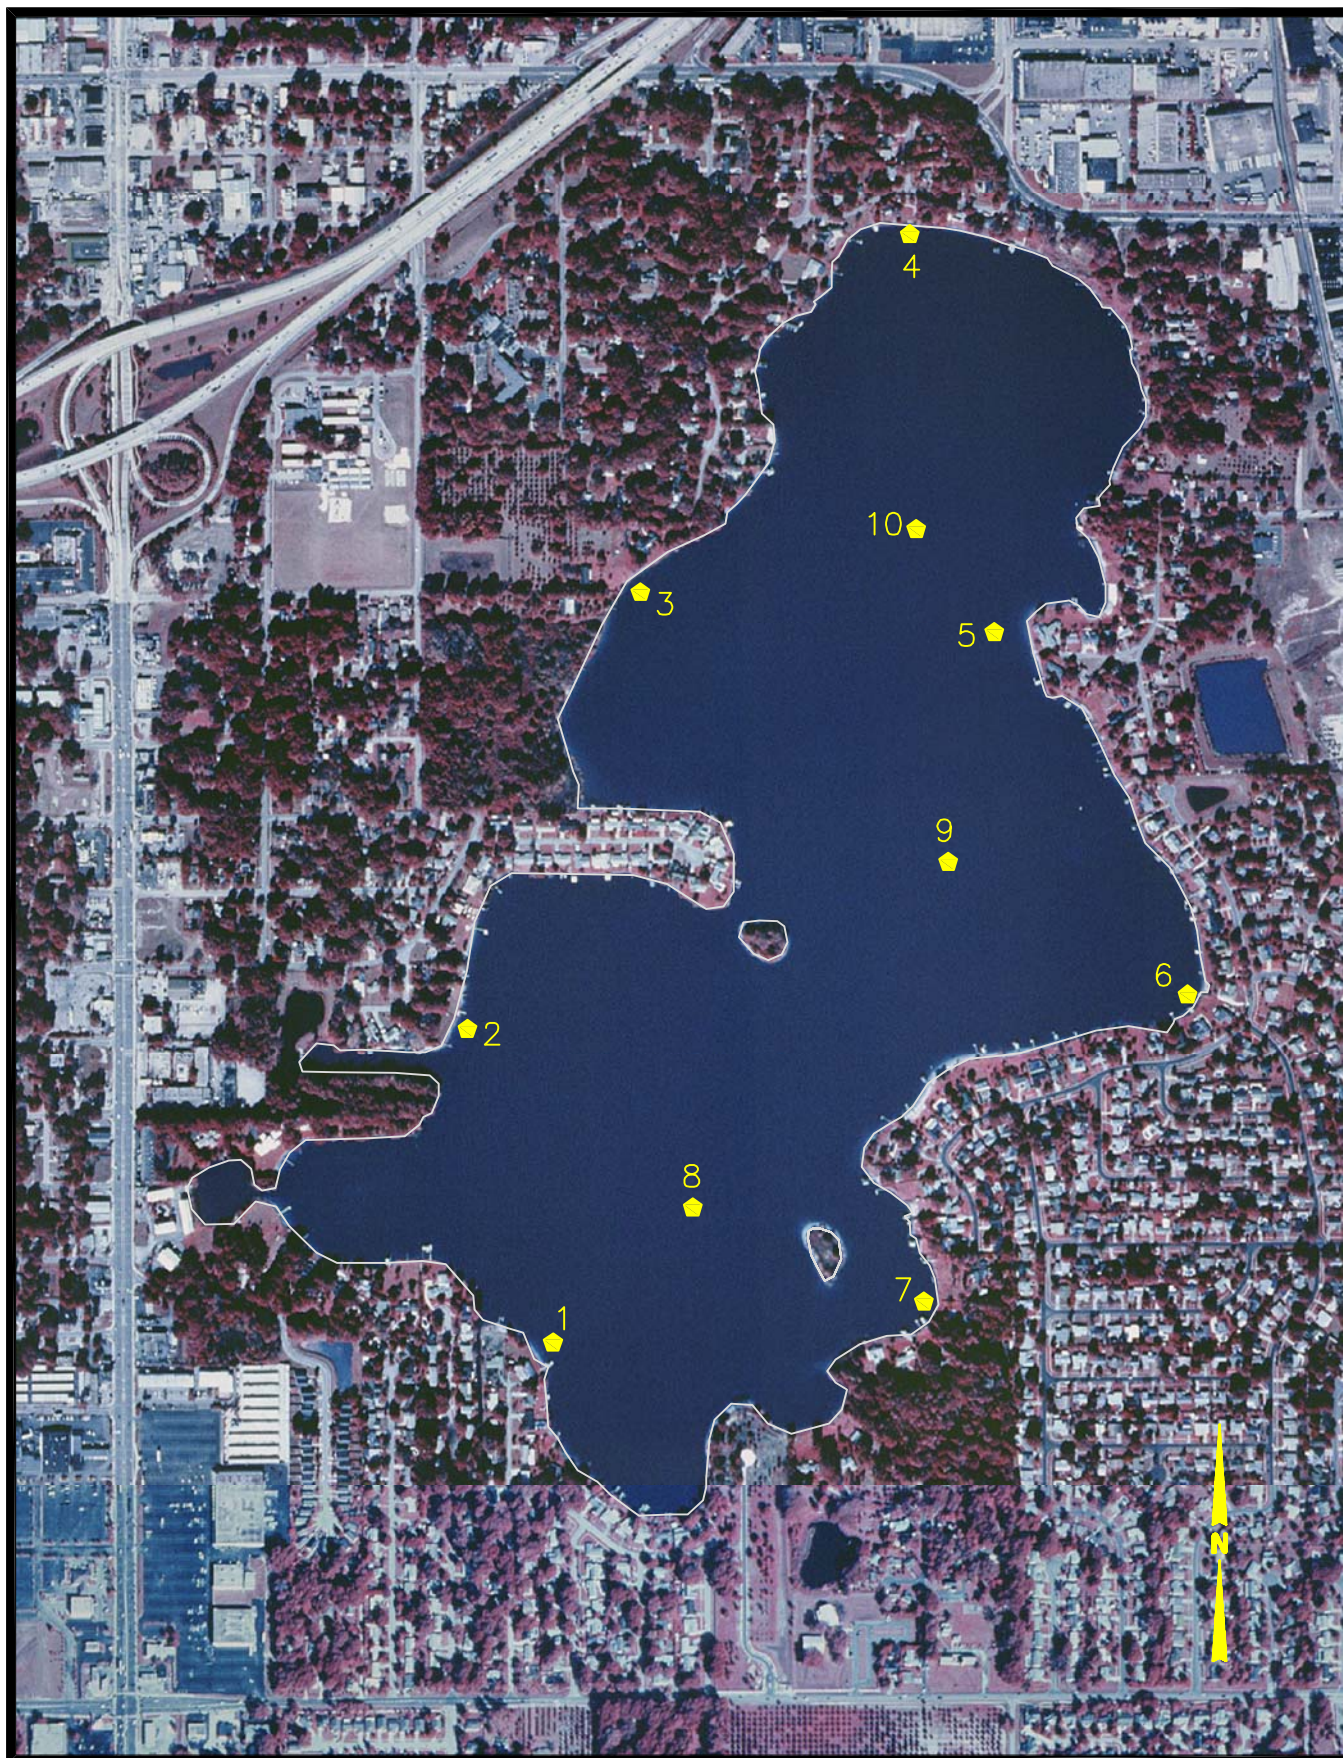
Each of the 10 seepage meters was monitored on approximately a monthly basis from April-October 2003. A total of seven separate seepage monitoring events was conducted for evaluation of quantity and quality at each of the monitoring sites, with a total of 59 samples collected between the 10 sites.

Figure 3-5. Seepage Meter Monitoring Sites.

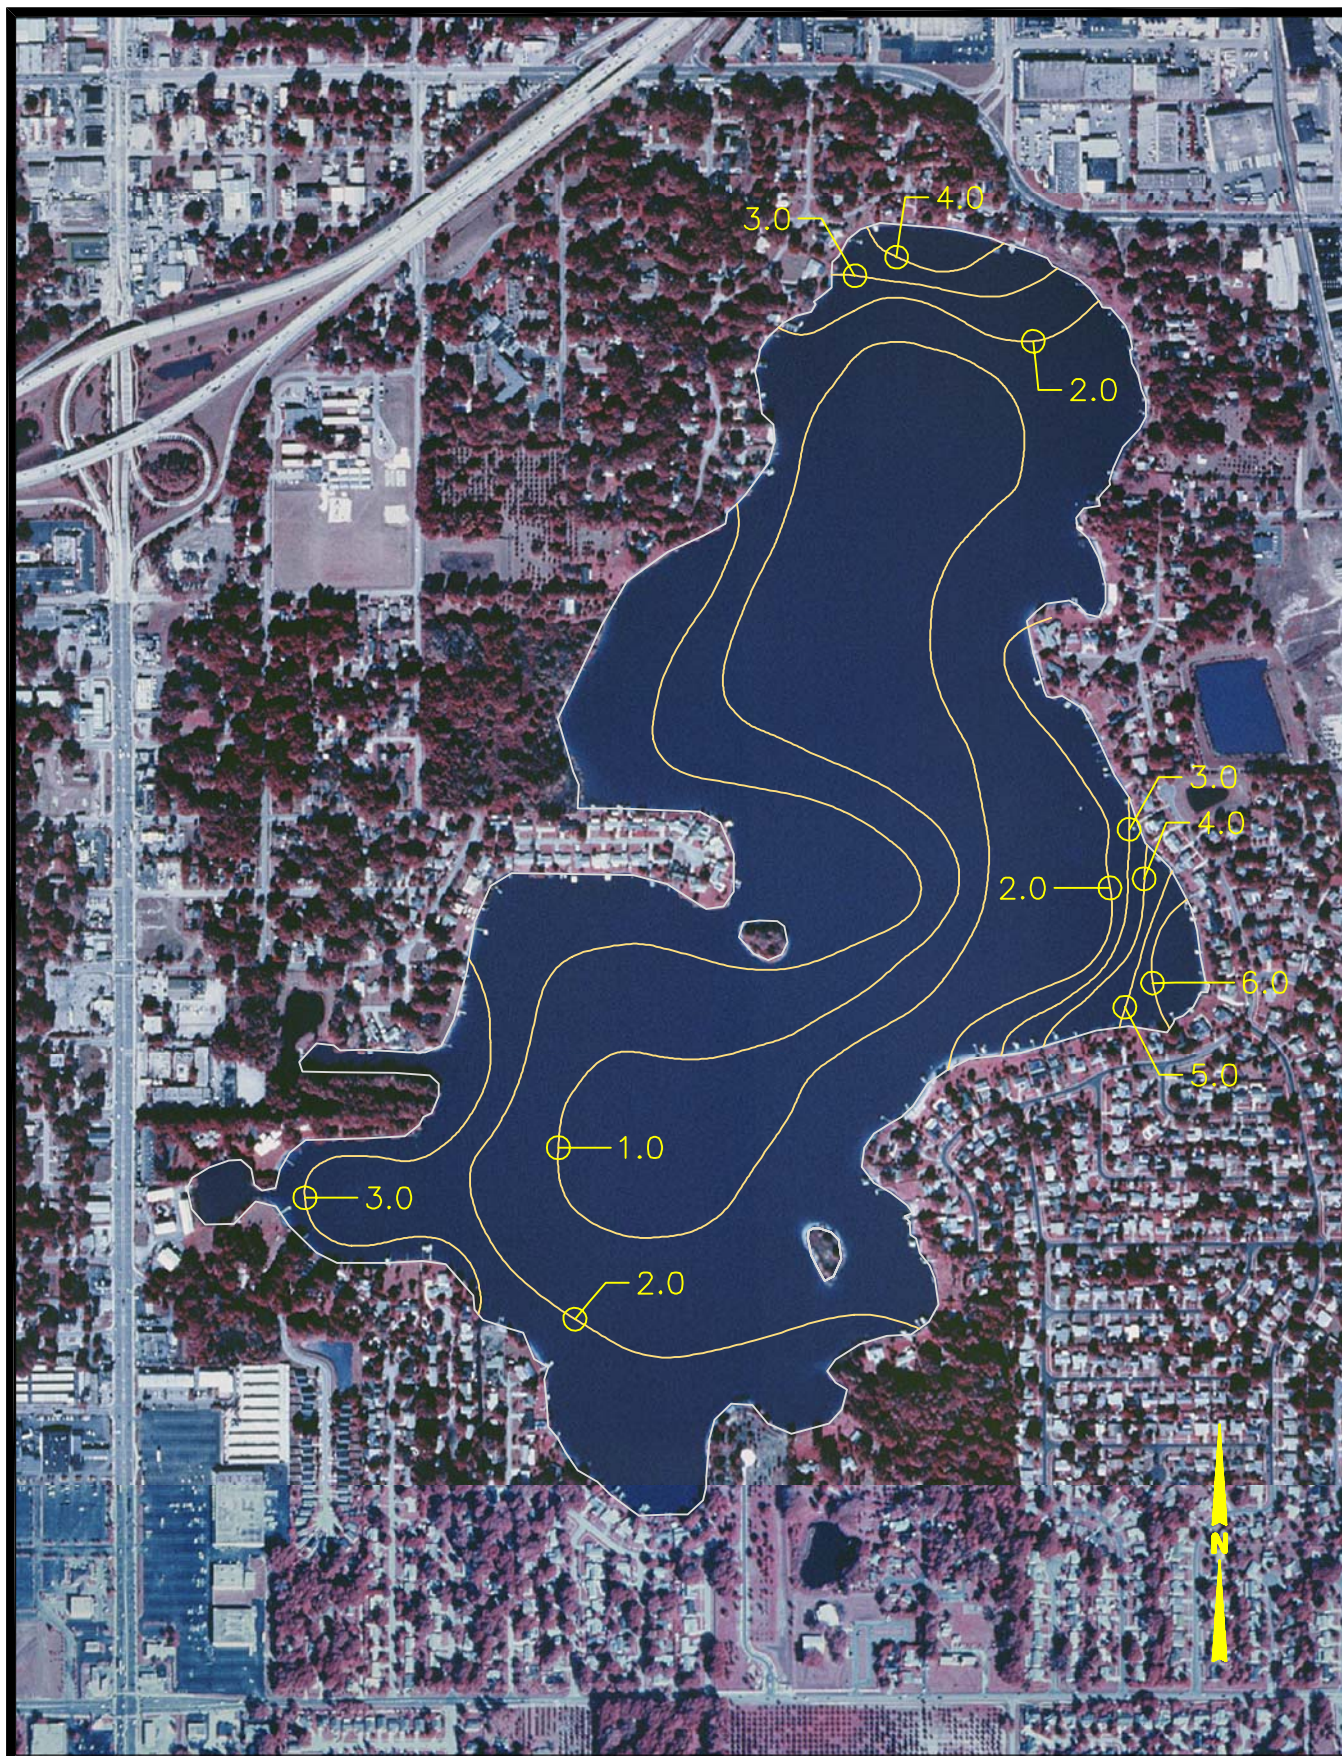
Estimated seepage inflow isopleths for Lake Holden are illustrated on Figure 3-6. The isopleths present estimates of mean groundwater inflow into the lake in terms of liters per square meter of surface area per day. The highest rates of seepage influx appear to occur in northern, eastern, and western portions of the lake, with lower estimated seepage inflow in central portions of the lake.

Figure 3-6. Isopleths of Groundwater Seepage ( $l/m^2 \cdot day$ ) inflow to Lake Holden.

The seepage isopleths indicated on Figure 3-6 were graphically integrated to obtain estimates of mean daily seepage influx into Lake Holden. This mean value was converted to an annual average by multiplying by 365 days/year. Based upon this analysis, seepage influx into Lake Holden is estimated to contribute approximately 564.75 ac-ft/yr of water inputs into the lake. This corresponds to an areal loading of 2.156 ac-ft per acre of lake area per year. These values are utilized in subsequent sections for development of an overall hydrologic budget for Lake Holden.
