# Lake Holden Revised Hydrologic / Nutrient Budget and Management Plan

Final Report

July 2004

**Environmental Research & Design, Inc.**

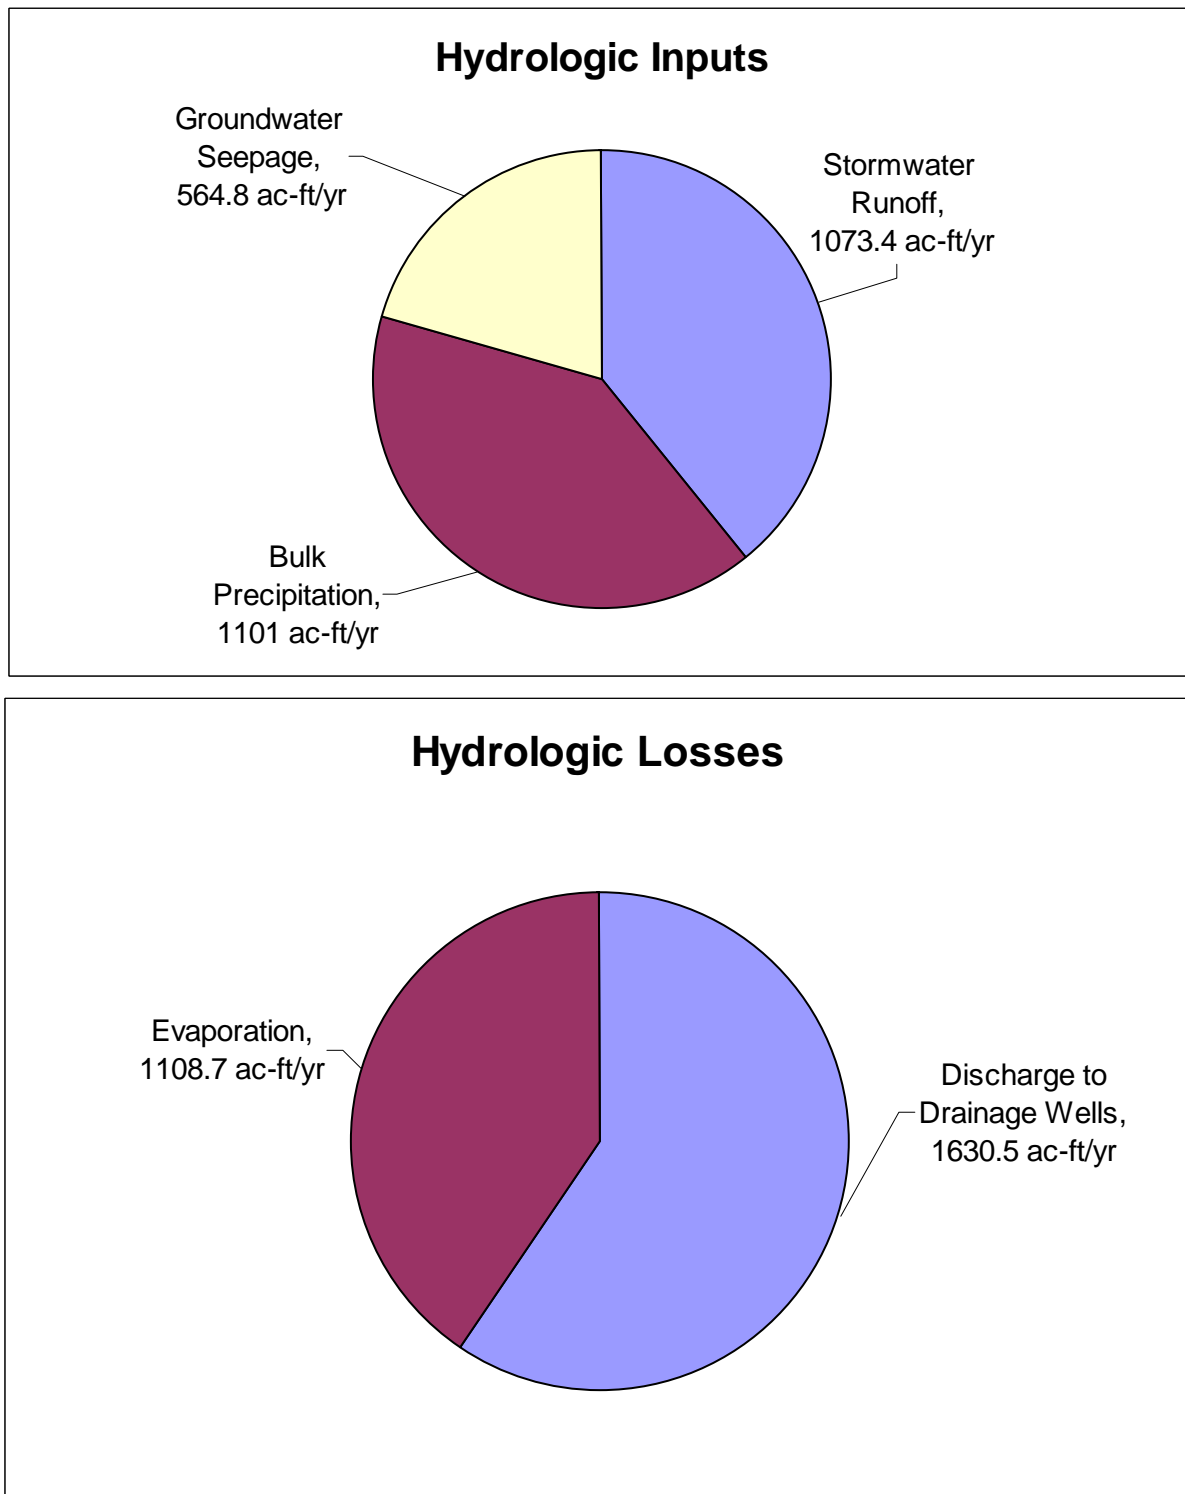
Hydrologic losses from Lake Holden occur as a result of surface evaporation and discharge into the drainage wells within the lake. As indicated in Section 3.4, evaporation losses from Lake Holden are estimated to be approximately 1108.7 ac-ft/yr. The difference between this value and the total estimated annual inputs of 2739.2 ac-ft/yr is assumed to be the volume which discharges into the drainage well structures. On an annual basis, this inflow is estimated to be approximately 1630.5 ac-ft/yr.

Figure 3-7. Annual Hydrologic Inputs and Losses to Lake Holden.

A summary of estimated volumetric losses from Lake Holden is given in Table 3-9. Approximately 59.5% of the annual hydrologic losses from the lake occur into the drainage well structures, with 40.5% of the annual losses occurring as a result of evaporation. A comparison of hydrologic losses from Lake Holden is also included on Figure 3-7.

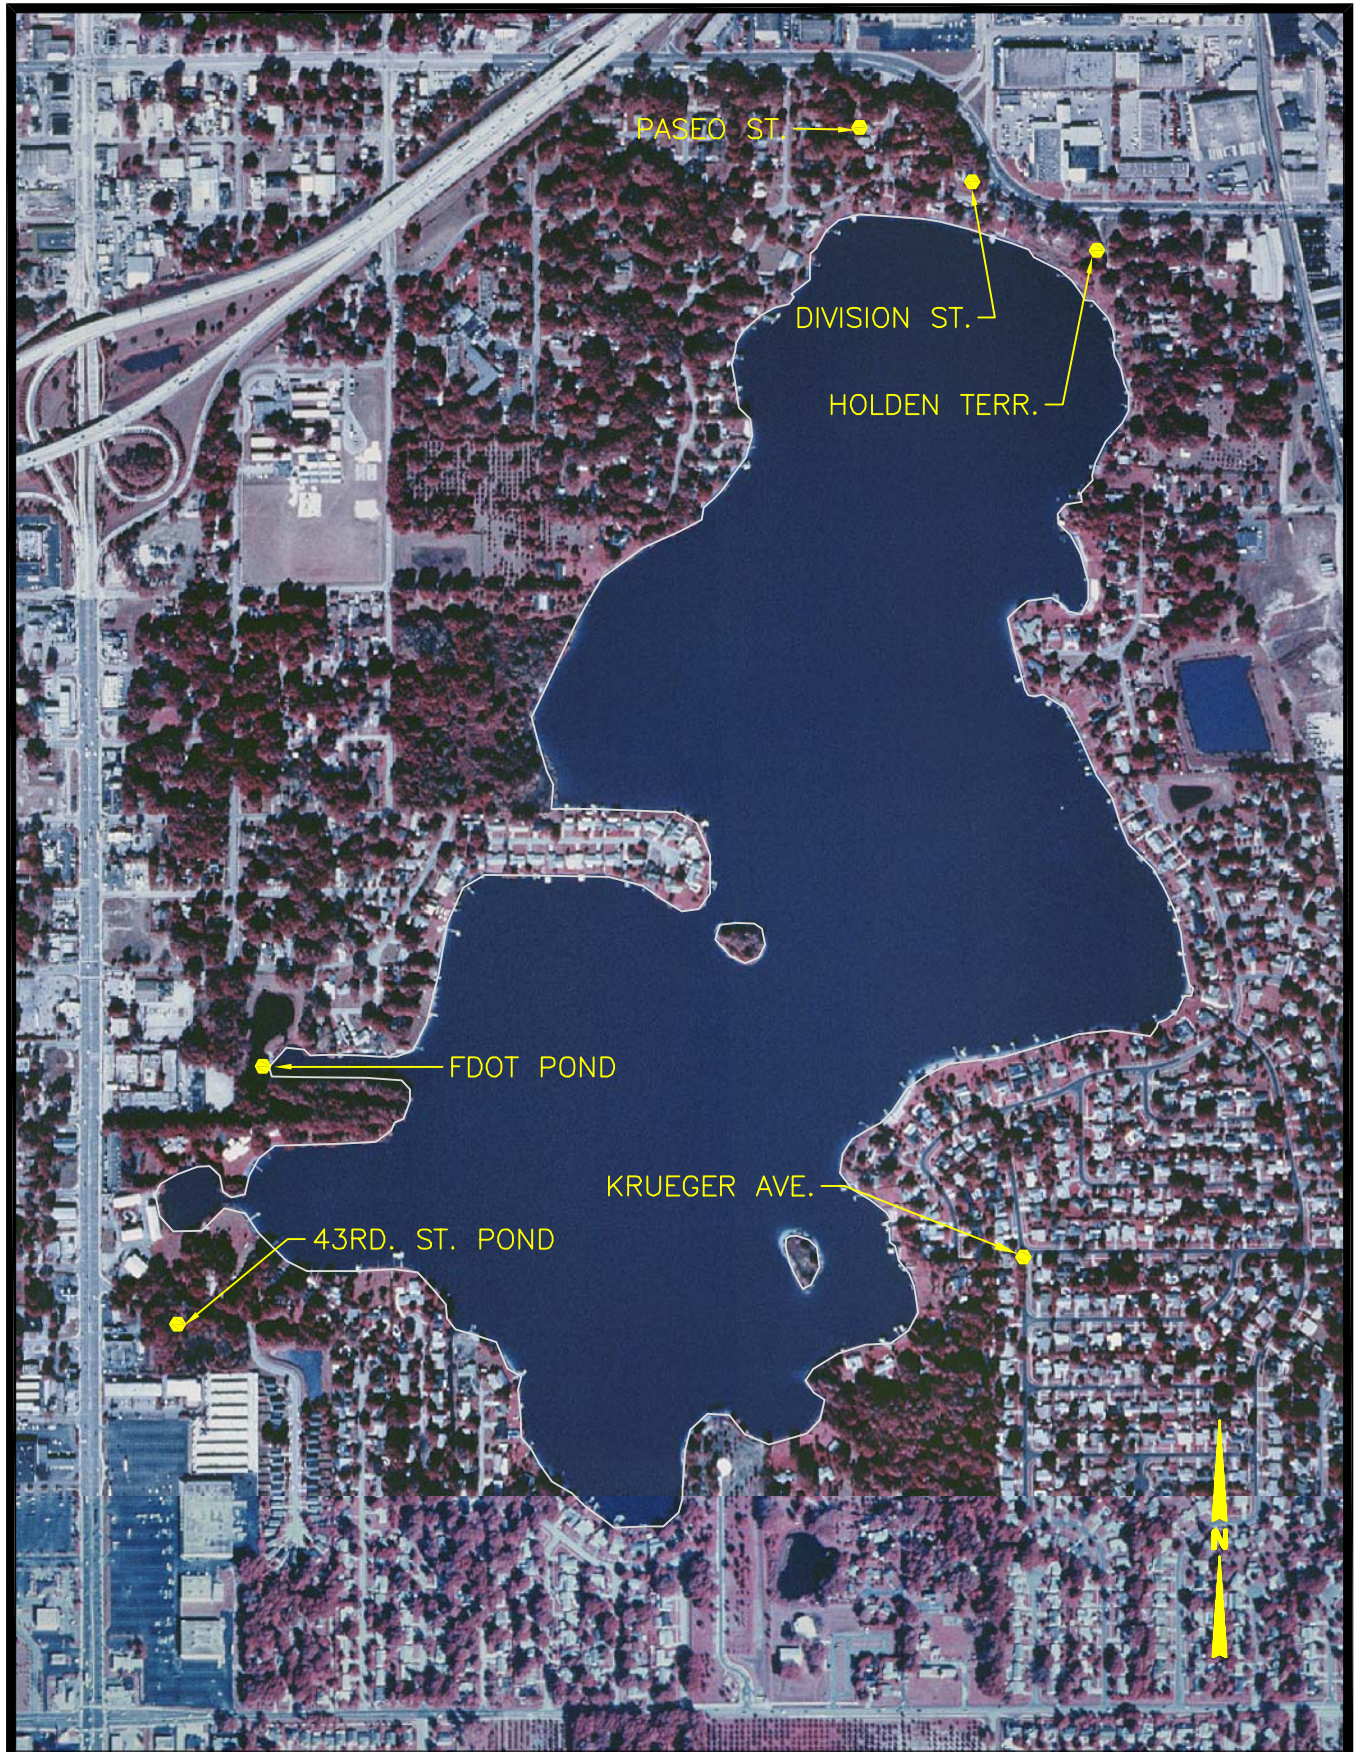
Figure 4-1. Locations of Stormwater Monitoring Sites

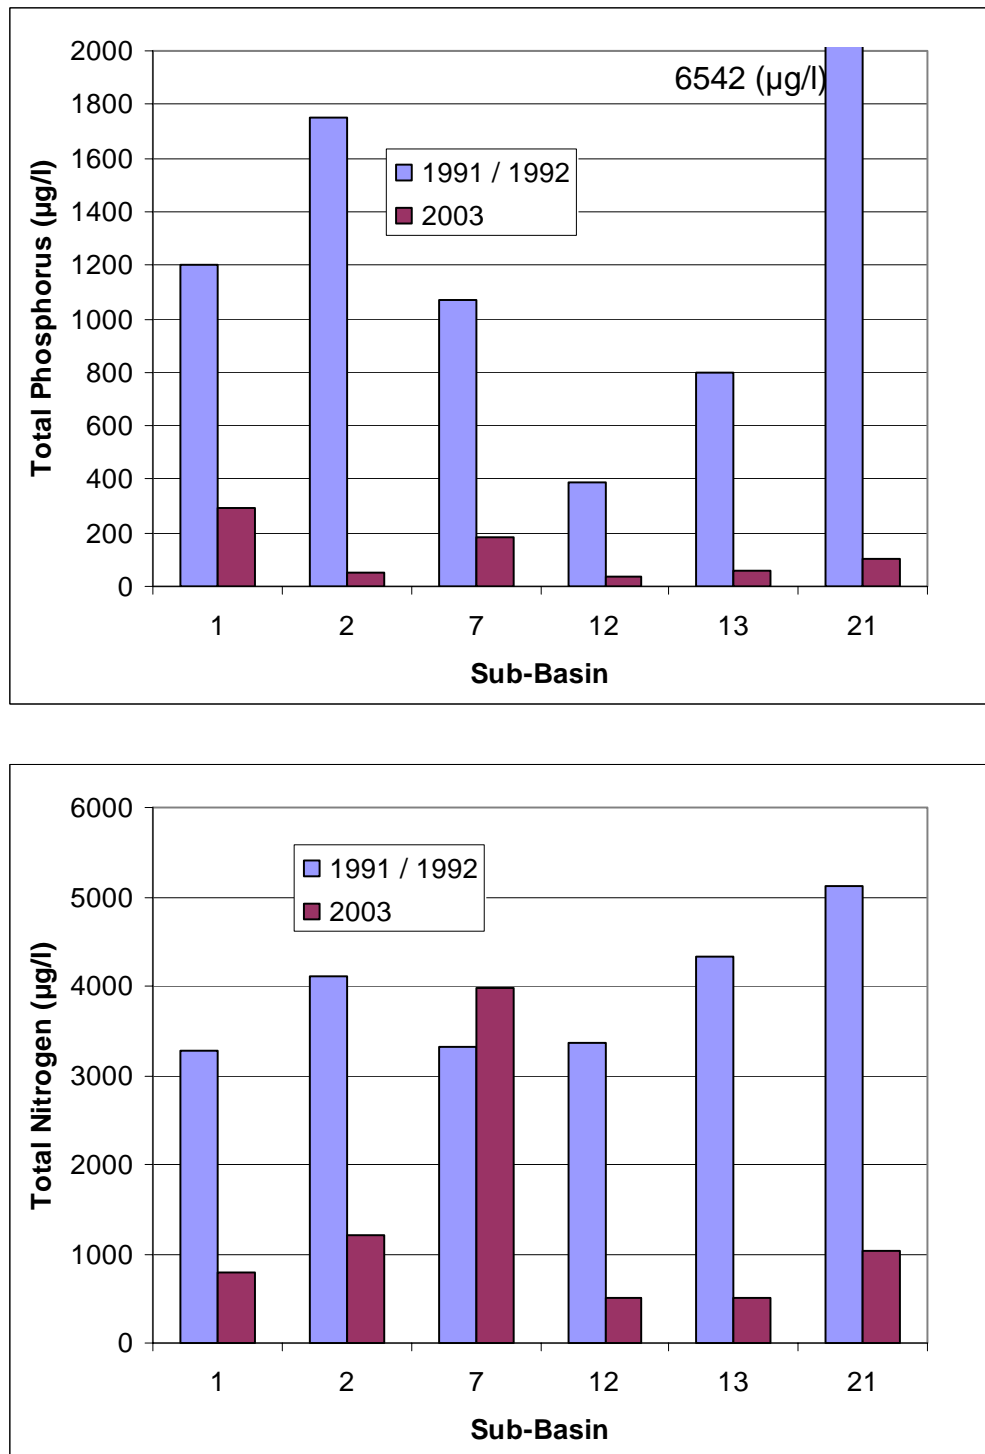
Figure 4-3. Comparison of Mean Concentrations of Total Nitrogen and Total Phosphorus in Stormwater Runoff entering Lake Holden during 1991/1992 and 2003.

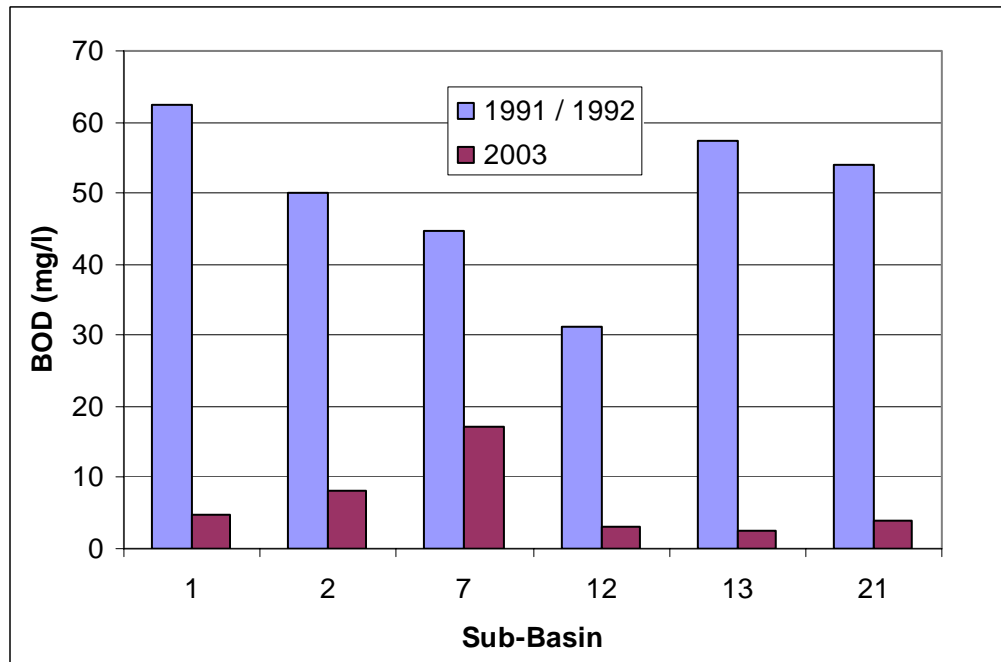
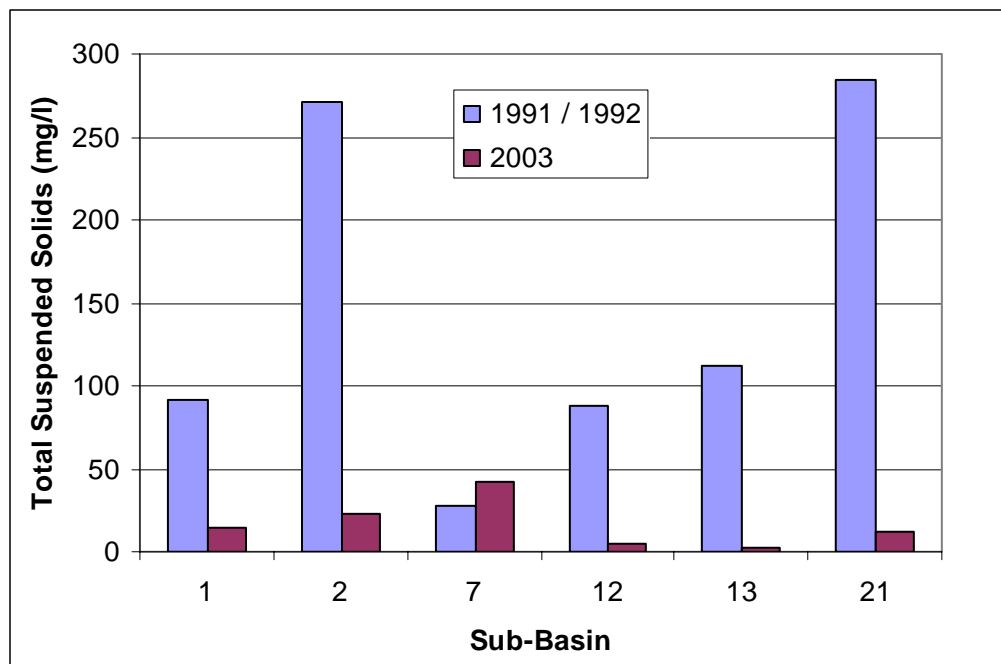
Figure 4-4. Comparison of Mean Concentrations of BOD and TSS in Stormwater Runoff entering Lake Holden during 1991/1992 and 2003.

A comparison of mean concentrations of TSS concentrations in stormwater runoff entering Lake Holden during 1991-92 and 2003 is also given in Figure 4-4. Substantial reductions in TSS concentrations are apparent at each of the five sites where stormwater treatment systems have been installed. TSS concentrations in Sub-basin 7, where stormwater treatment has not occurred, are relatively similar between the two monitoring periods.

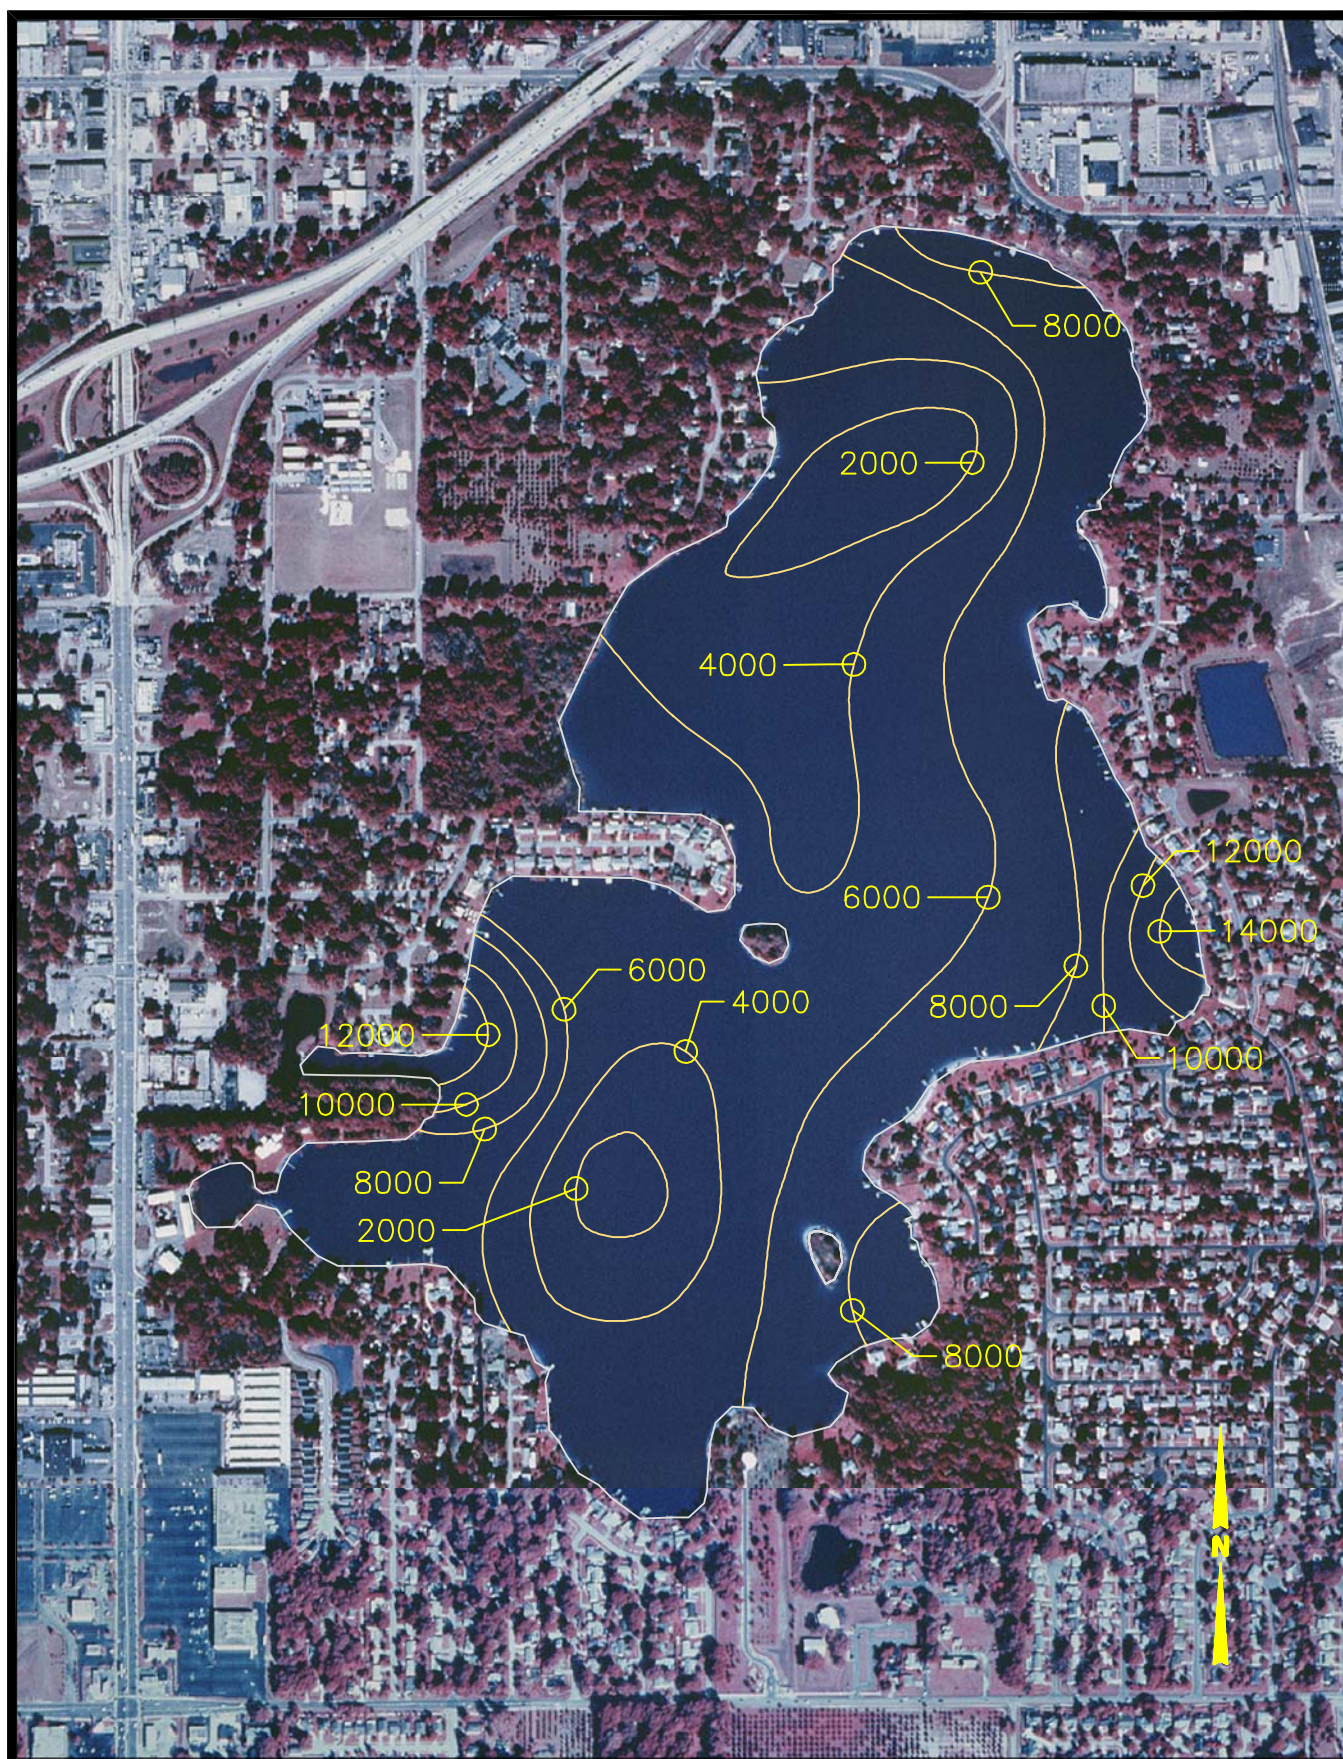
Figure 4-5. Isopleths of Total Nitrogen Influx ( $\mu\text{g}/\text{m}^2 \cdot \text{day}$ ) from Groundwater Seepage Entering Lake Holden.

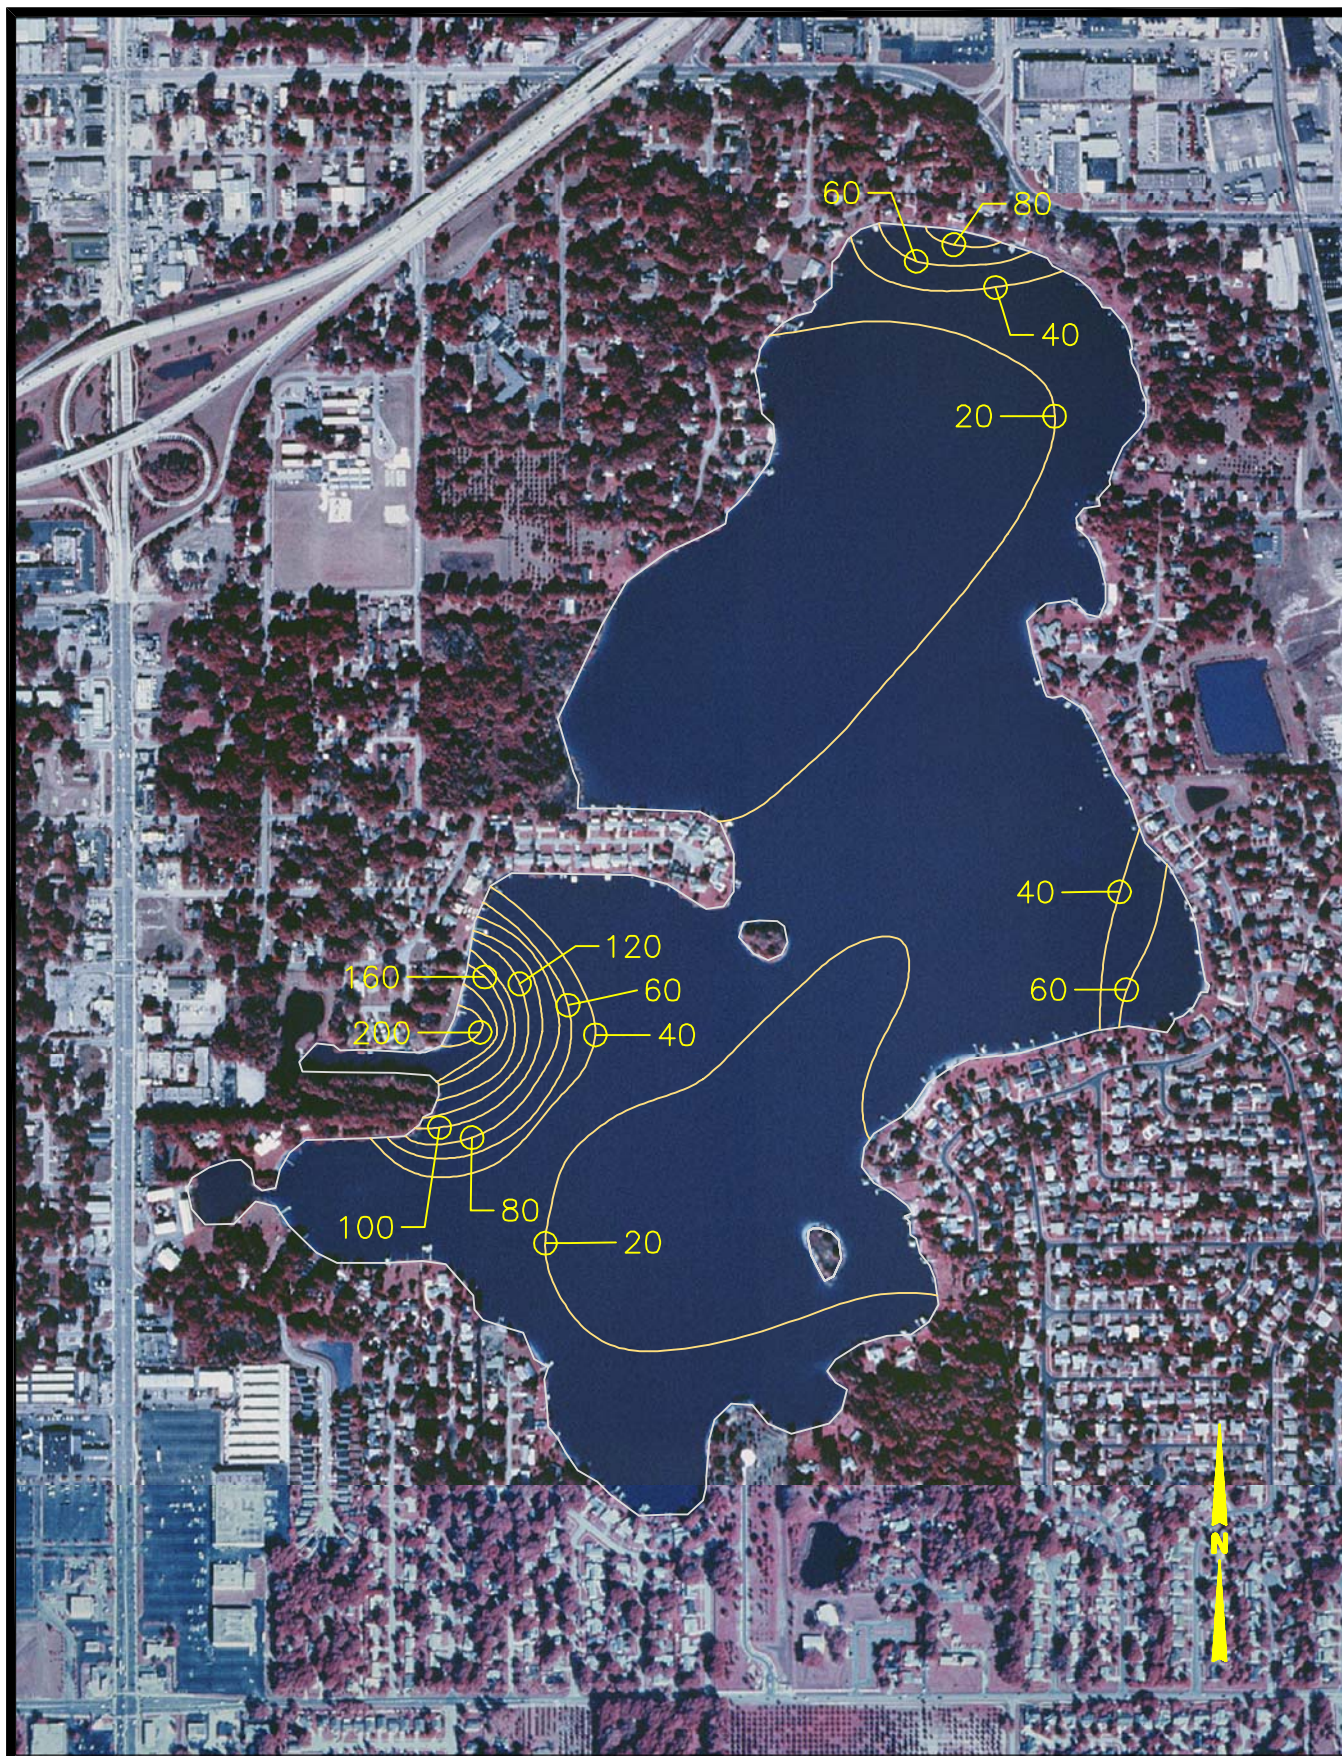
Figure 4-6. Isopleths of Total Phosphorus Influx ( $\mu\text{g}/\text{m}^2 \cdot \text{day}$ ) from Groundwater Seepage Entering Lake Holden.

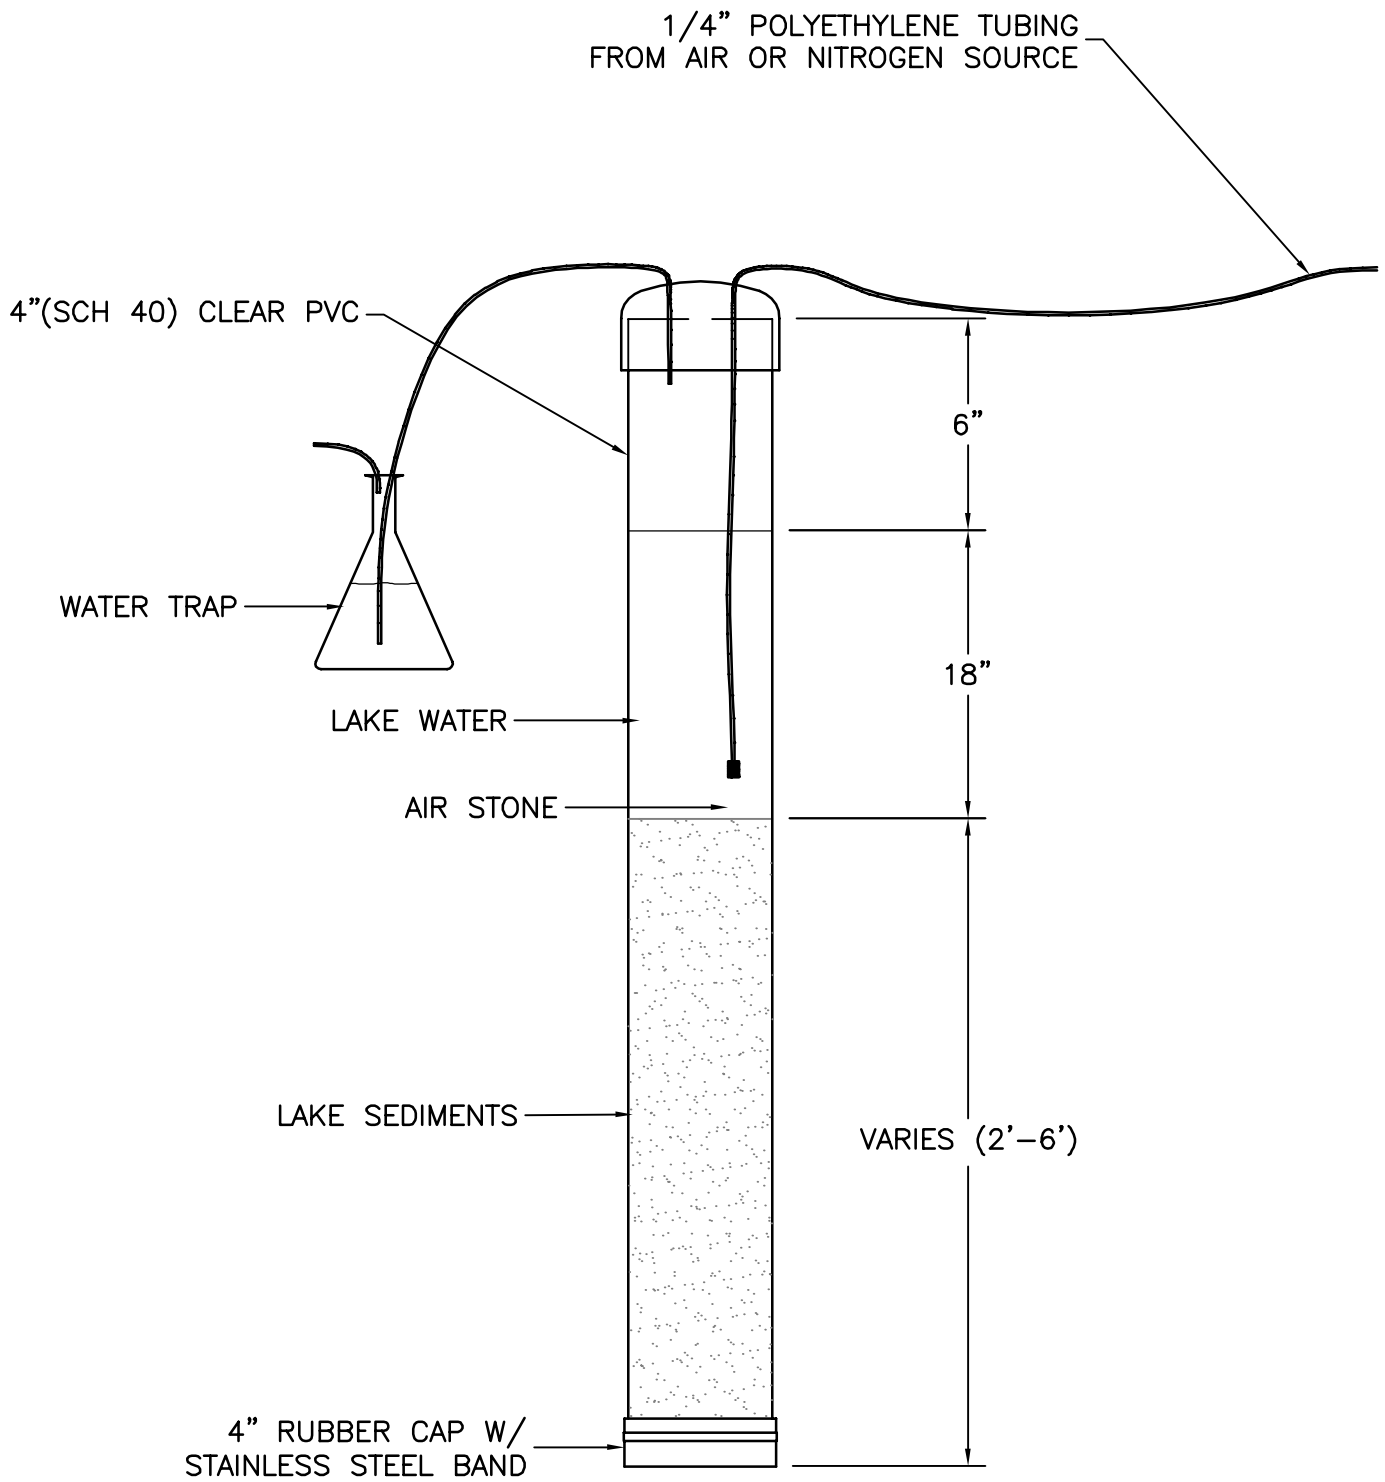
After initial set-up of the incubation apparatus, compressed air was introduced into each of the core tubes, through the individual diffusers, using a compressed air source. This process quickly created aerobic conditions within each of the six core tubes. This aeration process was continued in each of the core tubes for a period of approximately 60 days. During the aeration process, the water within each of the core tubes was well mixed, so that phosphorus released from the sediments could be quantified as a function of changes in phosphorus concentrations within the water column of each core tube. On approximately a 1-2 day interval, 15 ml of water was withdrawn from each of the columns using a 1/4-inch polyethylene tube and a plastic laboratory syringe. Each of the collected samples was immediately filtered using a 0.45 micron syringe type membrane filter and analyzed for orthophosphorus along with other significant laboratory parameters for research purposes. However, only the results of the orthophosphorus analyses are utilized in this report for purposes of estimating sediment phosphorus release rates.

Figure 4-7. Schematic of Sediment Incubation Apparatus.

At the conclusion of the experimentation under aerobic conditions, the compressed air source was replaced with a pure nitrogen source. Nitrogen gas was gently bubbled through each of the six columns to remove existing dissolved oxygen and create anoxic conditions within each tube. In general, creation of anoxic conditions, as indicated by measurements of redox potential ( $< 200$  mv) within each of the columns, occurred after approximately 5-7 days. At the onset of anoxic conditions, sample collection was conducted on a 1-2 day basis from each of the six columns using the method previously outlined for aerobic conditions. Incubation of samples under anoxic conditions was continued for approximately 30 days.

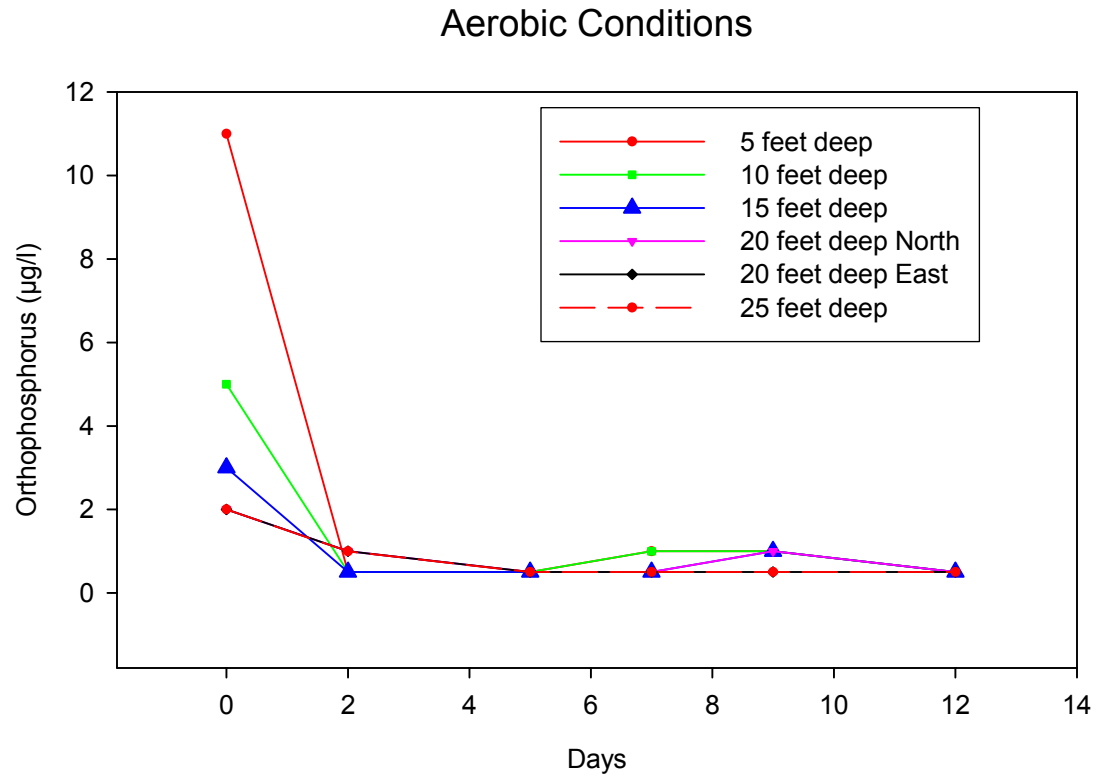
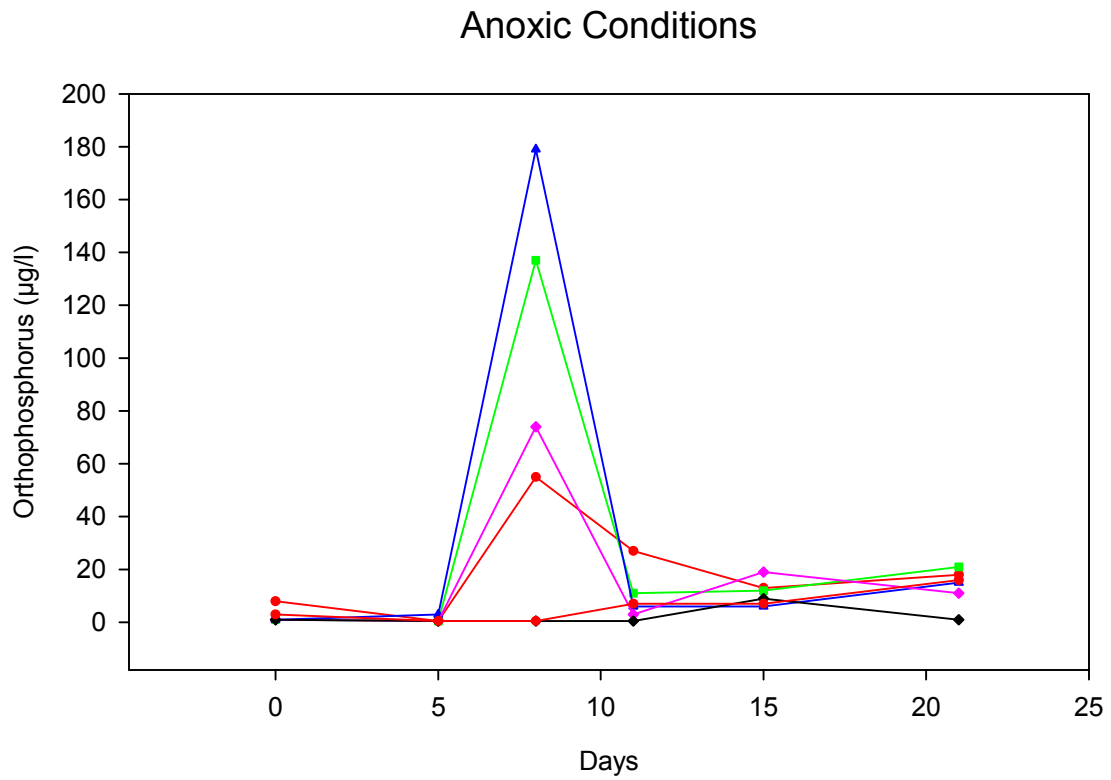
However, under anoxic conditions, substantial release of orthophosphorus was observed from the sediments in each of the sediment core tubes. This initial release occurred after approximately 5-10 days of incubation, followed by a rapid decrease in orthophosphorus concentrations as biological activity within the water column and sediments rapidly absorbed the available phosphorus as it was released. The large release of orthophosphorus released under anoxic conditions supports the presumption that sediments within Lake Holden are capable of releasing large amounts of phosphorus into the overlying water column during certain times of the year.

Figure 4-8. Orthophosphorus Release from Lake Holden Sediment Cores During Aerobic and Anoxic Conditions.

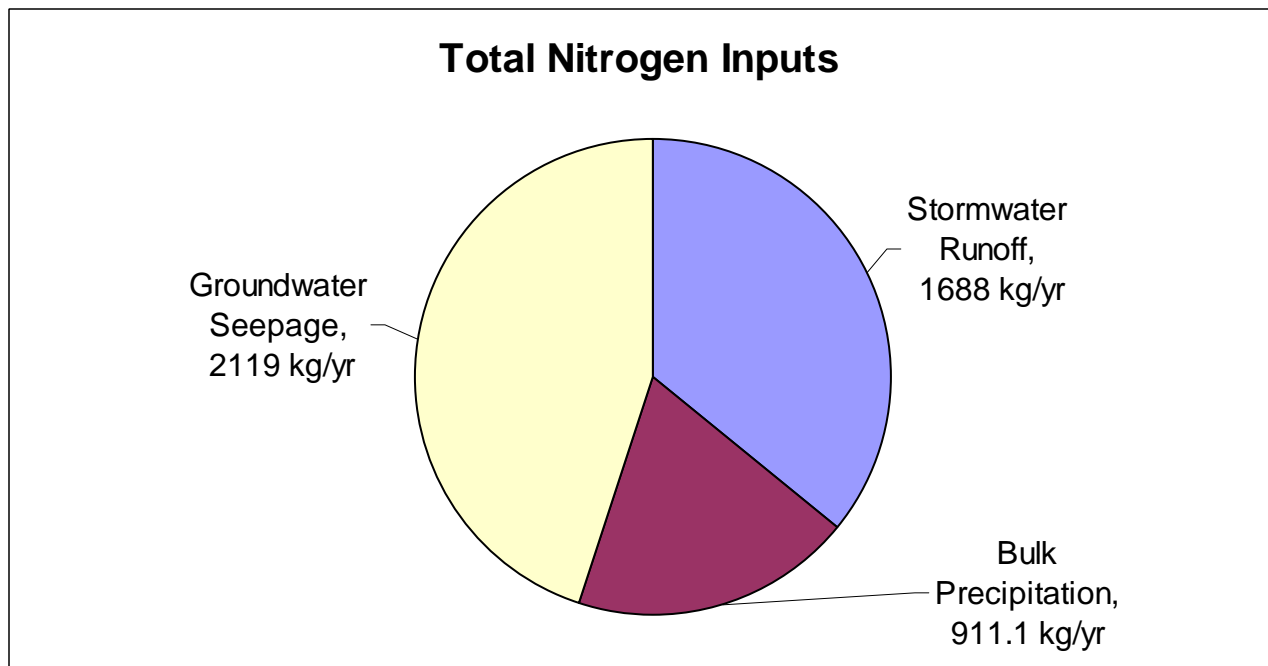
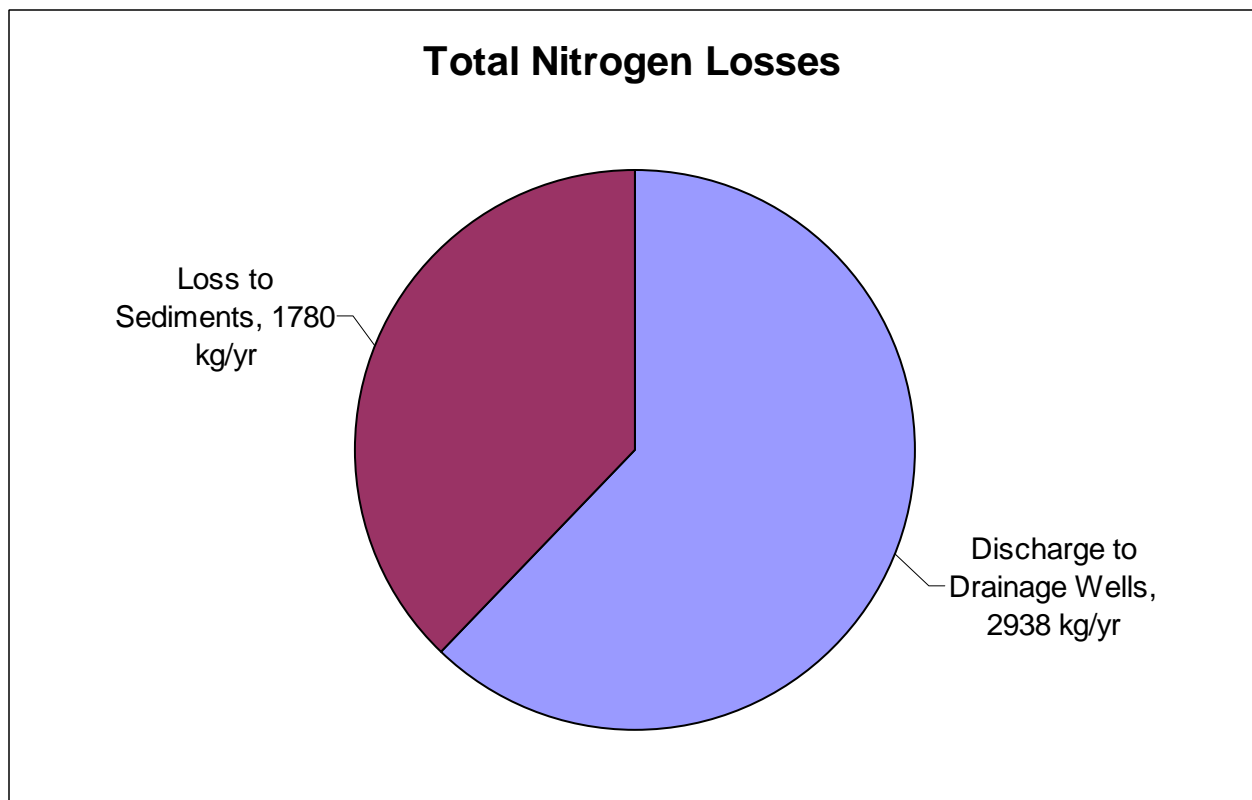
Estimated annual losses of total nitrogen from Lake Holden are summarized in Table 4-17. Approximately 62.3% of the total nitrogen inputs to Lake Holden are discharged to the drainage well structures within the lake. The remaining 37.7% of nitrogen inputs are deposited into sediments within the lake. A graphical comparison of inputs and losses of total nitrogen in Lake Holden is given in Figure 4-9.

Figure 4-9. Comparison of Inputs and Losses of Total Nitrogen in Lake Holden.

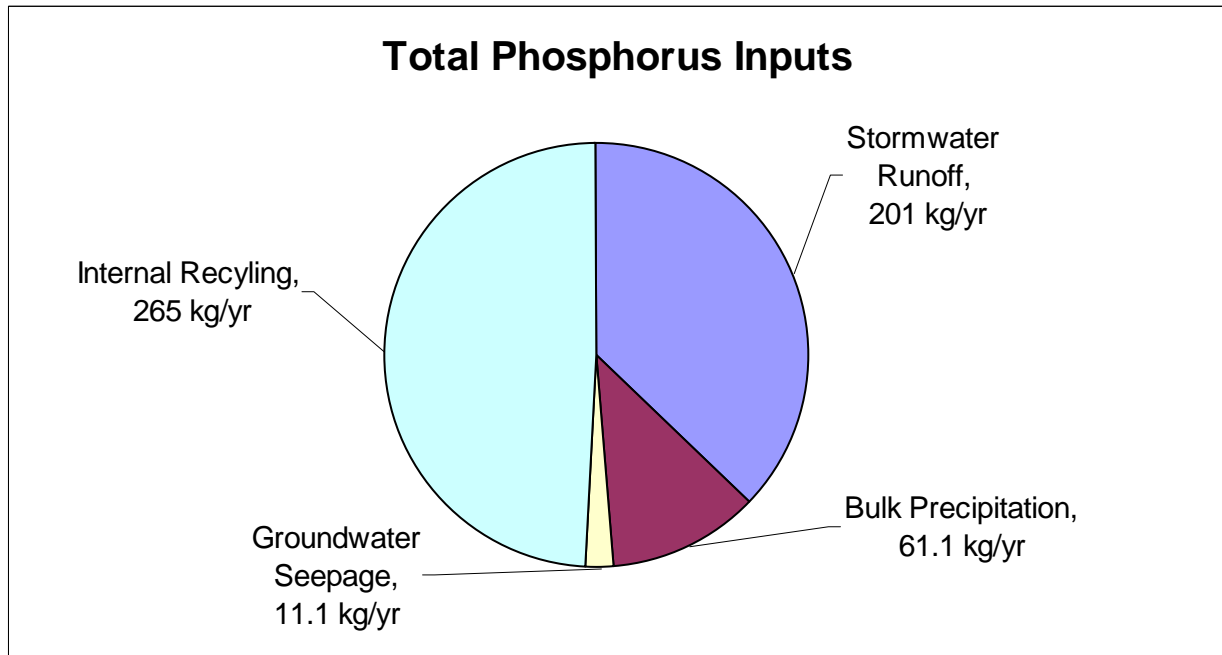
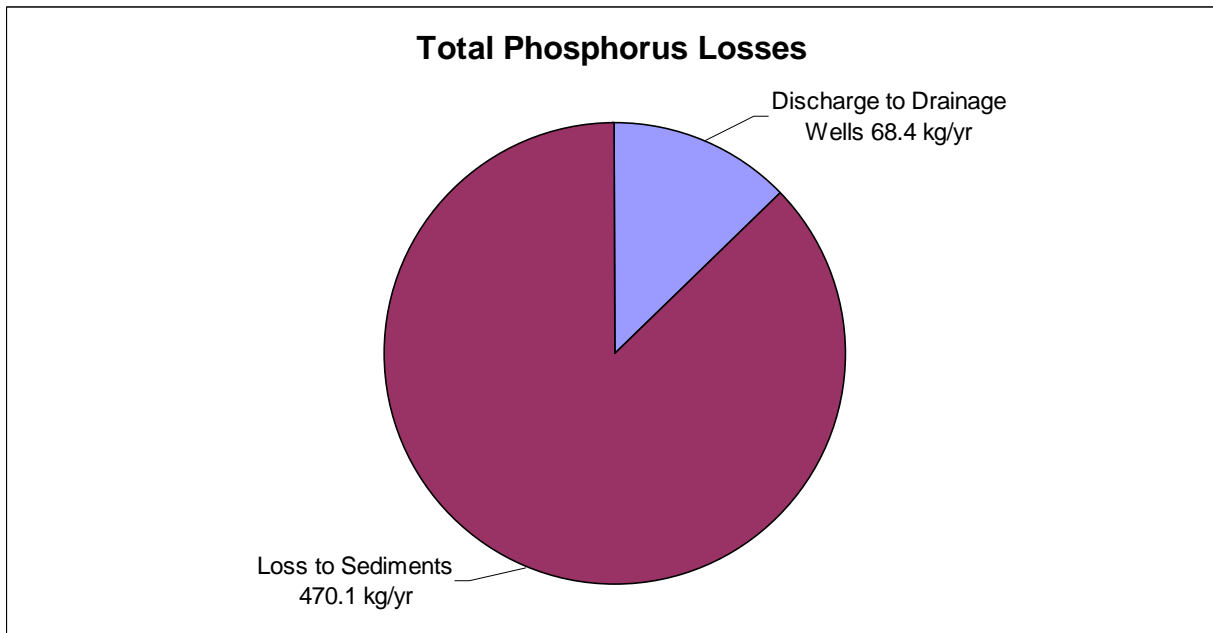
Figure 4-10. Comparison of Inputs and Losses of Total Phosphorus in Lake Holden.
